Metallurgical Analysis of Surface Defect in Telescopic Front Fork

Souvik Das, Janak Lal, Arthita Dey, Goutam Mukhopadhyay, Sandip Bhattacharya

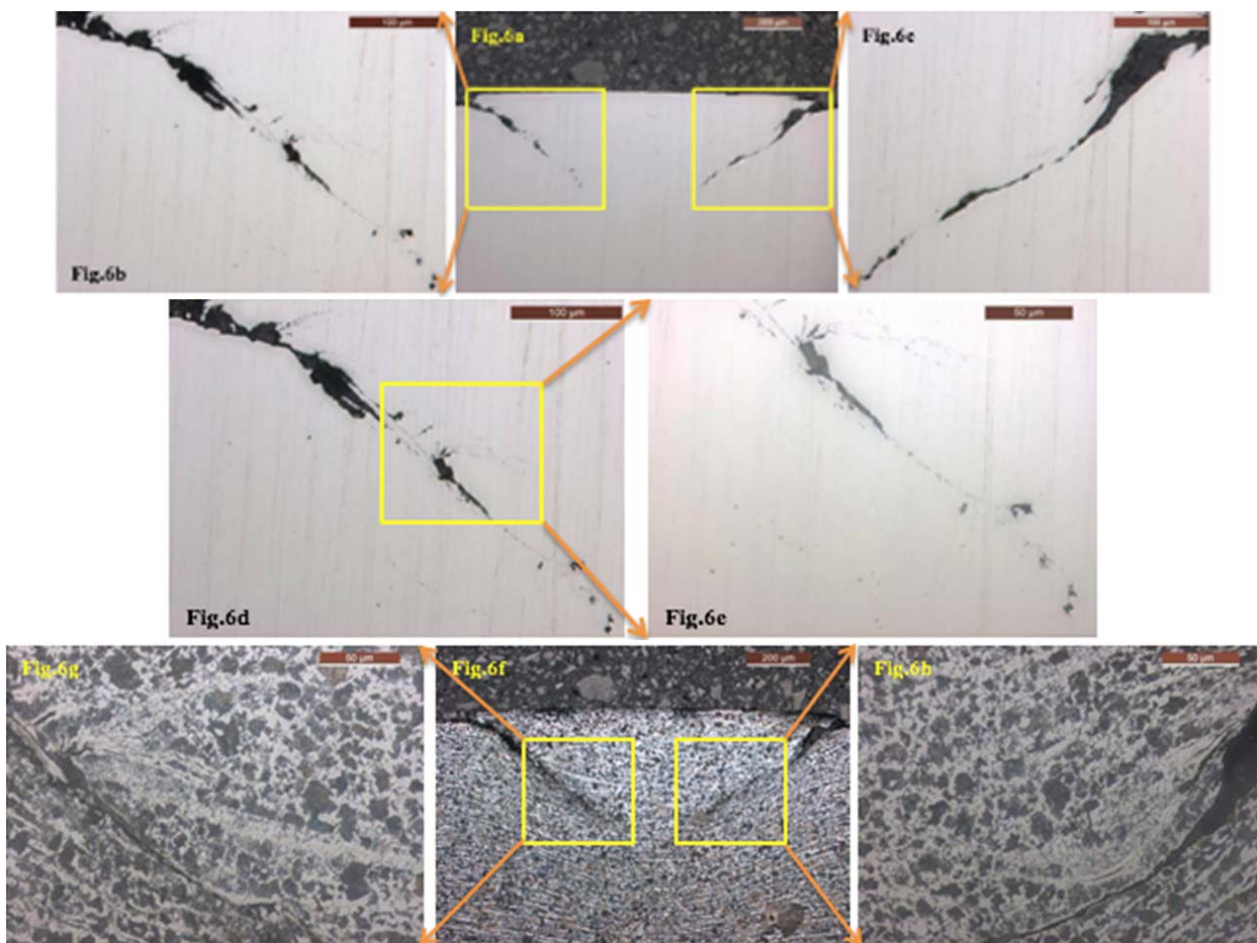
Sample #2: Un-etched micro image of the samples from defect area revealed bowl shaped defect. This was formed by chipped-off material as shown in Fig. 6 (a). Figs. 6 (b) and (c) show closer view of the cracks on both edges of the defect. It can be observed that the cracks contain some non-metallic entrapments in it. At higher magnification, as shown in Fig. 6 (e), suspected internal oxidation can be observed in chipped-off material.

The etched microstructure at the defect location is shown in Fig. 7 (a). Banded ferrite - pearlite structure was observed which followed the contours of the defect/chipped-off material. At higher magnification, decarburised grains were observed along the suspected internal oxidation. The chipped-off material does not show any banding or deformation. However, due to accumulation of this material, grains in the matrix below, it got deformed which is cold condition effect.

Fig. 6 (a)-(d) Un-etched micro image of the defect location at different magnifications, (e) Presence of dark brown entrapment along with internal oxidation (f)-(h) Etched micro image of the defect location at different magnifications

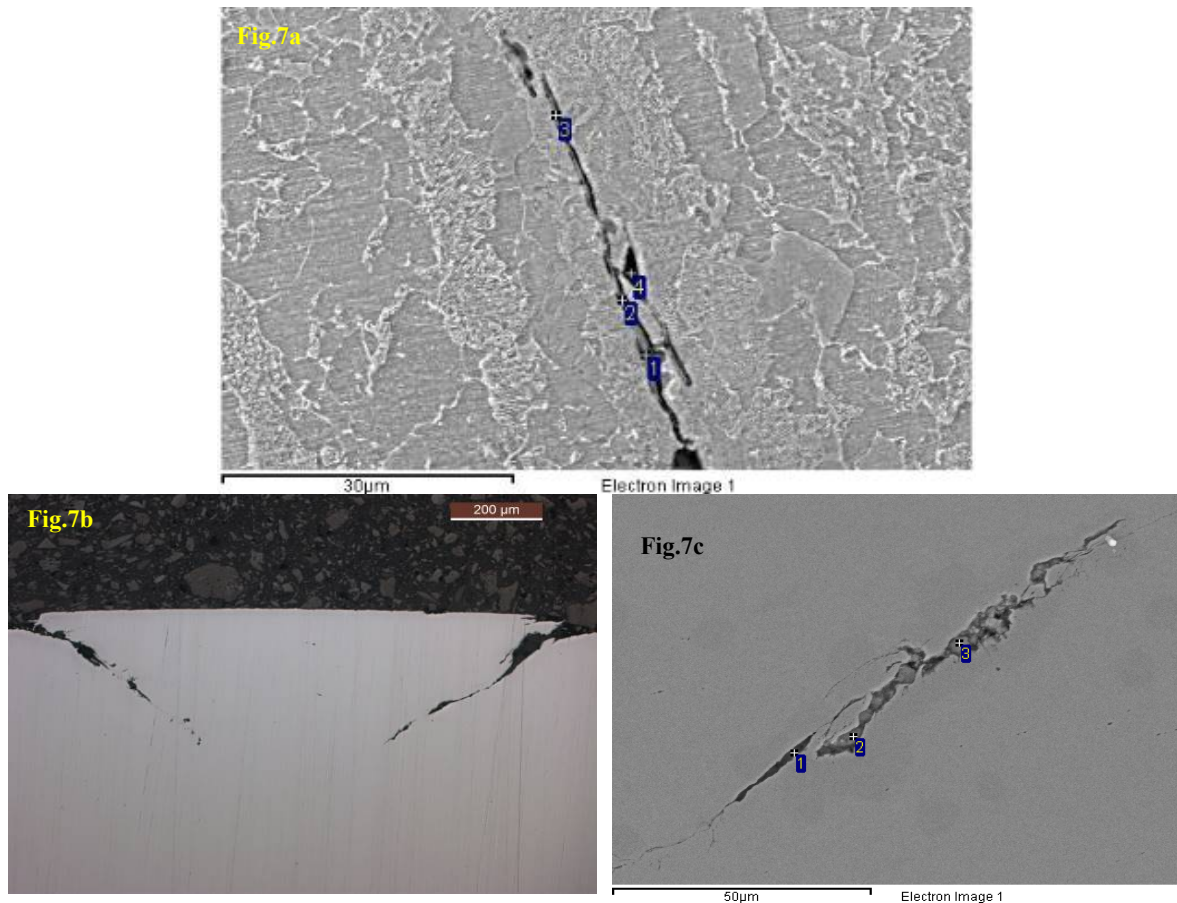
Sample #1: EDS analysis was carried out on non-metallic inclusion by Scanning Electron Microscope at an accelerating voltage of 15 kV. EDS analysis confirmed the inclusions as

MnS (Fig. 7 (a), Table II). Then, inclusion rating was also carried out by ASTM E 45 method to check overall cleanliness of the steel. The inclusion rating, shown in Table III, revealed higher MnS inclusions in steel.

Fig. 7 (a) EDS analysis of sample#1 at cracked location, (b) and (c) EDS analysis of sample#2 at defect location

Sample #2: EDS analysis of the dark brown entrapment revealed prominent peaks of Ca, Si, Al, Na, F and O which proves that crack has generated due to mould powder entrapment.
