Failure Analysis of a Medium Duty Vehicle Leaf Spring

Abstract—This paper summarizes the work conducted to assess the root cause of the failure of a medium commercial vehicle leaf spring failed in service. Macro- and micro-fractographic analyses by scanning electron microscope as well as material verification tests were conducted in order to understand the failure mechanisms and root cause of the failure. Findings from the fractographic analyses indicated that failure mechanism is fatigue. Crack initiation was identified to have occurred from a point on the top surface near to the front face and to the left side. Two other crack initiation points were also observed, however, these cracks did not propagate. The propagation mode of the fatigue crack revealed that the cyclic loads resulting in crack initiation and propagation were unidirectional bending. Fractographic analyses have also showed that the root cause of the fatigue crack initiation and propagation was loading the part above design stress. Material properties of the part were also verified by chemical composition analysis, microstructural analysis by optical microscopy and hardness tests.

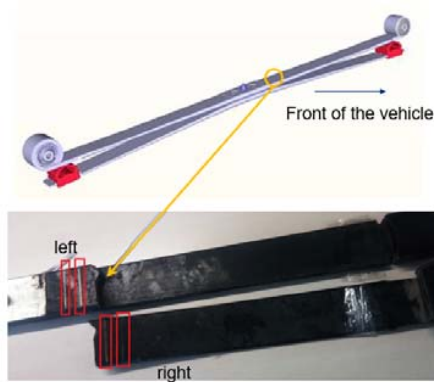
Location of failure is shown on Fig. 1. A complete separation of the upper leaf spring has occurred on vehicle due to fracture. Failure has occurred near to the center to the front side of the leaf. Red rectangles on the picture show the material verification test sample locations.

Fig. 1 Failure location

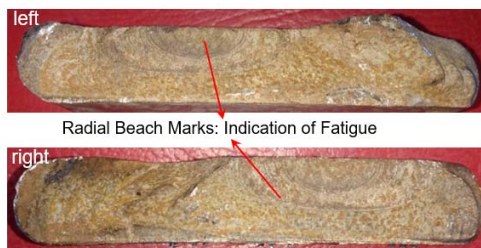
Fracture surface conditions are shown as-received on Fig. 2. Surfaces were corroded at field. However, radial beach marks which are indications of fatigue could still easily be detected.

Fig. 2 Fracture surfaces at as-received condition

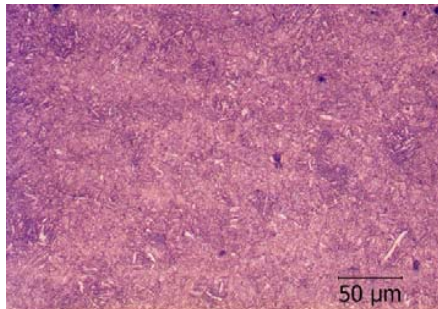
A microscopical analysis was carried out by optical microscope on samples from 5 mm and 50 mm to the failed section. Observed microstructure is tempered martensite as specified. No remarkable bainite or retained austenite phases were observed within the structure which may reduce mechanical strength and durability of the part under cyclic loading conditions.

Measured grain size is ASTM grade 8 as per ASTM E112 Method or finer which is as required. Fig. 3 shows a representative micrograph from the examined samples.

Fig. 3 Microstructure

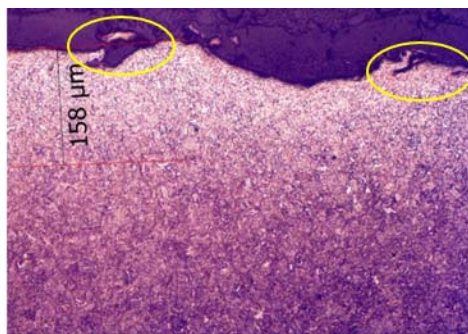
The specified level of decarburization depth of the part is 250 μm at maximum and partial type (Type 2). The observed decarburization type was partial and values of decarburization

depths from the examined region are within a range of 158 to 169 μm ; which describes no abnormal decarburization profile of the part surface.

During microstructural studies, small size of oxidized laps is potentially formed by subsequent oxidation of laps originated during hot rolling process. These surface irregularities were further searched for at the crack origin region whether there is a link to the failure mechanism, during fractographic examinations by SEM and will be discussed on the Micro-Fractography section. Fig. 4 shows a representative micrograph from the surface showing both the decarburization depth of 158 μm and oxidized laps.

Fig. 4 Decarburization extent and surface condition

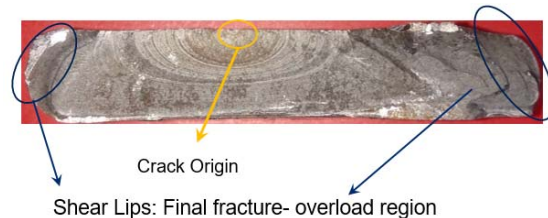
For microscopic examinations, the surfaces were cleaned by ultrasonic cleaning method with the usage of a special cleaning agent. Left-side fracture surface after cleaning is shown on Fig. 5. The thumbnail type of fatigue crack and shear lips at the final fracture region can be differentiated on this figure.

Macro examinations showed that a fatigue crack is present on the failed section. The shear lips and rough surface to the edges describe the final fracture region. Macroscopically observable size of the fatigue crack was found to be

approximately one-fourth of the total cross-sectional area. As the thumbnail shape of the crack is a possible indication of stress-corrosion cracking; further investigations were conducted on the micro-examinations and will be discussed in the micro-fractography section.

Fig. 5 Fracture surface (left-side) after ultrasonic cleaning

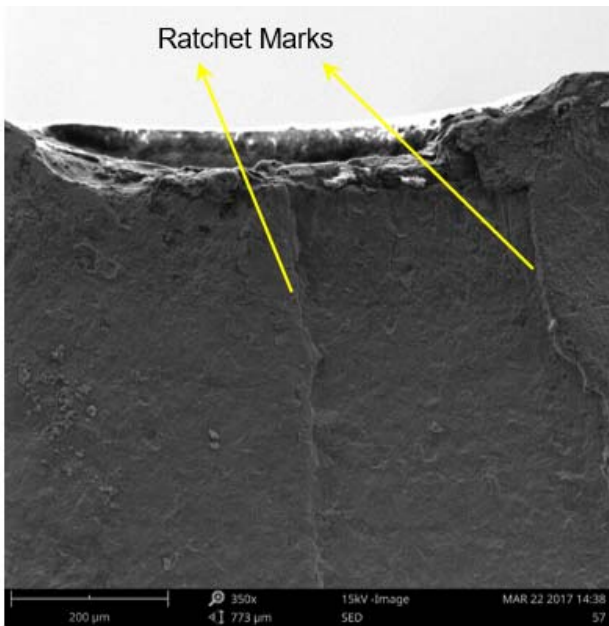
Fig. 7 shows the fatigue crack origin (point a) at X350 magnification. Ratchet marks which are indications of fatigue crack initiation mechanism were observed at the crack origin. Crack has emanated from a surface collapse of $\sim 500 \mu\text{m}$ which is possibly formed by plastic deformation of the surface during shot peening process. On the other hand, this is accepted as a natural phenomenon as these regions can act as local stress-raisers.

Examinations on crack origin showed that the crack initiation has occurred at single region. Singular crack initiation requires very low stress concentration. Examinations at crack origin region showed that this region is free of pre-existing cracks and metallurgical defects. These findings of low stress concentration and defect-free surface and singular type of crack propagation indicate that the reason of fatigue crack initiation and propagation is high magnitude of cyclic

Fig. 7 Crack origin

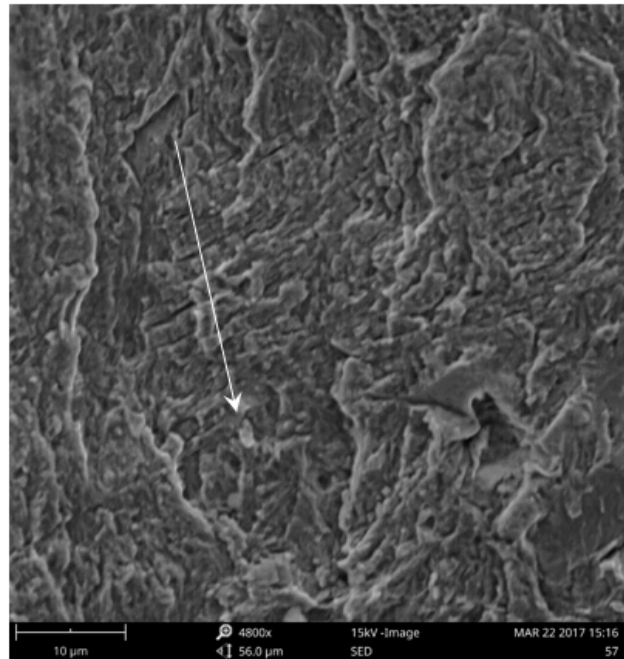
Fig. 9 Fatigue crack propagation direction and striations (point b)

Figs. 9 and 10 show the crack propagation directions. Fatigue striations can also be observed on Fig. 9 which are indications of stable crack propagation.

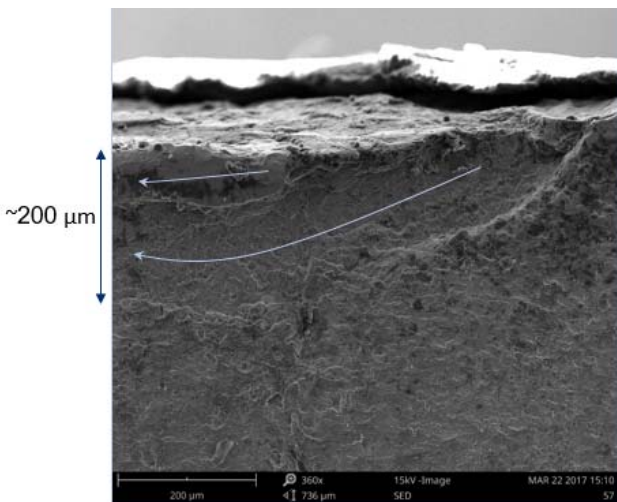
Fig. 8 shows the extension of crack initiations further beyond to the left (point b). However these cracks did not propagate and fatigue cracking continued with initial crack starting from point a.

Fig. 8 Extension of multiple crack initiation

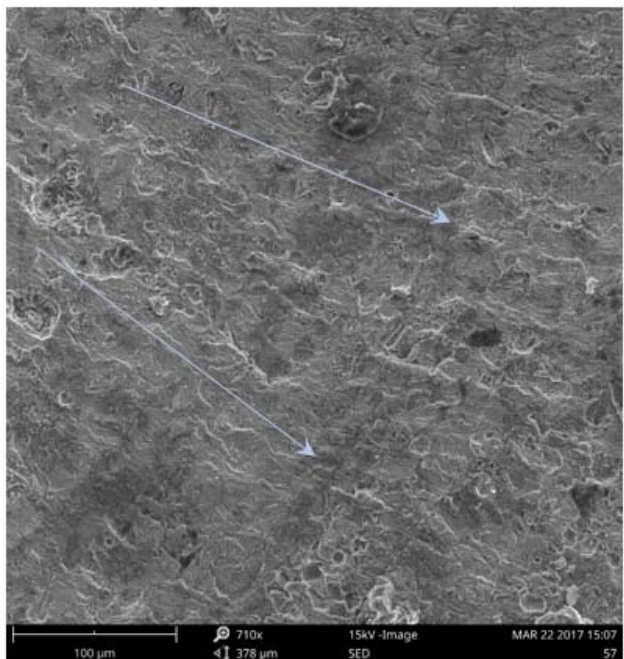
Fig. 10 Fatigue crack propagation directions (point c)

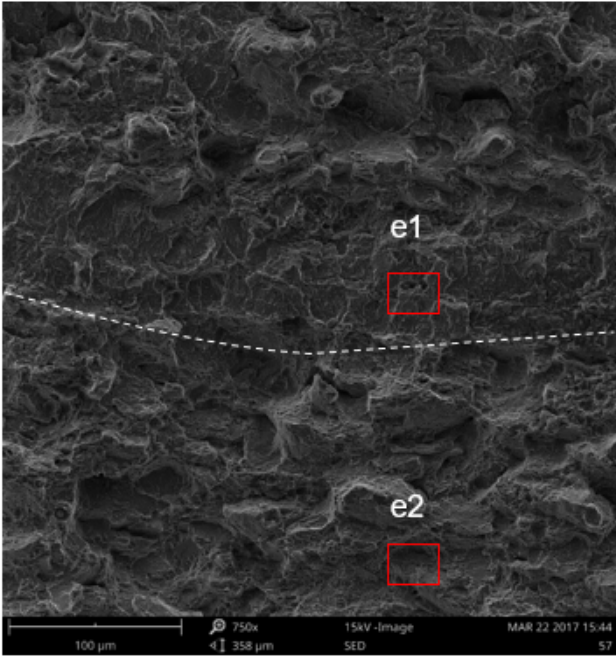
Micro examinations validated that the macroscopic transition from beach marks to rough and dull surface is the transition from fatigue to final overload fracture region. Figs. 11-13 describe the replication of fracture mechanism change from fatigue to ductile failure.

Fig. 11 Fatigue to overloading transition region (point e)

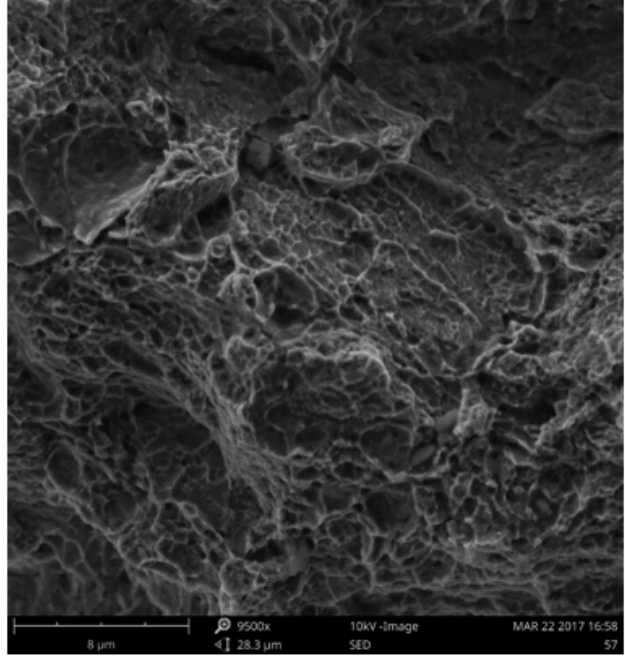
Striations and tear ridges were observed in fatigue region whereas dimples were observed on the overloading region.

Fig. 13 Ductile dimples due to overloading failure (e2)

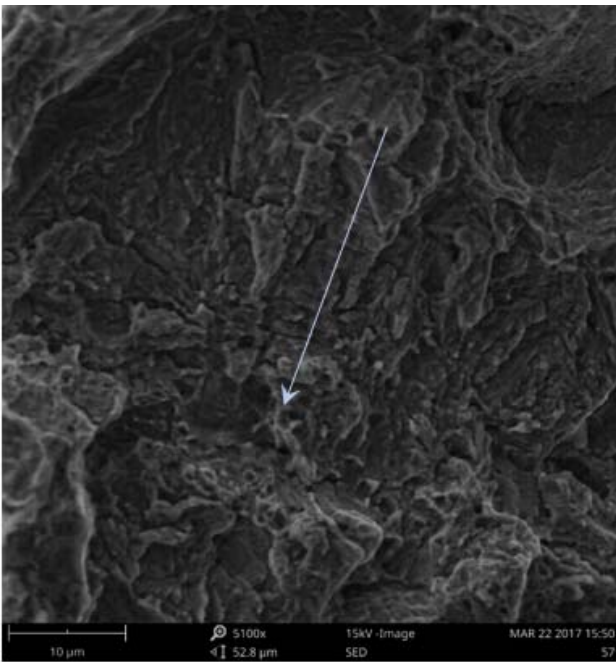
Fig. 12 Fatigue striations and tear ridges (e1)

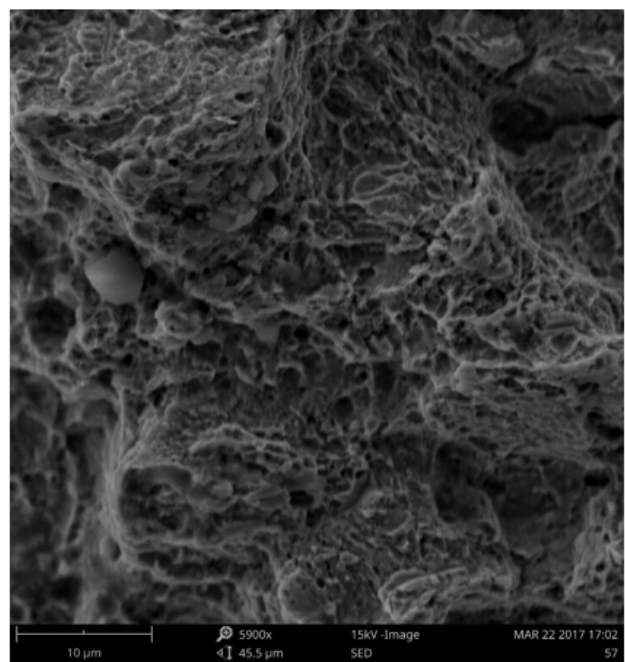
Fig. 14 Ductile dimples at final fracture (point f)

Figs. 14 and 15 show fractographs from the final failure regions. A complete ductile failure was observed near to the crack tip whereas both ductile and brittle features were observed near to the edge of the part. This may have occurred by more than one step of final overloading and increased strain rates at final stage resulting in cleavage plane formation due to brittle failure.

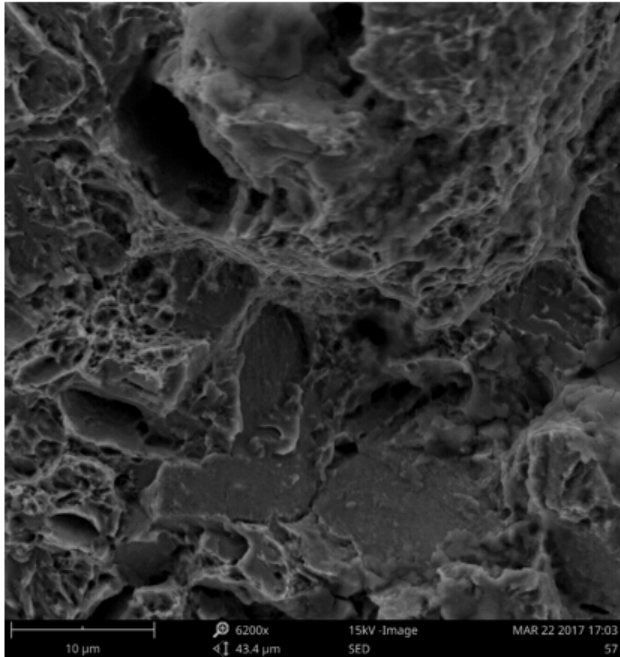
Fig. 15 Mixed type of overloading fracture (point g). Ductile dimples and brittle cleavage planes
