The Collapse of a Crane on Site: A Case Study

T. Teruzzi, S. Antonietti, C. Mosca, C. Paglia

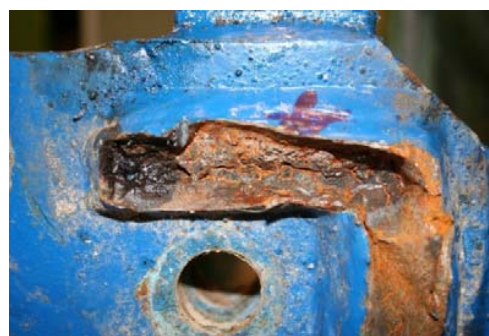
The problem addressed concerns on the analysis of the collapse of a tower crane used on a construction site. The structural collapse of the tower occurred at the upper joints of the extension element used to increase the height of the crane. This element consists of a steel lattice structure; the joints were prepared by arc welding of corner profiles with connecting plates to the adjacent tower element. The joints are of T-type. In the vicinity of the upper joints, the corner profiles have tapering which reduces the side from 140 to 90 mm (nominal dimensions). The breakage of the joints is always observed at the corner profiles at the height of the weld seam edge. Immediately after the collapse of the tower, the fracture surfaces were partially covered with rust (Fig. 1, joint

2). This may indicated that the opening of the joints did not occur instantly, but began before the accident. Furthermore, the detachment of the weld seam from the wall of the corner profiles is observed locally.

Fig. 1 Joint n. 2. Fracture surfaces covered with rust

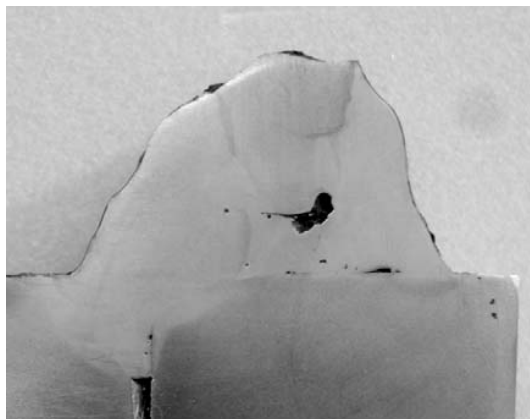
Fig. 2 Joint n. 1, Lack of penetration of the filler metal and pores

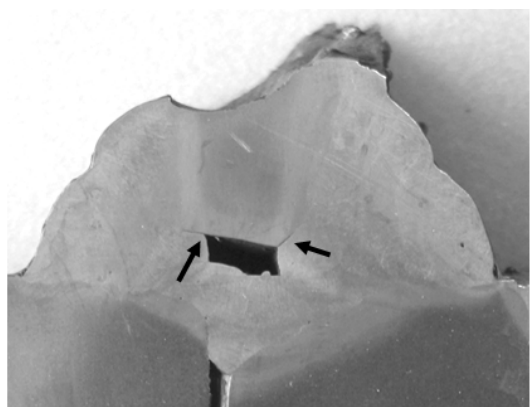
Fig. 3 Joint 2A, Lack of penetration of the filler metal and lack of fusion (arrows)

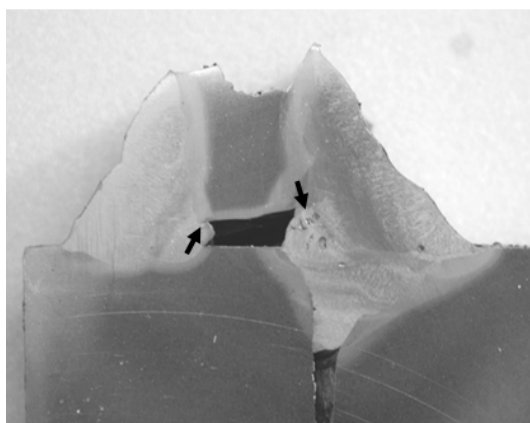
Fig. 4 Joint 3, Lack of penetration of the filler metal and lack of fusion (arrows)

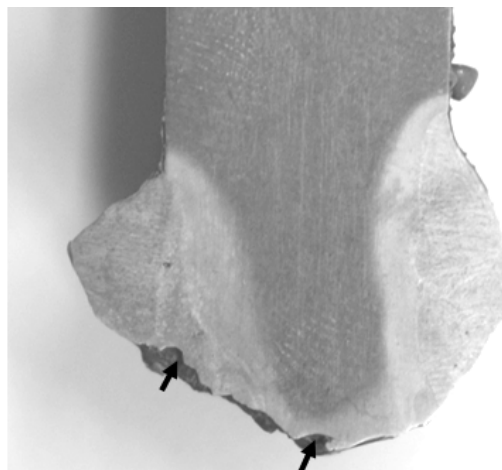
Fig. 5 Joint 2B, Presence of vacuoles along the fracture margin (arrows)

In joint 2, the fracture occurred partially in the filler material. In the specific case, the breakage surface is rich in pores and slags (Fig. 5).

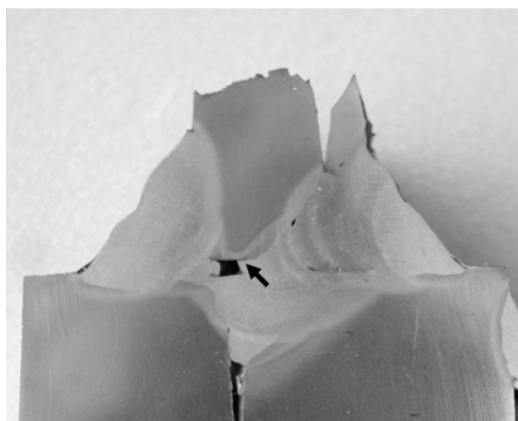
Fig. 6 Joint 4, Welding seam between the corner profile and the plate overlaps to the joint between the two elements making up the plates. Lack of penetration of the filler metal and lack of fusion (arrows)

The examination of the connection plates corresponding to the broken joints revealed that they are not monolithic, but they were obtained by joining two elements by welding. Locally, the welding seam between the corner profile and the plate overlaps the joint between the two elements making up the plates (Fig. 6). Welding on an existing welded joint is not in accordance with practice and is not recommended.

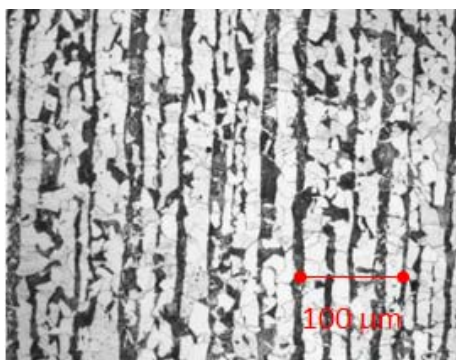
Fig. 7 Joint 1, Corner profile, base metal: micrograph #.1

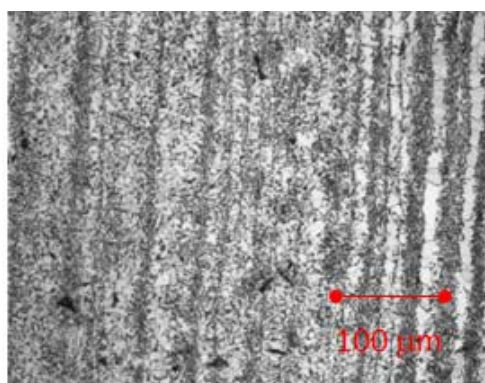
Fig. 8 Joint 1, corner profile, HAZ: micrograph #.2

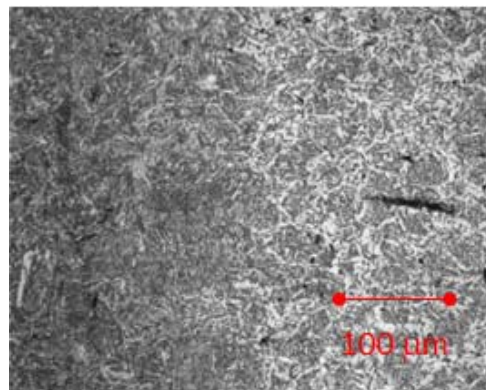
In the fusion welded joint there are three different areas: the fusion zone (FZ), the HAZ and the base material. The three areas have different microstructure. The conditions of the material can be clarified specifically, the implementation of surface treatments, any thermal treatments and therefore ascertaining the existence of probable deterioration phenomena (fatigue breakages, wear phenomena, surface corrosion, etc.) [6]. To highlight the microstructure of the samples, the glossy sections are subjected to an acid etching process (Nital 2%). The images are obtained with an optical microscope with reflected light in bright field mode. The microstructure of the corner profiles in the unaltered areas is characterized by the alternation of bands of ferrite and perlite oriented parallel to the axis of the profiles (Fig. 7). This is a typical structure of hot rolled products. The HAZ of the corner profiles has an approximate width of 2-3 mm and is characterized by the gradual dissolution of the perlite bands and by the formation of a globular ferritic-pearlitic structure with refined grain, similar to that obtainable by normalization treatment (Fig. 8). The structure of the corner profile in the area adjacent to the FZ is bainitic with enlarged grains (Fig. 9). The filler metal is characterized by a ferritic-bainitic structure.

Fig. 9 Joint 1, corner profile, FZ: micrograph #.4

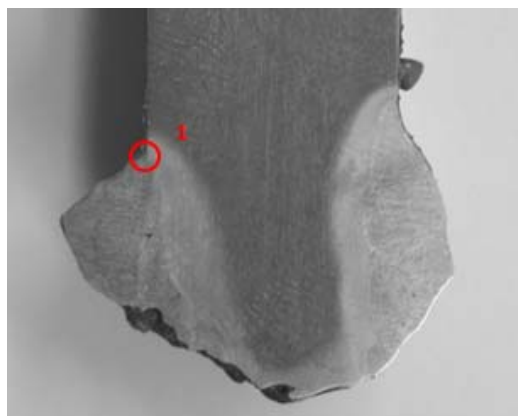
Fig. 10 Joint 2B, Corner profile, location micrograph #.1

At joint no. 2, in particular on specimen 2B, the presence of a marginal crack inside the HAZ of the corner profile is observed (Figs. 10, 11). It propagates from the upper edge of the weld seam and initially runs along the border line with the FZ, and then continues towards the core of the profile. It is a cold crack. This two-dimensional defect is unacceptable as it represents a discontinuity which, over time can lead to the failure of the joint, depending on the operating stress.

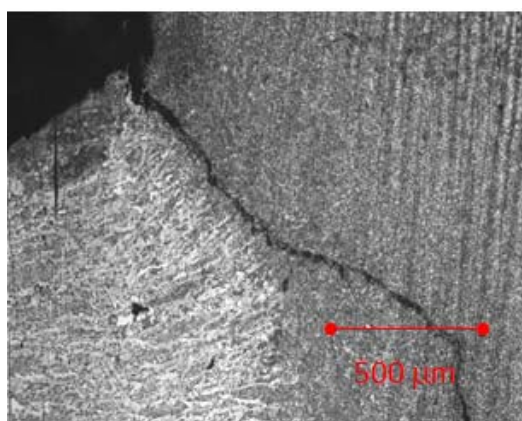
Fig. 11 Joint 2B, corner profile, HAZ: micrograph #.1. Cold cracking
