# Modelling for Roof Failure Analysis in an Underground Cave

M. Belén Prendes-Gero, Celestino González-Nicieza, M. Inmaculada Alvarez-Fernández

**Keywords**—Forensic analysis, hypothesis modelling, roof failure, seismic monitoring.

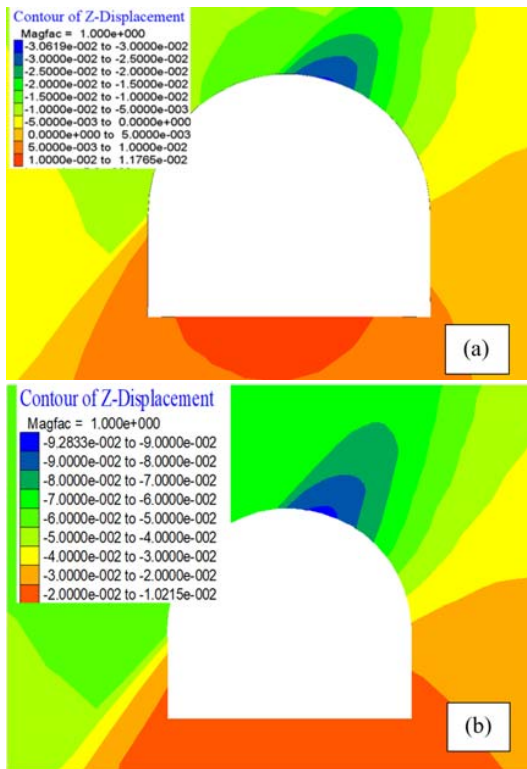
The simulation shows displacements of 3 cm in the roof and swellings of 1 cm in the floor. These displacements increase to 9 cm and 2 cm respectively after the longwall exploitation.

Fig. 7 Vertical displacements: (a) during tailgate opening; (b) during longwall exploitation

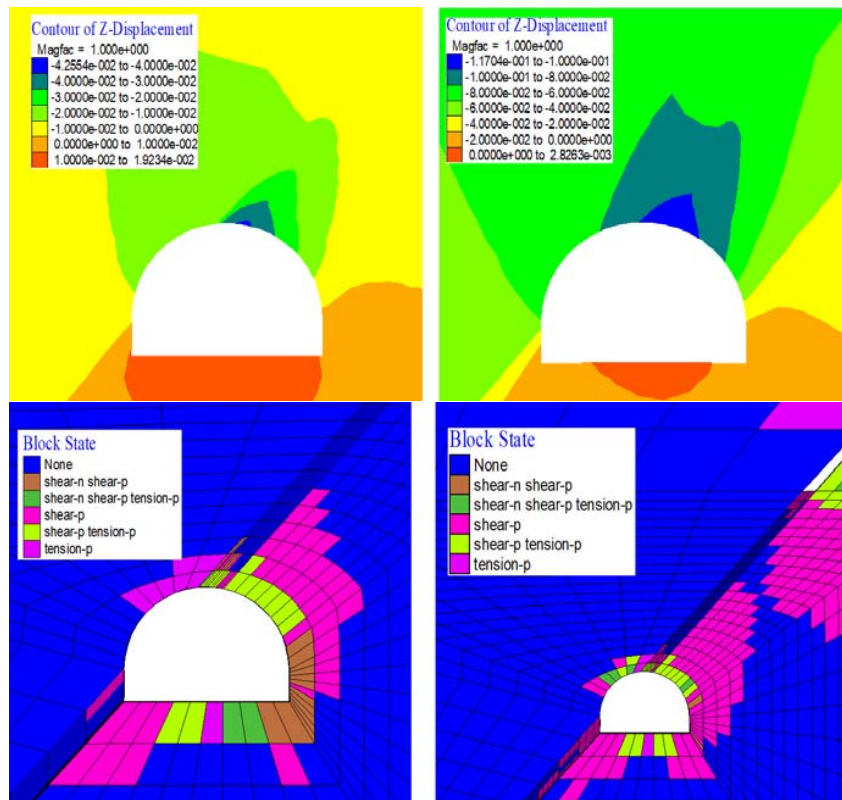
The bigger dimensions of the cross section produce an increase in the vertical displacements until 4 cm. Besides, a plasticized zone around the tailgate appears not only along the exploitation but also before it (Fig. 9).

Fig. 9 Vertical displacements and failure surrounding of the tailgate before and after the exploitation

Again, a change in the deformation appears in the intersection with the coal layer affecting the integrity of the shotcrete and producing cracks and detachments. The axial effort reaches the 24 t bigger than in the first case with one effort of 20 t.

After the exploitation, the displacements and the fractured surrounding increase in an important way and the support is overloaded until 60 t.

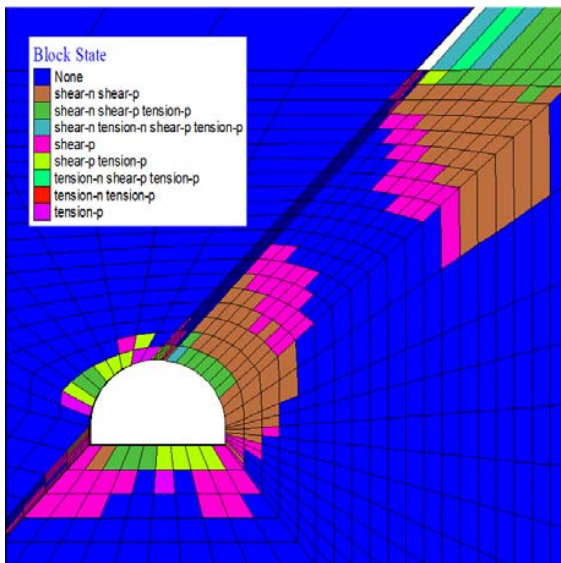
diagonal (14 m) because in this case, the plasticizing areas around the tailgate and the exploitation workshop appear again. On the other hand, with 80 m protection pillars, the plasticizing areas around the exploitation workshop and the tailgate are not connected (Fig. 12). Therefore, in case of one slide, it would be a local break in which the volume of material that can fall is much less and the support would

behave better. Based on these observations, it seems to be confirmed that the detachment was originated as a consequence of one sliding in the layer wall, due to the large roof span present in the place of the accident, and probably triggered as a consequence of the existence of a protection pillar insufficient.

Fig. 12 Failure surrounding after the exploitation for 14 m and with protection pillar of 80 m
