Fatigue Failure Analysis in AISI 304 Stainless Wind Turbine Shafts

M. F. V. Montezuma, E. P. Deus, M. C. Carvalho

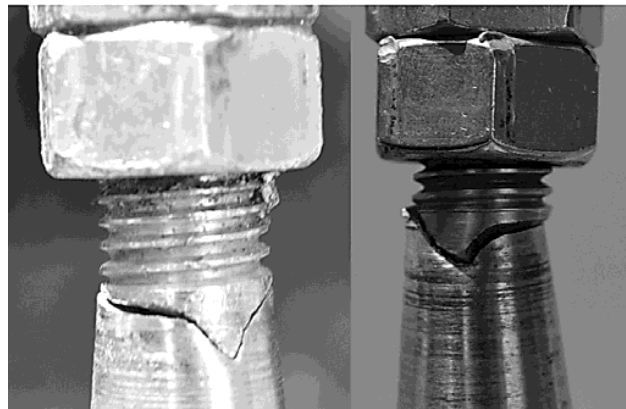
In the visual analysis, different failures morphologies were observed and compared with Metals Handbook [5]. The generator shafts A1700 - AP and RA broke at the beginning of the thread, Fig. 4, with fatigue break marks shown in detail in Figs. 5 and 6.

Fig. 4 AP and RA fractured shafts - Model A1700

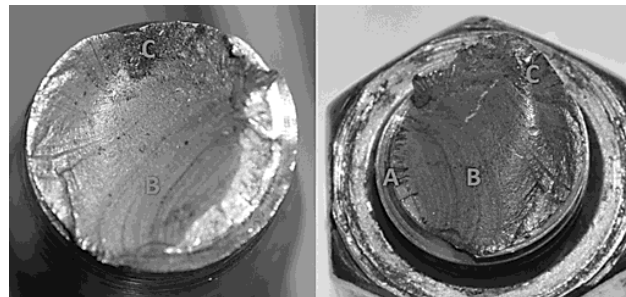
Fig. 5 View of the fatigue fracture region of the RA shaft: A - beginning of the fracture, B - beach marks, and C - final region of the fracture

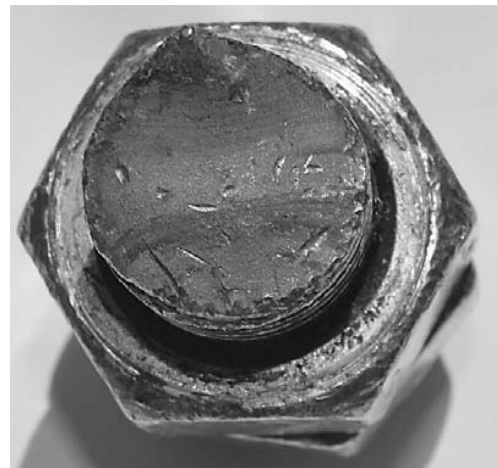
Fig. 6 View of the fatigue fracture region of the AP shaft – verification of beach marks

The visual inspection of the fracture on the AP shaft was compromised due to the numerous tool marks in the fracture regions, Fig. 6. However, it was possible to observe the "beach marks" characteristic of fatigue fracture.

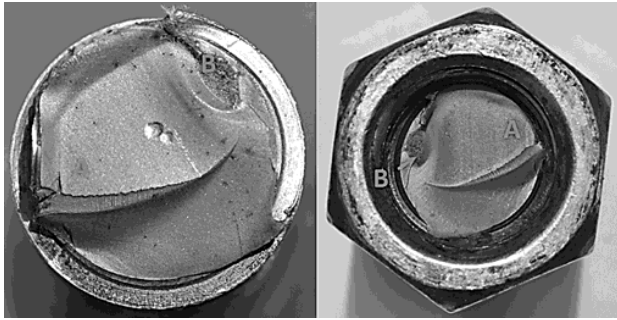
Fig. 7 View of the fatigue fracture region of the shaft I - Model A3300

The shaft I surface observed in Fig. 7 presented a region with a smooth aspect (A), corresponding to the area over which the crack spread slowly, and the smaller area (B) with a fibrous texture corresponds to the region the failure occurred. Quickly (catastrophic), which characterizes a fatigue failure.

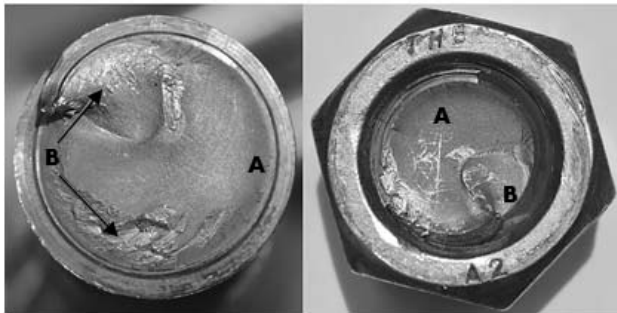
The B1 shaft, Fig. 8, presented two different types of fracture surface. On the right side, smooth surface (A), there is the fatigue zone, while on the other end, rough surface (B), the plastic zone is characterized by the appearance of tearing.

Fig. 8 View of the fatigue fracture region of the B1 shaft - Model A3300

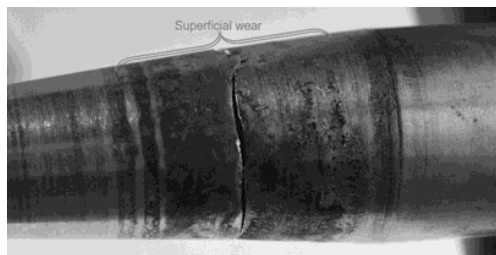
A superficial wear is visible on the PP axis of the A1700 wind turbine, where the part broke in the tapered transition region, favoring the initiation and propagation of cracks and fatigue failure, Fig. 9.

Fig. 9 View of the superficial wear on the fracture region of the PP axis - Model A1700

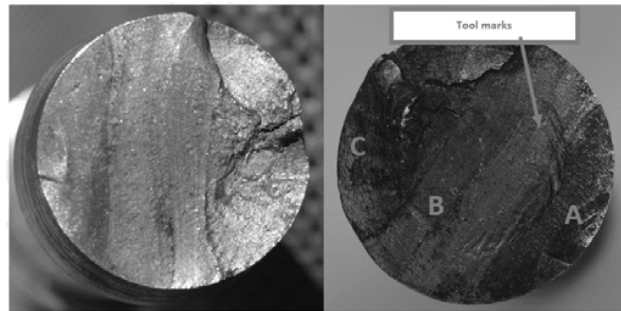
The fracture surface of the PP shaft can be seen in Fig. 10. Point A indicates the beginning of the crack that has spread, leaving "beach marks," indicated by point B and finally point C indicating the final region of the fracture. The fracture or rupture of the material usually occurs with the formation and propagation of a crack that begins at points where there is structural or compositional imperfection or a high-stress concentration, which generally occurs on the surface, as presented in the piece, where the wear marks and the consequent oxidation generated stress concentrating points. The darker coloration at point A shows oxidation and infiltration of contamination during the fracture's relatively long propagation stage.

Fig. 10 View of the fatigue fracture surface of the PP axis - Model A3300

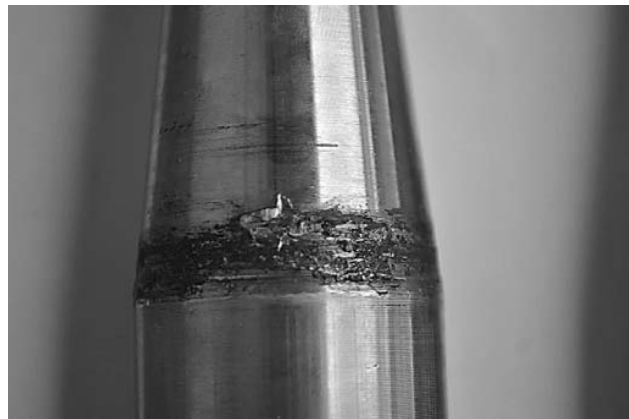
Similar wear was also observed in the B2 axis of the A3300 wind turbine, Fig. 11, and the other axes, however, with less intensity.

Fig. 11 Critical region of axis B2, due to loss of material due to wear (contact marks) and oxidation - Model A3300

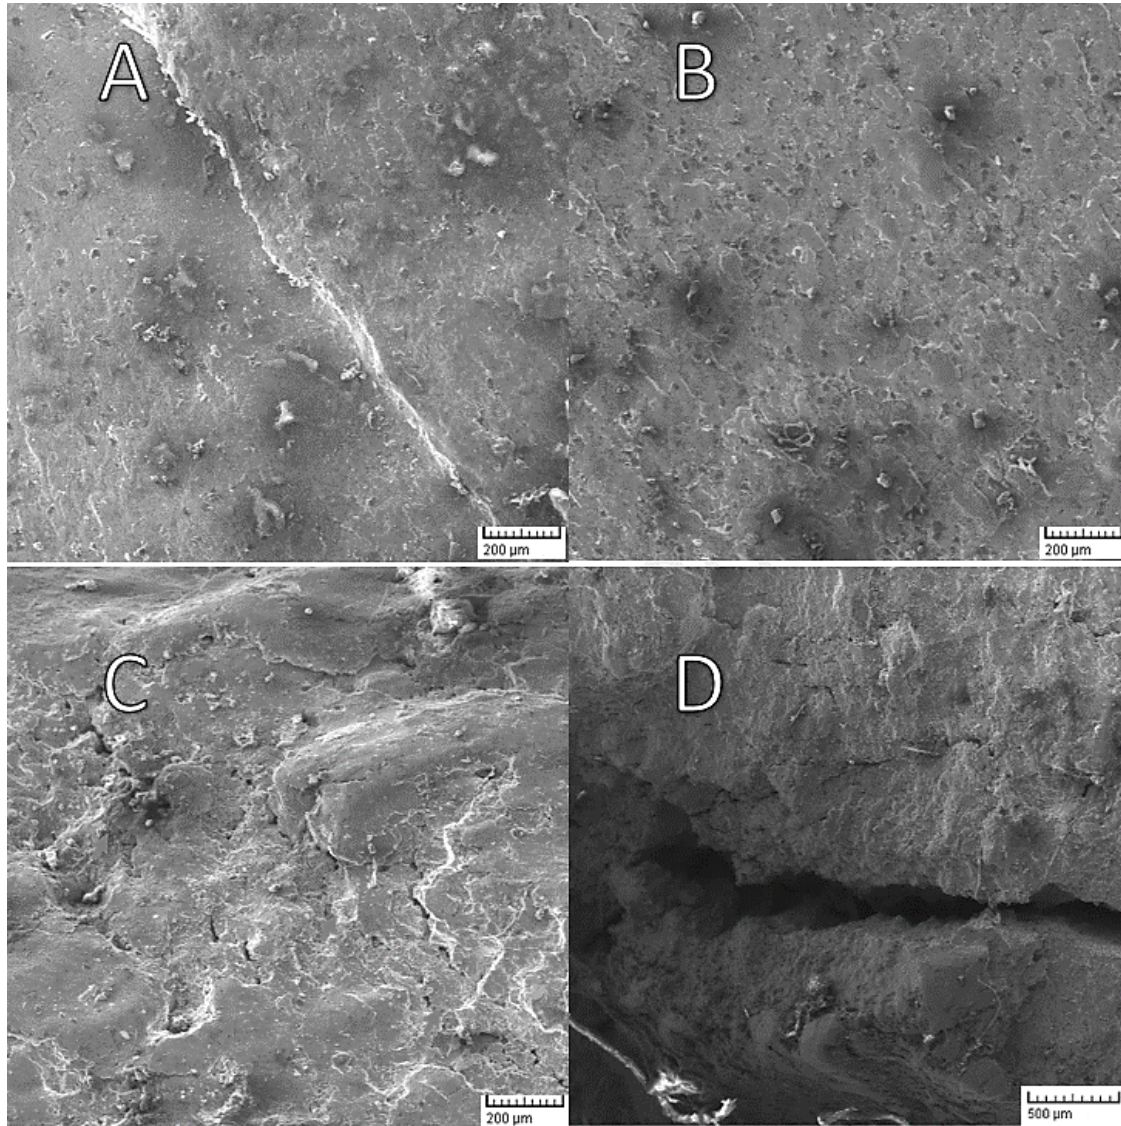
Fig. 12 SEM of the fractured region of the PP axis: A - region of the beginning of the failure, B - a region of the beach marks, C - a region of the catastrophic fracture with several secondary cracks, and D - secondary crack highlighted

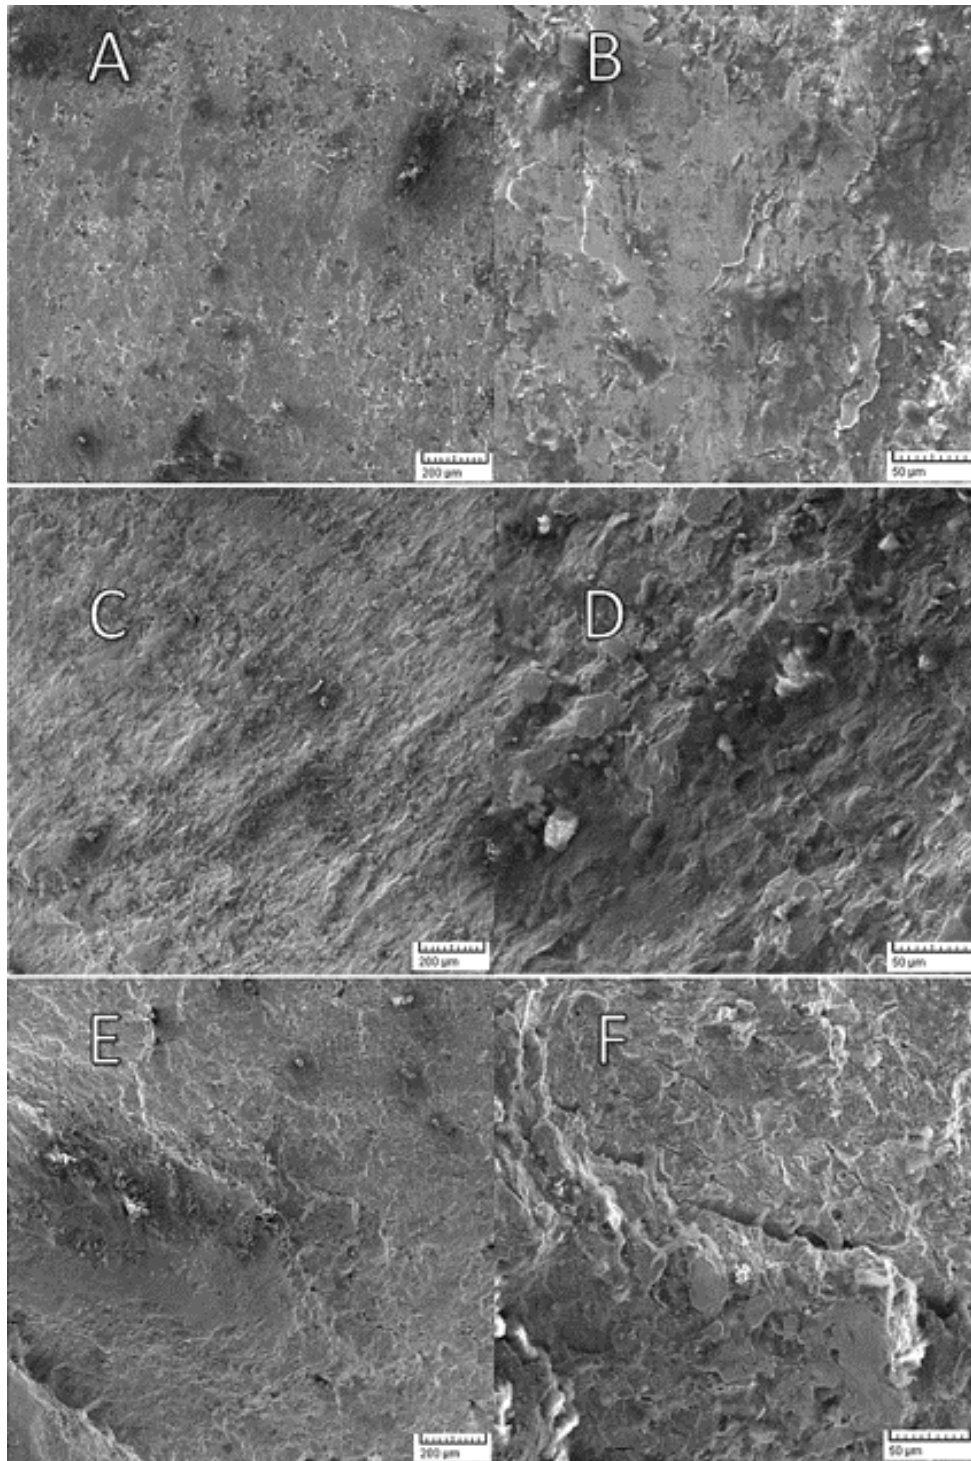
Fig. 13 SEM of the fractured region of the AP axis: A - a region of the beginning of the fatigue failure, B - detail of the region of fatigue in which the crack propagated slowly, C - a region of the beach marks, D - fatigue striation, high rate of deformation, E - catastrophic fracture region with secondary cracks and F - secondary crack highlighted

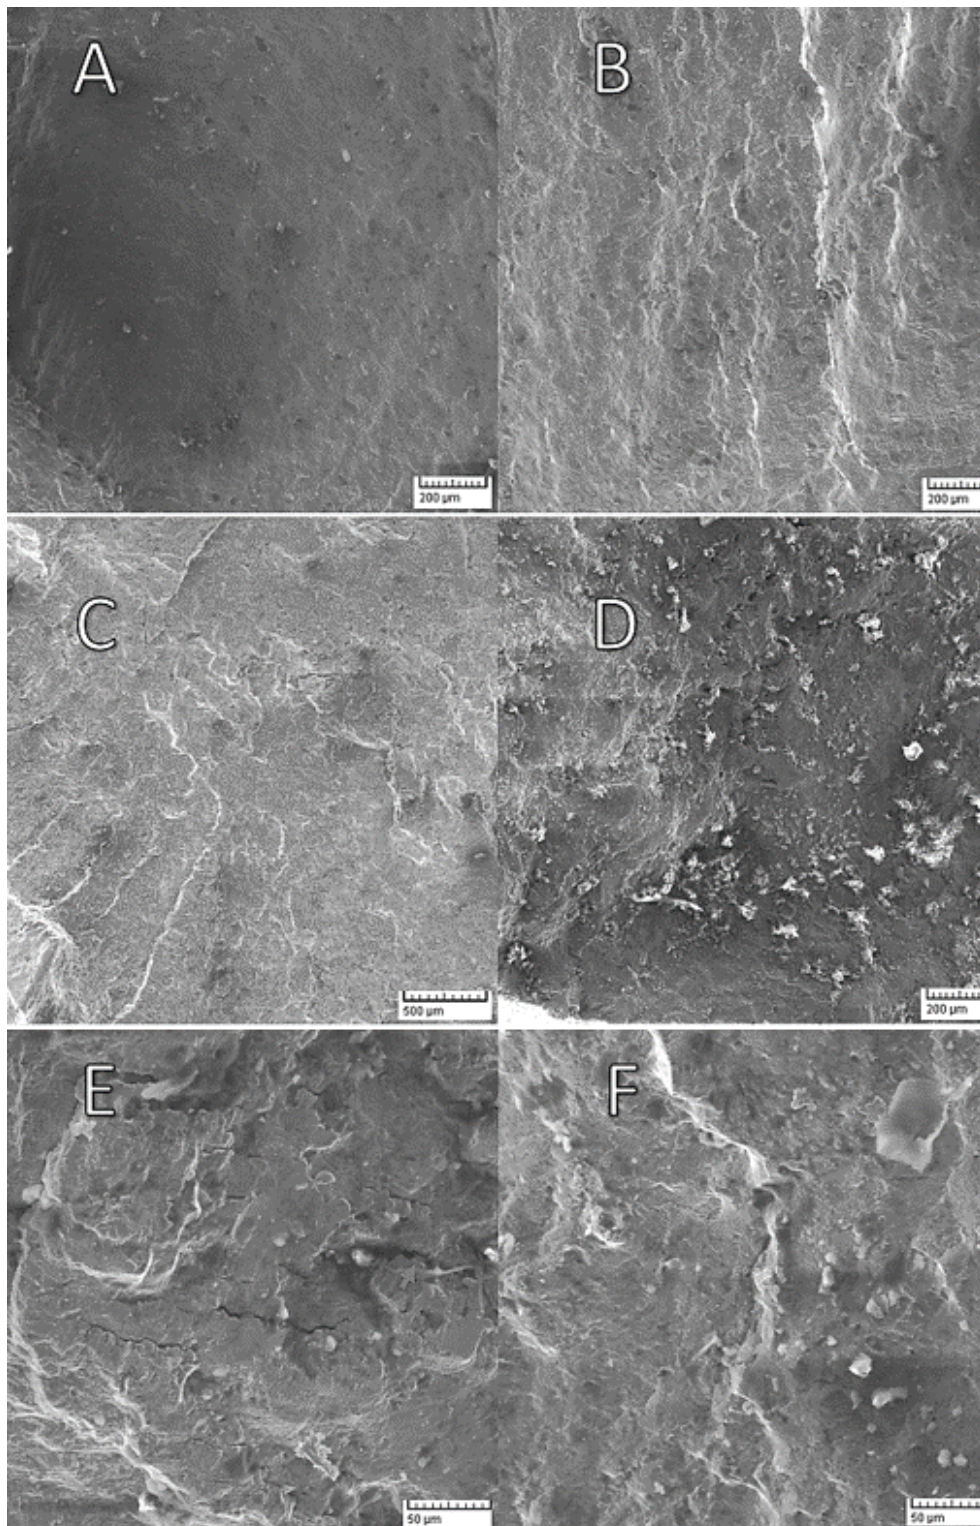
Fig. 14 SEM of the fractured region of the RA axis: A - region of the beginning of the fatigue failure, B - detail of the region of fatigue in which the crack spread slowly, the appearance of beach marks, C- a region of beach marks, D - region beginning of catastrophic fracture, the appearance of secondary cracks, E and F - regions of catastrophic fracture with secondary cracks

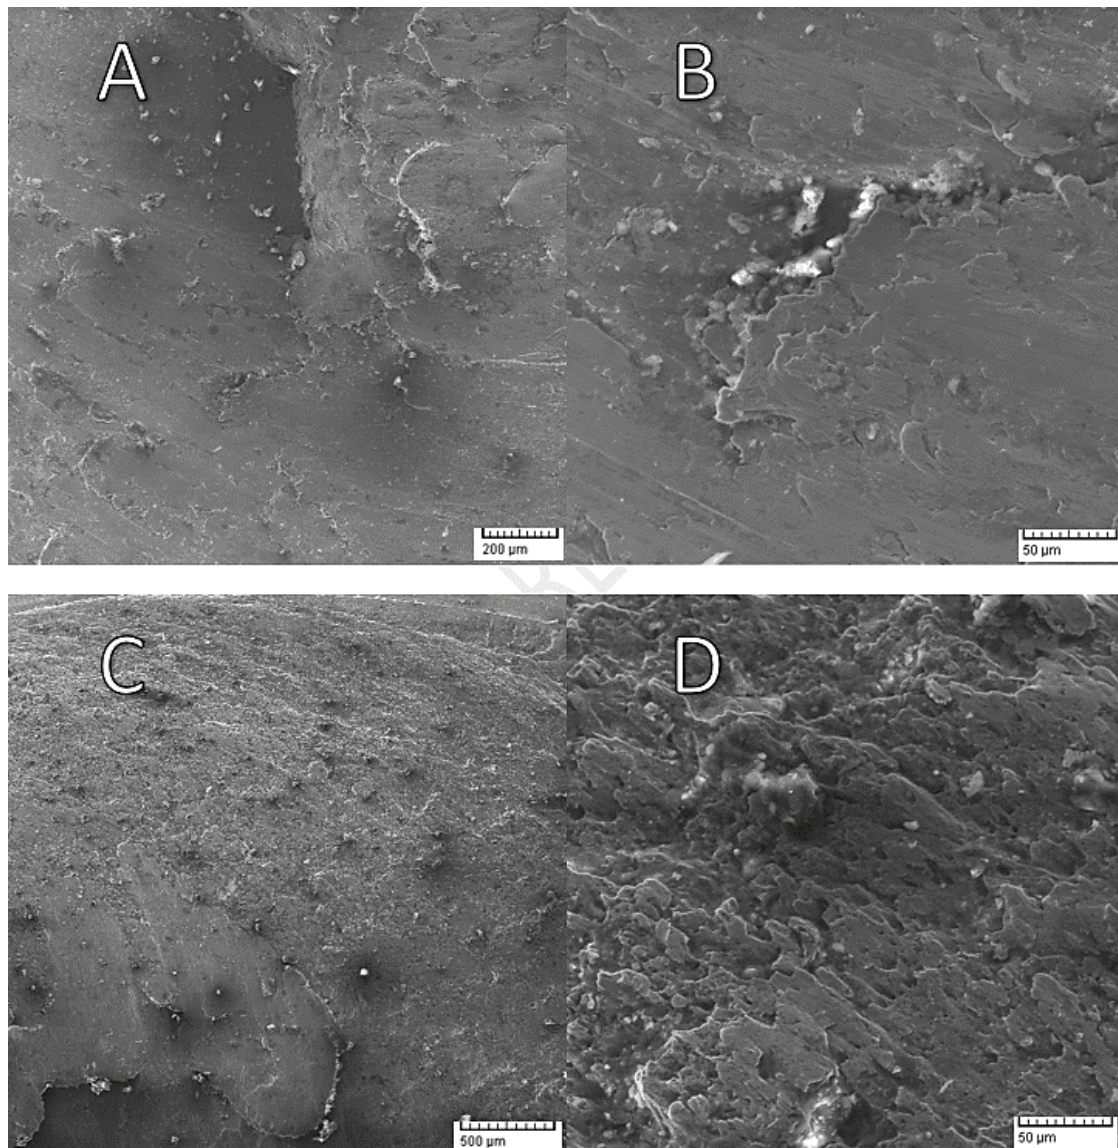
Fig. 15 SEM of the fractured region of axis I: A - region of the beginning of the fatigue failure, B - detail of the region of fatigue in which the crack propagated slowly, C - a region of slow/catastrophic failure transition D - a region of the catastrophic fracture

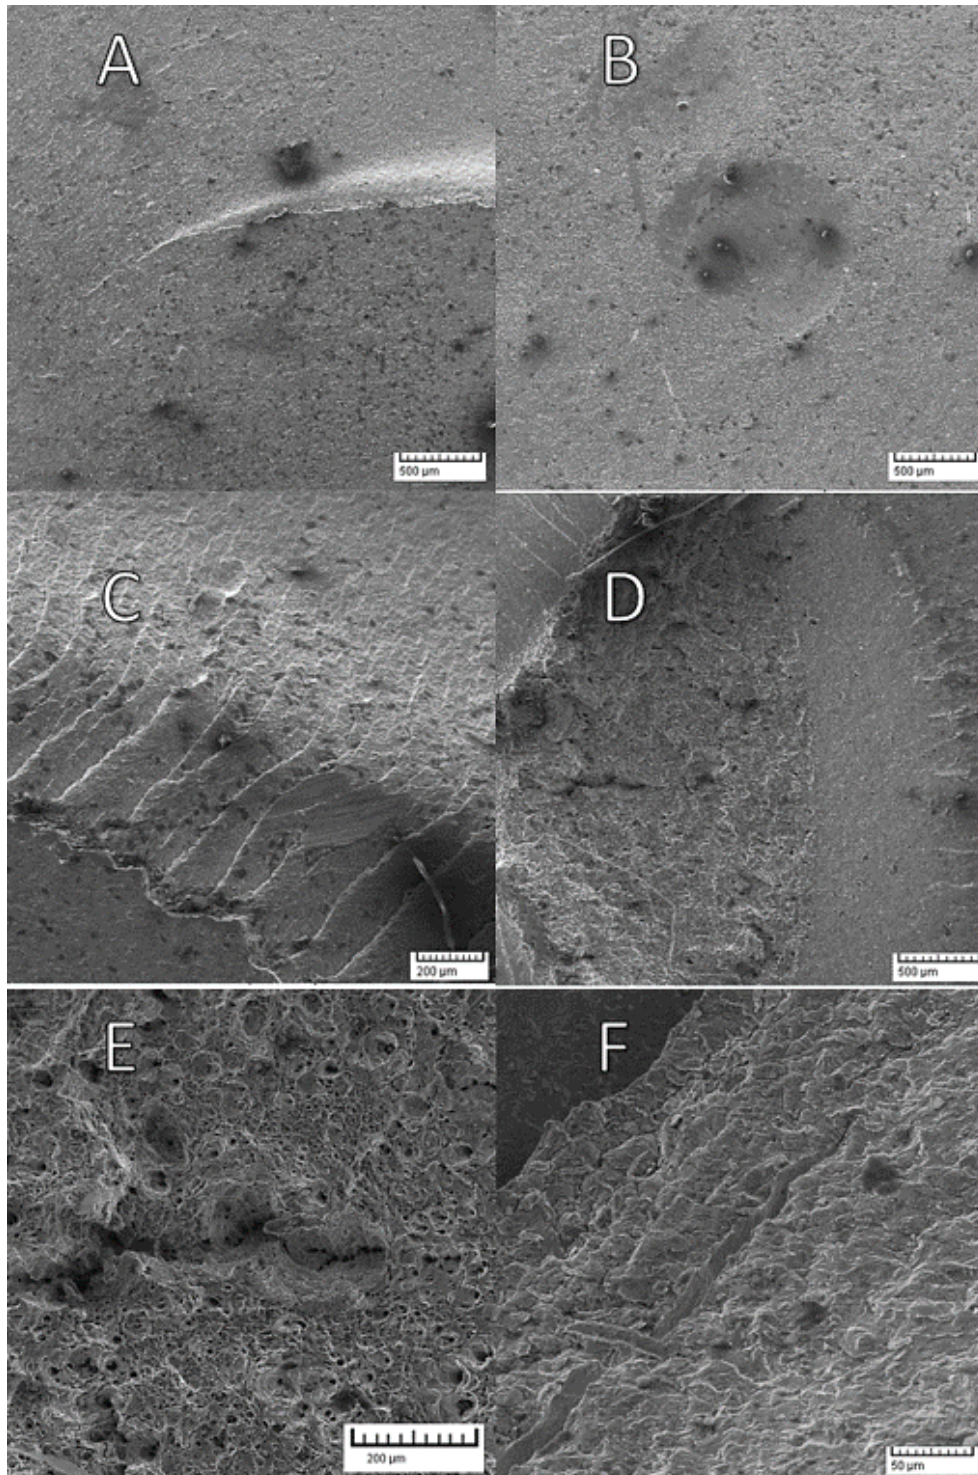
porosity found in the B1 axis demonstrates a possible manufacturing problem, since the presence of gases dissolved in the metal liquid can result both in the presence of various types of oxide inclusions, as well as in the formation of porosities of endogenous origin, that is, metallurgical causes, inherent to the quality of the metal cast in the molds. There are also exogenous origin defects originating from external causes, such as molds and leakage and feeding channel

Fig. 16 SEM of the fractured region of the B1 axis: A - region of the beginning of the fatigue failure, B - Inclusions, C - beach marks, D - a region of the beginning of the catastrophic fracture, the appearance of secondary cracks, E - secondary cracks and porosity and F - secondary crack

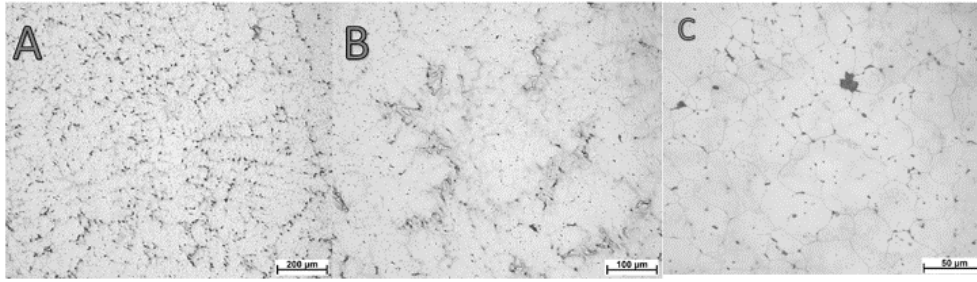
Fig. 17 Metallographic samples of the material

The structure of austenitic steel (stainless steel) with chromium-rich carbides precipitation was observed in the grain boundary region. This type of steel becomes susceptible to intergranular corrosion due to the phenomenon of sensitization, which is a process related to the precipitation of chromium-rich carbides in the grain boundary region, leaving the adjacent region depleted of chromium [8].
