Analysis of Surface Spalling on a First Intermediate Roll in Sendzimir Mills

Shiang-Cheng Jeng and Horng-Shing Chiou

Abstract—A first intermediate roll of Sendzimir mills was failure by surface spalling during operation. After analyzing by visual, stereo microscope, optical microscope, scanning electron microscope, glow-discharged spectrometer and hardness test, respectively, the results show that some voids and cracks existed on the contact surface as well as subsurface. Further examination verified inadequate hardness and inclusions were responsible for the failure of surface spalling.

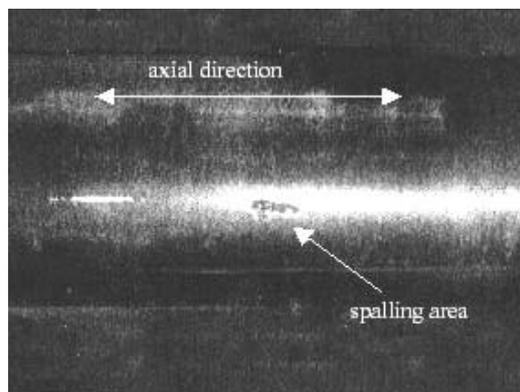
One 1st intermediate roll of the Sendzimir cold-rolling mills was found to be failure due to some spalling were happened on the surface, as shown in Fig. 2. After be examined carefully by visual inspection,

Fig. 2 A macrograph of the surface spalling roll of Sendzimir mills

After visual and stereo-microscope observation, it is found that the spalling areas revealed by elongating along the axial direction of the roll and characterized with an "apex" tips, as indicated in Figs. 2 and 3. Meanwhile, there are some small pits and cracks existing on the surface which are located under the spalling areas, please see Fig. 4.

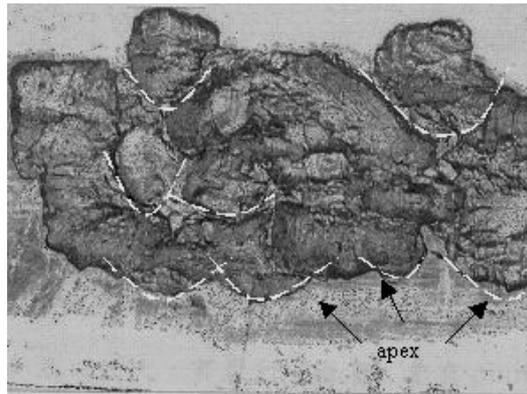
Fig. 3 A stereograph of the spalling area. (8X)

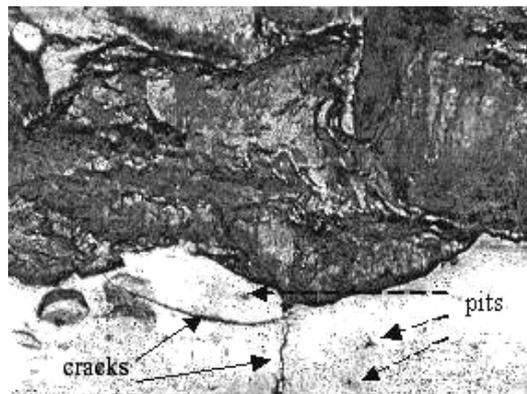
Fig. 4 The lower portion of the spalling area. (32X)

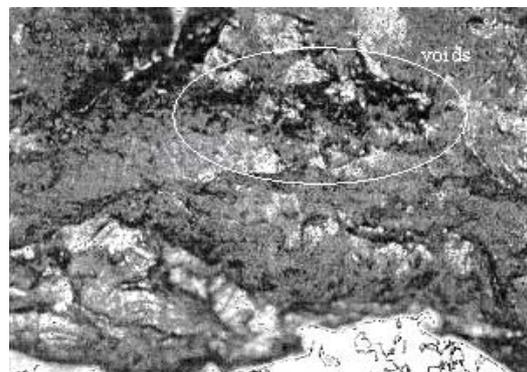
Fig. 5 A higher magnification of the spalling area. (64X)

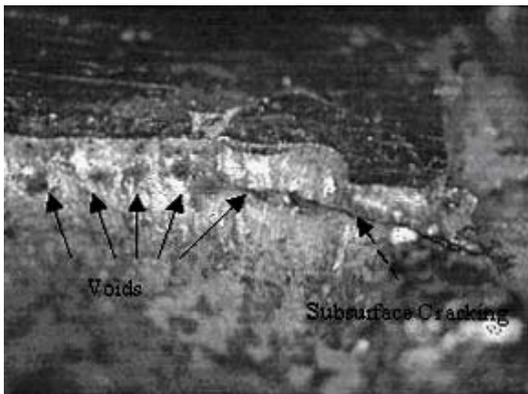
Fig. 6 The side-viewed of the spalling area. (64X)

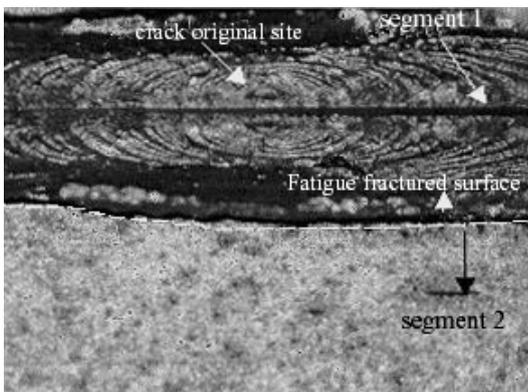
Fig. 7 An example of the fatigue fractured surface. (32X)

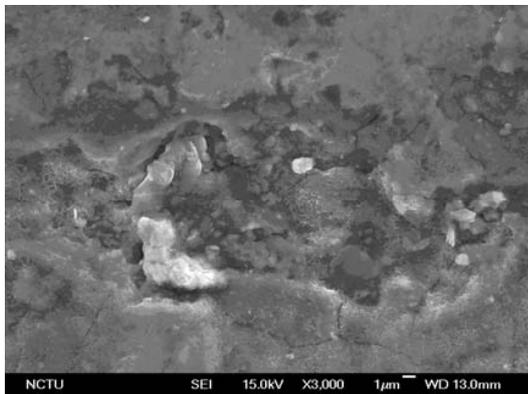
Fig. 8 A SEM micrograph of the origin of fatigue crack

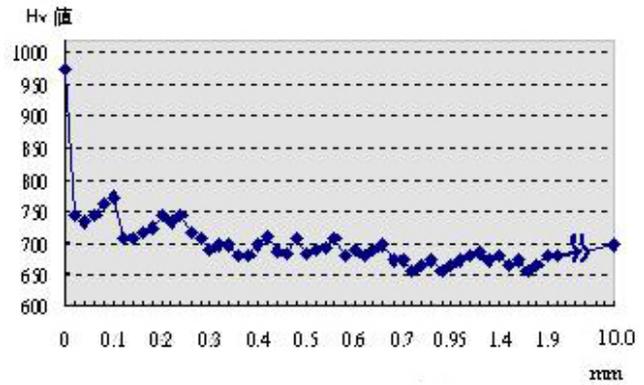
Fig. 9 The micro-hardness distribution of the subsurface

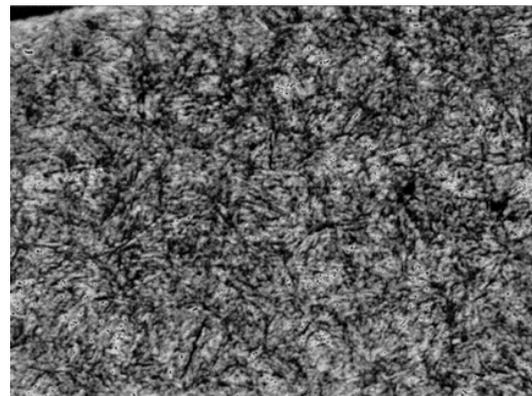
Fig. 10 A optical micrograph of the subsurface microstructure
