Analysis of the Root Causes of Transformer Bushing Failures

E. A. Feilat, I. A. Metwally, S. Al-Matri, and A. S. Al-Abri

Abstract—This paper presents the results of a comprehensive investigation of five blackouts that occurred on 28 August to 8 September 2011 due to bushing failures of the 132/33 kV, 125 MVA transformers at JBB Ali Grid station. The investigation aims to explore the root causes of the bushing failures and come up with recommendations that help in rectifying the problem and avoiding the reoccurrence of similar type of incidents. The incident reports about the failed bushings and the SCADA reports at this grid station were examined and analyzed. Moreover, comprehensive power quality field measurements at ten 33/11 kV substations (S/Ss) in JBB Ali area were conducted, and frequency scans were performed to verify any harmonic resonance frequencies due to power factor correction capacitors. Furthermore, the daily operations of the on-load tap changers (OLTCs) of both the 125 MVA and 20 MVA transformers at JBB Ali Grid station have been analyzed. The investigation showed that the five bushing failures were due to a local problem, i.e. internal degradation of the bushin

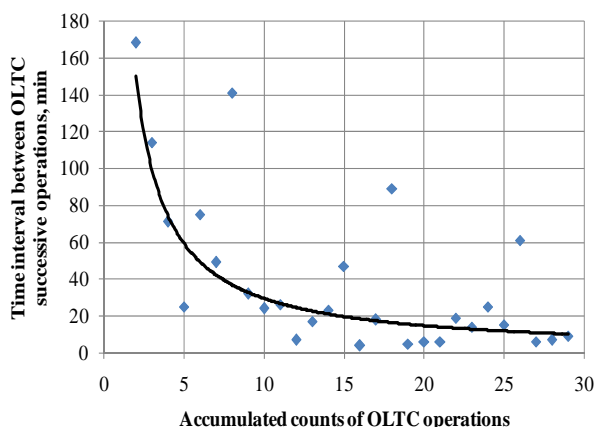
Fig. 3 JBB Grid station, TX1, 8-9-2011

Statistical analysis of the faulty operation of the OLTCs of JBB Ali Grid S/S is depicted in Fig. 3. Fig. 3 shows the time

interval between OLTC successive operations for the faulty JBB Ali Grid transformer. The results indicate that the OLTC time intervals are too small which implies an abnormal operation as a result of frequent variation of the 33 kV voltage level of the 125 MVA transformers. This fast variation could be attributed to successive partial discharges activities in the bushing insulation.

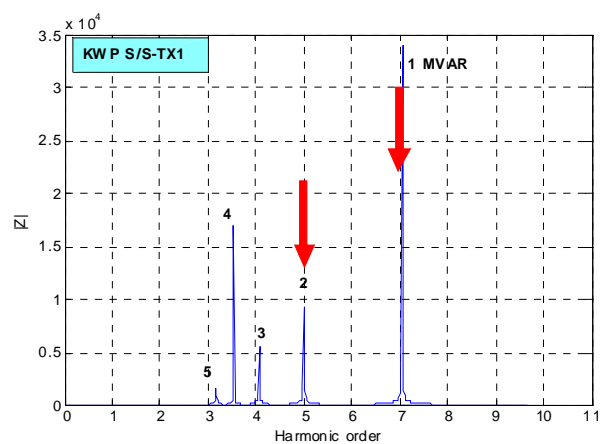
Fig. 4 Impedance scan- Al Kamel water pump S/S (TX1)

11 kV-bus where the capacitor banks are located has been computed for the ten S/Ss. Fig. 4 displays the frequency scan for Al Kamel water pump S/S. The results indicate that there is a possibility of resonance at the 5th and 7th harmonic frequencies. Therefore, if either the 5th or 7th harmonic current exists, the corresponding magnified harmonic voltage will be superimposed on the 50-Hz 11-kV bus.

Examining Fig. 4, it can be seen that harmonic parallel resonance at Al Kamel water pump S/S-TX1 is possible at the 5th and 7th harmonic frequencies corresponding to 3 and 1 MVAR compensation, respectively. The overall impedances of the combination of the capacitor bank and system equivalent short-circuit reactance as seen from the PCC $Z_{R5} = 90 \text{ k}\Omega$ $Z_{R7} = 34 \text{ k}\Omega$, respectively. For 5th and 7th harmonic currents $I_{h5} = 2.3\%$ and $I_{h7} = 0.7\%$, with $I_{h1} = 24 \text{ A}$, the corresponding magnitudes of the magnified 5th and 7th harmonic voltages are $V_{h5} = 75\%$ and $V_{h7} = 86\%$, respectively. However, the damping provided by resistance in the system and the overvoltage surge arresters are often sufficient to prevent catastrophic voltages and currents.

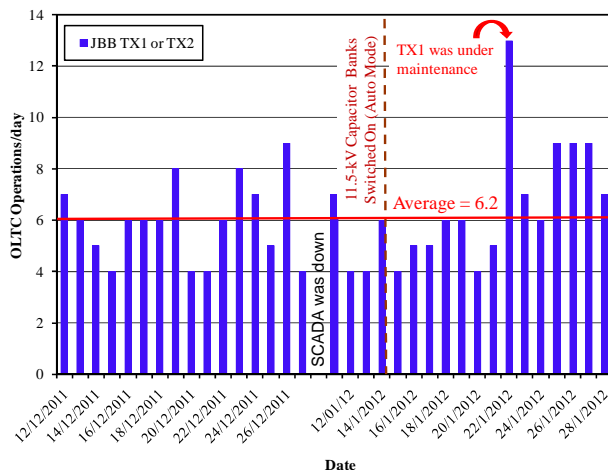
Fig. 7 Hourly 132-kV OLTC at JBB Grid S/S in Dec. 2011 and Jan. 2012 before and after switching-on of the 11.5-kV capacitor banks

This average number of operations was within the known operation range for normal networks [9] even after switching

on the 11 kV capacitor banks at JBB Ali grid S/S to the auto mode. No significant effect of switching on the capacitor banks on OLTC operations per day in Dec. 2011 and Jan. 2012.

from 12/12/2011 to 28/01/2012 fall within the stable network operation as demonstrated in Fig. 7. The average daily operations was 6.2 operations/day or 0.26/hour.

Following the five failures of TX1 and TX2, the six 33 kV bushings were replaced. Accordingly, the daily operations of the OLTCs of both TX1 and TX2 during the time interval
