# Behavior of RC Buildings to Tsunami Action

Carlos H. Cuadra

**Abstract**—The present report describes the characteristics of damages and behavior of reinforced concrete buildings during the tsunami action. The discussion is based on the field damage survey in selected cities located on the coast of the zone affected by the Great East Japan Earthquake on March 11, 2011. This earthquake is the most powerful know earthquake that has hit Japan with a magnitude 9.0 and with epicenter located at 129 km of Sendai city (off the coast). The earthquake triggered a destructive tsunami with run up height of up to 40 meters that mainly affect cities located on the Pacific Ocean coast of the Tohoku region (north-east region of Japan). Reinforced concrete buildings in general resist the tsunami without collapse however the non-structural elements like panels and ceilings were severely damaged. The analysis of damages has permitted to understand the behavior of RC buildings under tsunami attack, and has also permitted to establish recommendations for their use to take refuge from tsunami in places where natural topography makes impossible to reach hilltops or other safer places.

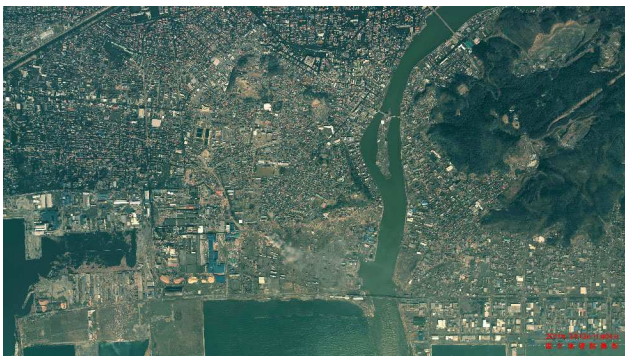
Fig. 2 Detail of Ishinomaki city port affected by the tsunami

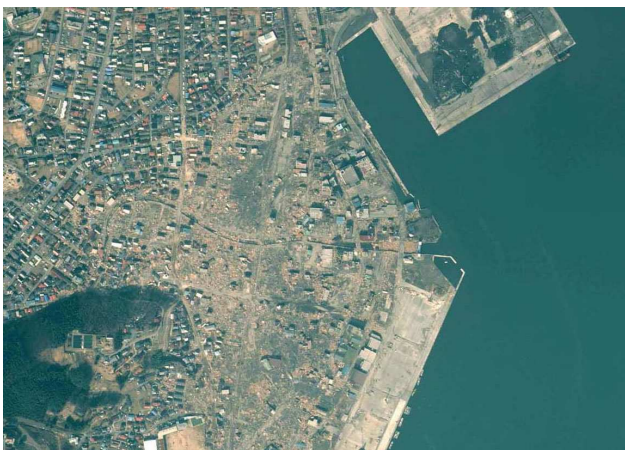
In Fig. 3 a portion of Ofunato city is shown. It is clear from the figure that only large building remains in the inundated zone while small building like wooden houses were washed up. These buildings were steel structures and reinforced concrete structures that resist the lateral forces originated by the inundation of the tsunami. In the left part of the Fig. 3, some intact constructions can be observed. These building are located on a high ground level that was not reached by the tsunami.

Fig. 3 Aerial photograph of Ofunato city after the Tsunami

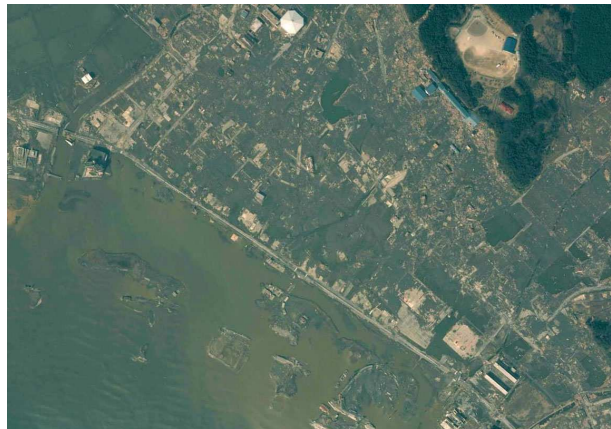
In Fig. 4 a portion of the aerial photograph of Rikuzentakata city can be observed. Near the coast line only few buildings remained after the tsunami attack. The behaviour of the buildings located in the left part that was a hotel and the buildings of the right lower side which correspond to apartment buildings is described in the next section. It can be observed that the tsunami destroyed first a sea wall and now the sea water reaches the road that can be observed as a straight line from the left to the right lower corner. On the right upper corner by observing the color of the vegetation the limit of the inundation area can be inferred. This place corresponds to a high ground level where a school building is located. These school facilities are now used as shelter zone.

Fig. 4 Aerial view of Rikuzentakata city after the tsunami

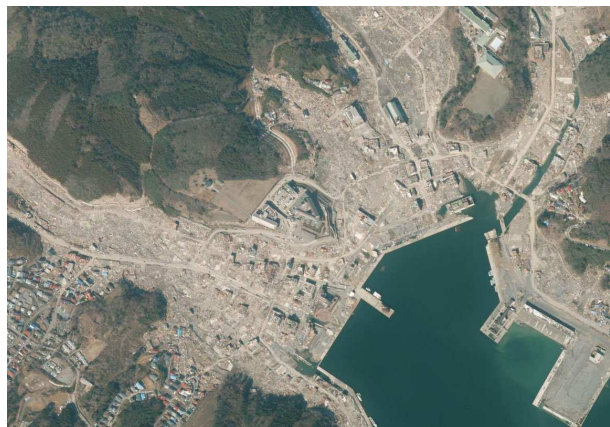
Fig. 5 shows the condition of Onagawa town after the tsunami damage. In this aerial view it is possible to identify clearly the zones of high ground level by observing the condition of the vegetation. As can be observed in the figure, the area between the sea line and high ground level is narrow, and therefore the tsunami reached high inundation depths. This high level of water and poor soil condition originated the overturning of some RC buildings which is described in the next section.

Fig. 5 Aerial view of Onagawa city after tsunami inundation

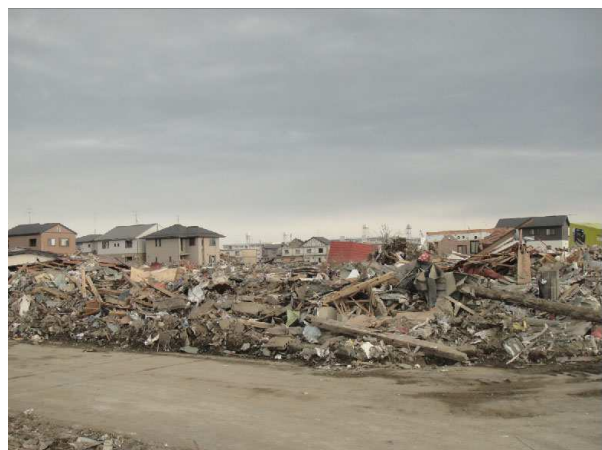
In Fig. 7 to Fig. 10 some typical damages on wooden houses that were produced by the tsunami are shown. In Fig. 7 it can be observed that wooden houses were completely destroyed by the tsunami action. It can be also observed that houses located on high sites are not affected.

Fig. 7 General damages of wooden houses

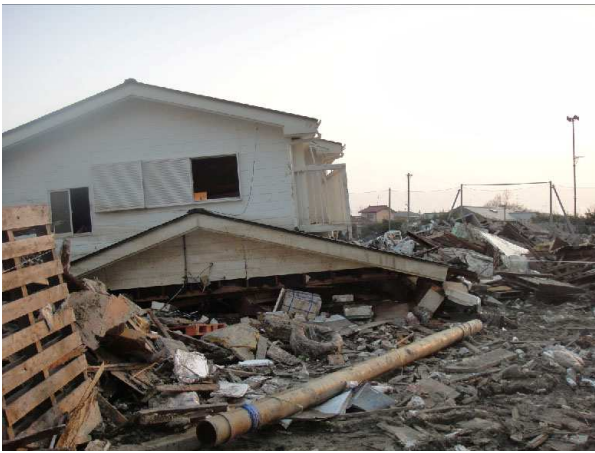
Fig. 8 Failure of the first floor

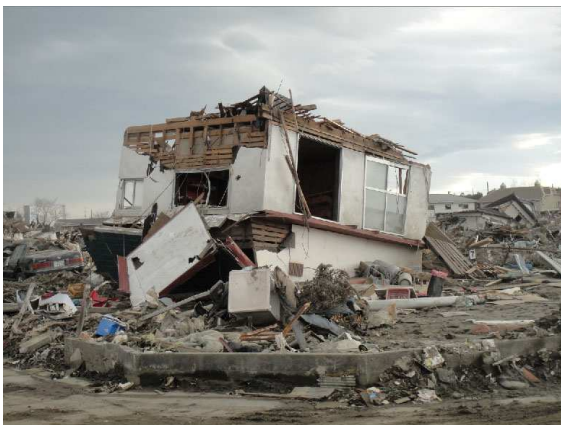
location. In the case of Figure 10(d) the tsunami destroyed the first floor and also produced the overturning of the remaining upper floor.

Fig. 10 Over turning of upper floors

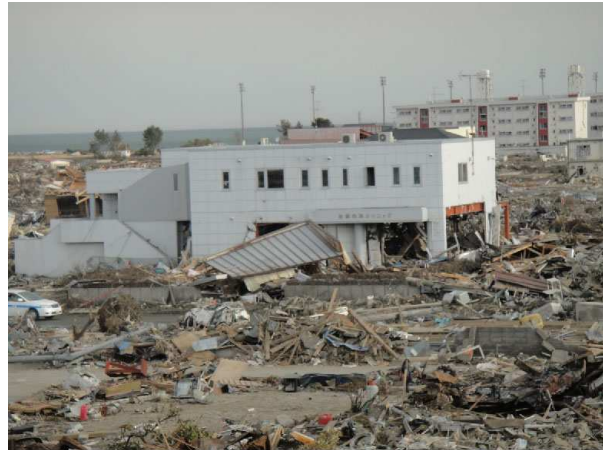
Damages on Steel structures can be observed in Figures 11 to 14. When the inundation depth reaches only the first floor the structure remains almost intact however the wall panels of the first floor suffer some damages as can be observed in Fig. 11. In Fig. 12 and Fig. 13 the inundation depth reached the second floor and wall panels and ceiling are destroyed. In this case the structures remain stand up however some local failure of the structural elements were observed. Fig. 14 shows a total collapse of steel structures. In this case the building was completely covered by the water.

Fig. 11 Steel structure almost intact

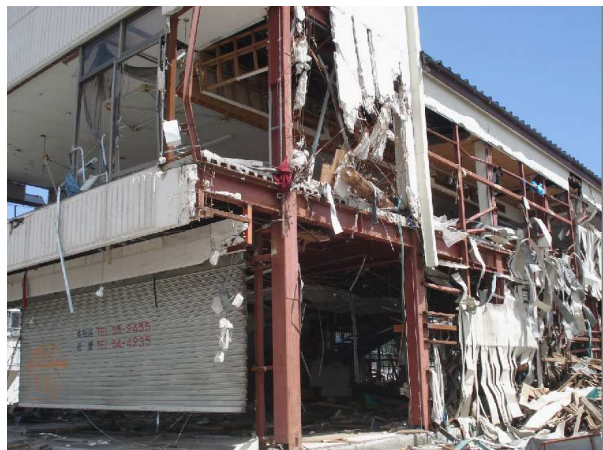
Fig. 12 Destruction of panels

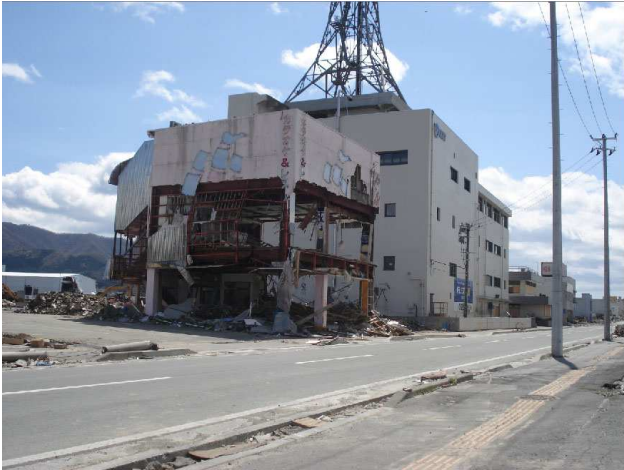
Fig. 13 Destruction of wall panels

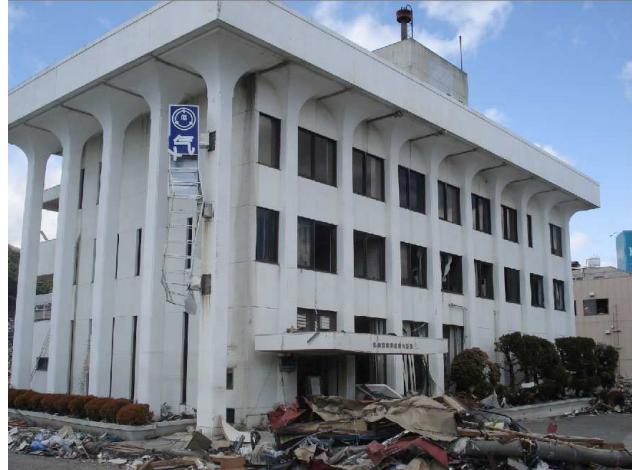
Fig. 15 RC building (Ofunato city)

Many reinforced concrete structures resisted the tsunami action without collapse as can be observed in Figures 15 to 20. Fig. 15 shows the building of a local bank located at Funato city. It can be observed from the damages of the windows and the damage of the advertisement panel of the left corner of the building that the tsunami reaches the third floor.

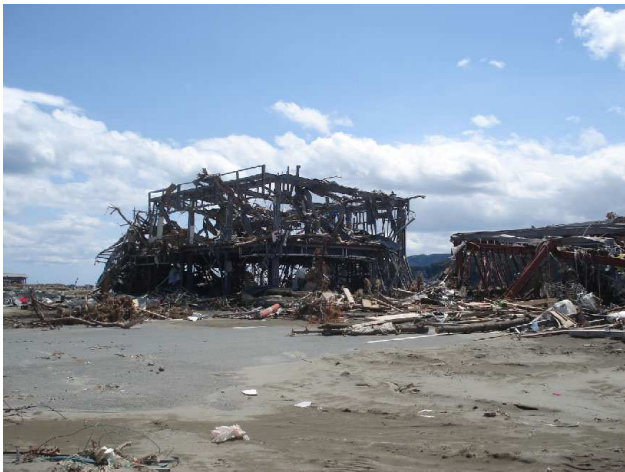
Fig. 14 Collapse of steel structure

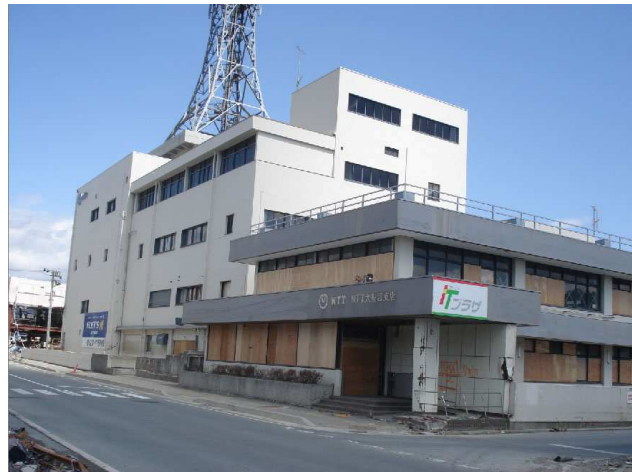
Fig. 16 Two story RC building

In Fig. 16 it is also inferred that the tsunami covered the second story of the building by observing that the windows glasses were destroyed and now are replaced by wood panels.

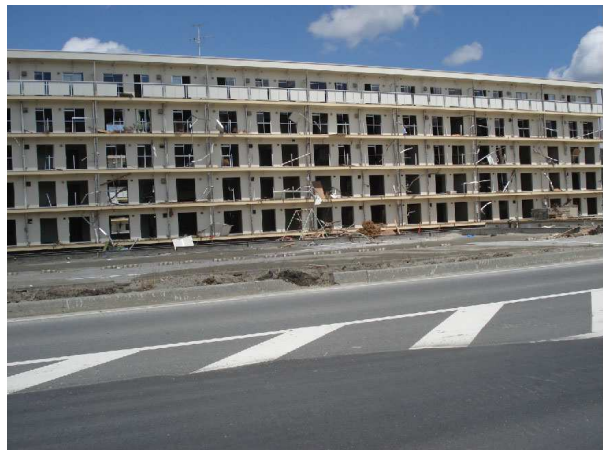
Fig. 17 shows an apartment building located at Rikusentakata city and from the damages of the balconies it is inferred that the tsunami reaches the fourth floor. Detailed of the damages of the balconies can be observed in Fig. 18, where the panels of the balconies of the fifth floor are intact while the panels of the lower floors are completely destroyed.

Fig. 17 Building at Rikusentakata city

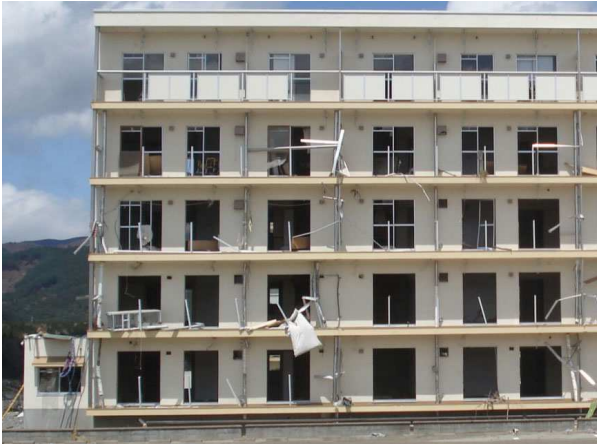
Fig. 18 Detail of damages on balconies

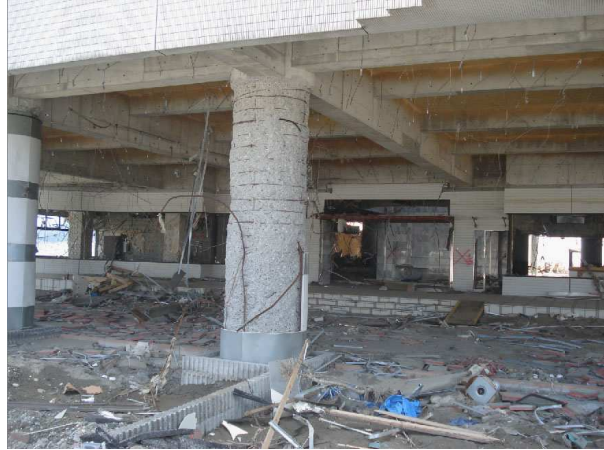
Fig. 20 Detail of RC columns

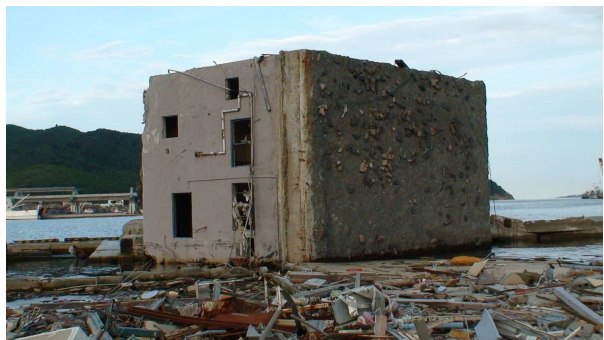
Fig. 22 Detail of slab foundation of collapsed building

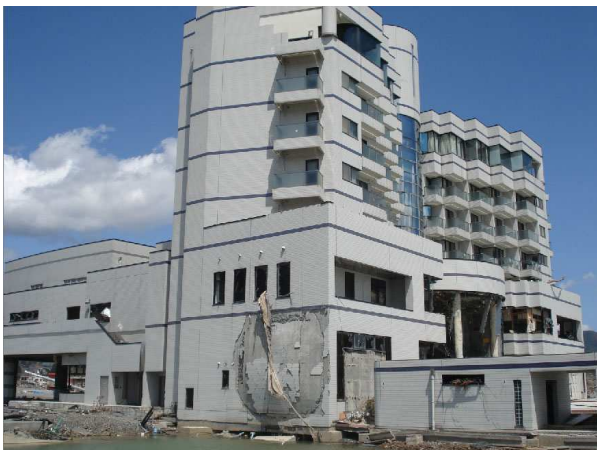
Fig. 19 and Fig. 20 show the condition of a hotel building located very near the shoreline in Rikuzentakata city. The building resists the tsunami attack however the lower floors suffered the destruction of the non-structural elements and also, as it is observed in the Fig. 19, the building suffered the damage of a reinforced concrete wall due to the lateral water pressure. In this building it was also observed that the cover concrete of structural elements of columns was spall-out probably due to a combination of earthquake vibration action and posterior tsunami as can be observed in Fig. 20

Fig. 19 RC building hotel

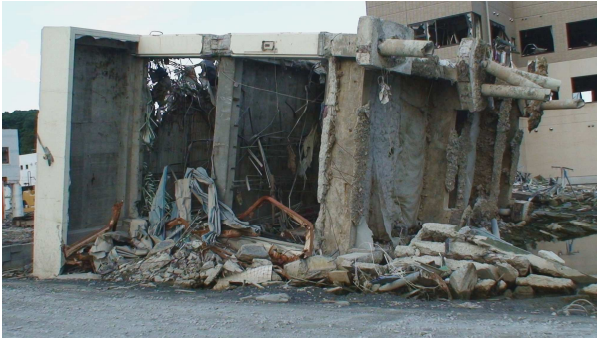
Fig. 23 shows the overturning of a 2-story building with exposition of the pile foundation. The use of piles for lower rise buildings indicates the poor quality of the foundation ground. On the other hand in the Fig. 24 it can be observed that the building has suffered the impact of some body (probably a ship) that could originate the overturning of the building.

Fig. 23 Collapse of 2 story RC building

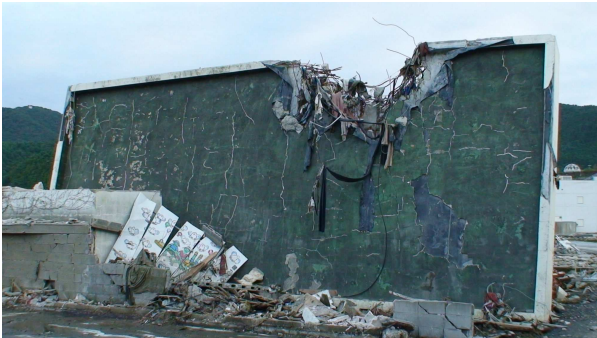
Fig. 24 Detail of impact on the building
