# Causes of Rotor Distortions and Applicable Common Straightening Methods for Turbine Rotors and Shafts

Esmaeil Poursaeidi, Mostafa Kamalzadeh Yazdi

**Key words**—Distortion, FEM, Hot Spot Area, Rotor Straightening

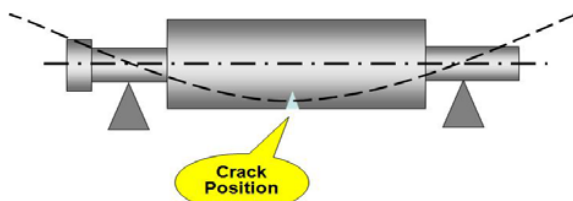
Transverse cracking in rotors can be initiated at surface stress concentrations by corrosion, pitting, thermal fatigue (starts related), or by high cycle fatigue due to self weight rotating bending stresses (Fig. 2). Transverse crack propagation is eventually driven by the bending stresses and this phase can take place over time scales in years. Because they do not directly affect the balance of a rotor, such cracks will not have much effect on normal vibration levels until they occupy a significant portion of the rotor cross section (e.g. 25%). Large cracks can have a sufficient effect in changing the compliance (transverse stiffness) of a rotor that clearances are lost and then rubbing, followed by the bending mechanisms described above takes place.

Fig. 2 Schematic of bending due to cracking

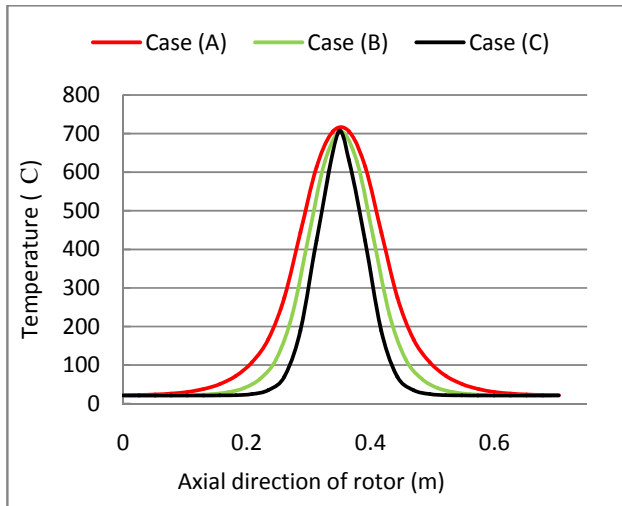
Simulation of hot spotting with three different hot spot areas and heat fluxes was done. The graph of thermal distribution along axial direction of rotor (Fig. 6) shows that the case (C) with the smallest hot spot area has the most thermal gradient between the hot spot area and its surrounding area which is ideal in straightening process but the amount of hot area (cherry red area) is too small to cause required bend. Also it shows that case (A) with the largest hot spot area has the least thermal gradient. The contour of plastic strain magnitude during hot spotting process for three aforementioned cases in Fig. 7 demonstrates that amount of plastic strain in case (A) is not enough to achieve required straightness. In contrast, magnitude of plastic strain in case (C) is the most rather than other cases which may cause some undesirable effects such as thermal shock and phase transformation of the rotor material. Therefore it is resulted that case (B) would cause the most satisfactory straightening effects.

Fig. 6 Thermal distribution along axial direction of rotor

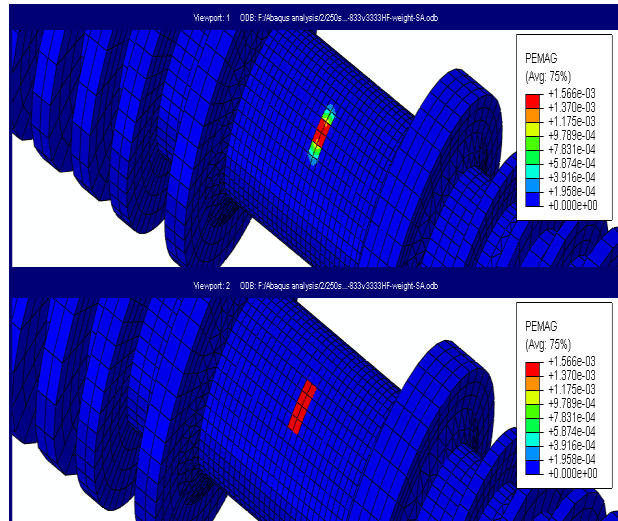
Fig. 8 Contour of plastic strain area at the temperature of (a) 705°C, (b) 750°C

Another simulation was done to investigate the effects of extra heating. Fig. 8 makes a comparison between the size of plastic area at two different temperatures of 705°C and 750°C. It illustrates that extra heating would significantly cause to develop the location of maximum plastic strain along the perimeter of the rotor. Yielding of the material through this large plastic area would contain extra energy to increase distortion of the rotor with no control. On the other hand, according to previous investigations exceeding permutation temperature will cause undesirable sequels on the material structure.

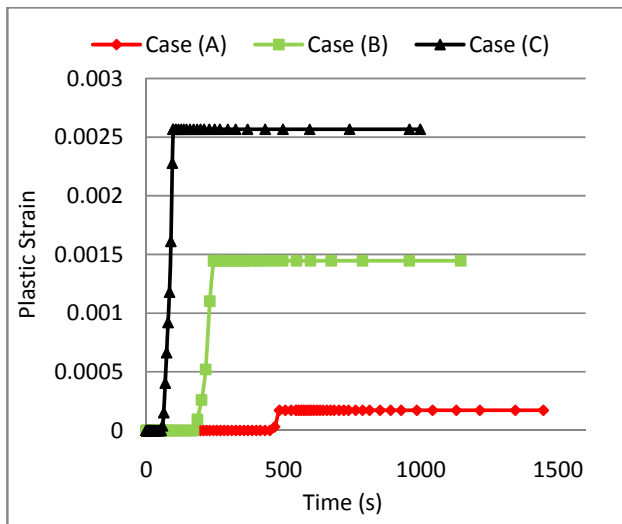
Fig. 7 Magnitude of plastic strain during hot spotting

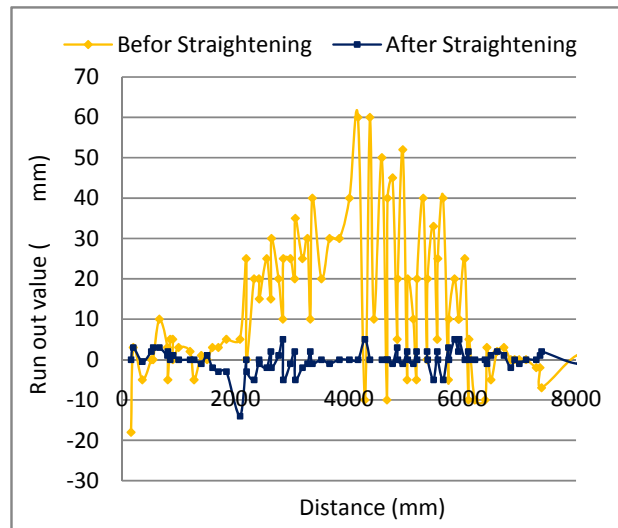
Fig. 9 Results of initial and final run out tests at an angle of 90°

A comparison between received experimental data from initial and final run out tests (Fig. 9) shows that performing the hot spotting execution according to simulated results, has been reduced the rotor eccentricity noticeably. Therefore we recommend using a numerical method before carrying out the selected straightening method.
