# Condition Monitoring for Controlling the Stability of the Rotating Machinery

A. Chellil, I. Gahlouz, S. Lecheb, A. Nour, S. Chellil, H. Mechakra, H. Kebir

**Abstract**—In this paper, the experimental study for the instability of a separator rotor is presented, under dynamic loading response in the harmonic analysis condition. The global measurement and analysis of vibration on the cement separator RC500 is carried, the points of measurement used are radial dots, vertical, horizontal and oblique. The measures of trends and spectral analysis for reconnaissance of the main anomalies, the main defects in the separator and manifestation, the results prove that the defects effect has a negative effect on the stability of the rotor. Experimentally the study of the rotor in transient system allowed to determine the vibratory responses due to the unbalances and various excitations.

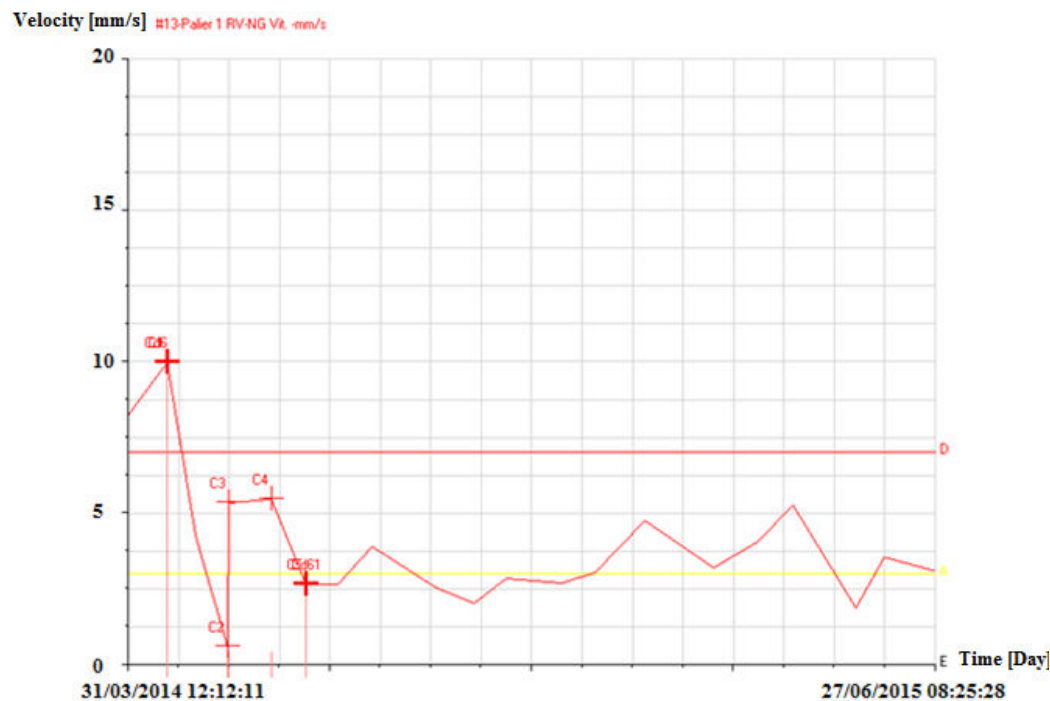
Fig. 4 Trend curve of bearing (01) RV-NG

The trend curve for the bearing N°01 (mm / s) is presented. There was an increase vibratory velocity level which exceeds the alarm threshold in point C4 (5.49 mm / s) which shows the presence of an anomaly, but we do not know their origin, after repair a speed decrease is observed with a reduction in (2.84 mm / s), for diagnosing the origin of the excess passes to spectral analysis.
