# Failure Analysis of a Medium Duty Vehicle Leaf Spring

Gül Çevik

**Abstract**—This paper summarizes the work conducted to assess the root cause of the failure of a medium commercial vehicle leaf spring failed in service. Macro- and micro-fractographic analyses by scanning electron microscope as well as material verification tests were conducted in order to understand the failure mechanisms and root cause of the failure. Findings from the fractographic analyses indicated that failure mechanism is fatigue. Crack initiation was identified to have occurred from a point on the top surface near to the front face and to the left side. Two other crack initiation points were also observed, however, these cracks did not propagate. The propagation mode of the fatigue crack revealed that the cyclic loads resulting in crack initiation and propagation were unidirectional bending. Fractographic analyses have also showed that the root cause of the fatigue crack initiation and propagation was loading the part above design stress. Material properties of the part were also verified by chemical composition analysis, microstructural analysis by optical microscopy and hardness tests.

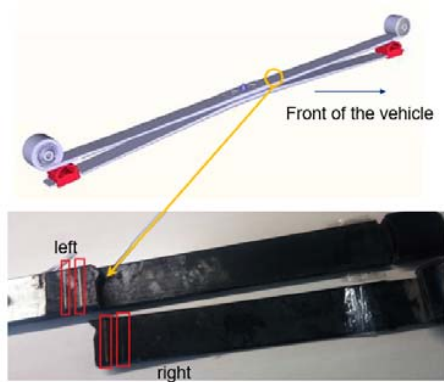
Fig. 1 Failure location

Location of failure is shown on Fig. 1. A complete separation of the upper leaf spring has occurred on vehicle due to fracture. Failure has occurred near to the center to the front side of the leaf. Red rectangles on the picture show the material verification test sample locations.

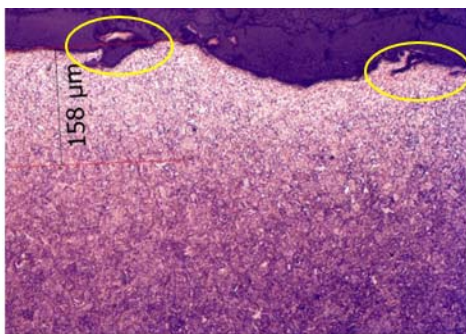
Fig. 4 Decarburization extent and surface condition

The specified level of decarburization depth of the part is 250  $\mu\text{m}$  at maximum and partial type (Type 2). The observed decarburization type was partial and values of decarburization

depths from the examined region are within a range of 158 to 169  $\mu\text{m}$ ; which describes no abnormal decarburization profile of the part surface.

During microstructural studies, small size of oxidized laps is potentially formed by subsequent oxidation of laps originated during hot rolling process. These surface irregularities were further searched for at the crack origin region whether there is a link to the failure mechanism, during fractographic examinations by SEM and will be discussed on the Micro-Fractography section. Fig. 4 shows a representative micrograph from the surface showing both the decarburization depth of 158  $\mu\text{m}$  and oxidized laps.

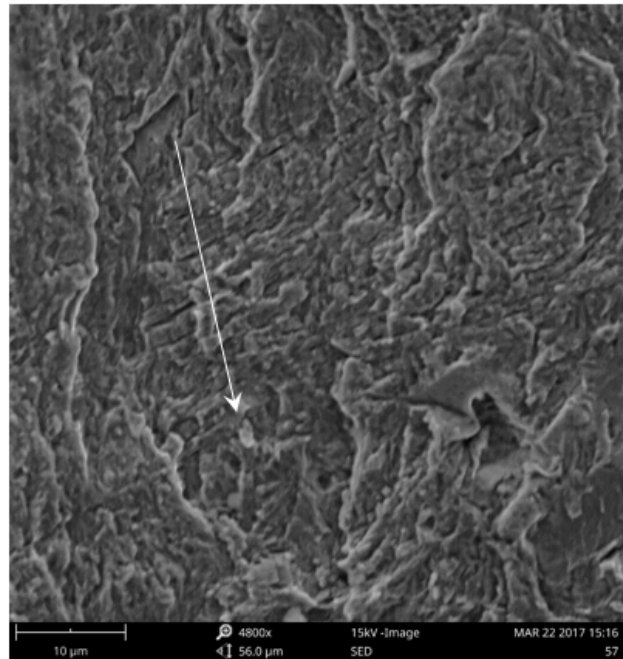
Fig. 9 Fatigue crack propagation direction and striations (point b)

Figs. 9 and 10 show the crack propagation directions. Fatigue striations can also be observed on Fig. 9 which are indications of stable crack propagation.

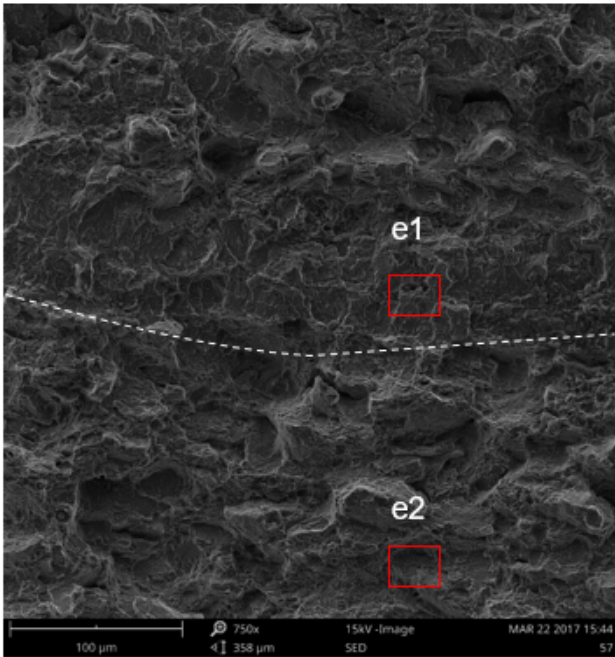
Fig. 11 Fatigue to overloading transition region (point e)

Micro examinations validated that the macroscopic transition from beach marks to rough and dull surface is the transition from fatigue to final overload fracture region. Figs. 11-13 describe the replication of fracture mechanism change from fatigue to ductile failure.

A ratio of 1:4 fatigue crack to final fracture region was also validated microscopically; which describes again a high stress

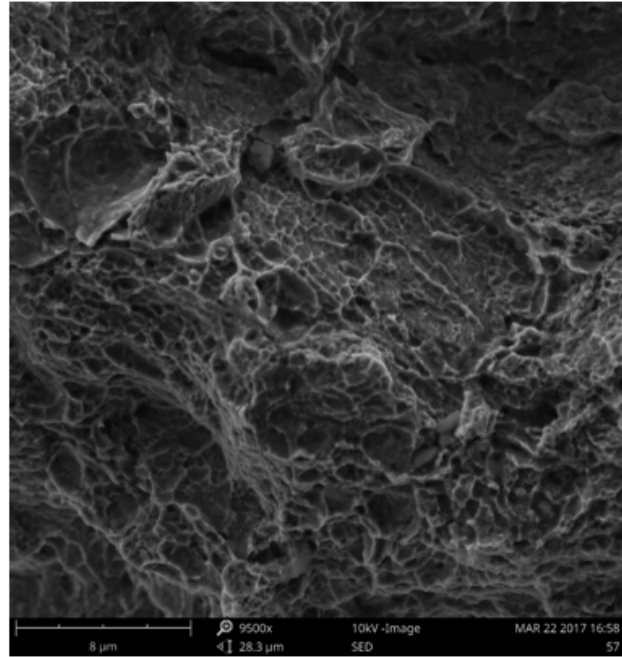
Fig. 13 Ductile dimples due to overloading failure (e2)

Striations and tear ridges were observed in fatigue region whereas dimples were observed on the overloading region.
