# Failure Analysis of a Medium Duty Vehicle Leaf Spring

Gül Çevik

**Abstract**—This paper summarizes the work conducted to assess the root cause of the failure of a medium commercial vehicle leaf spring failed in service. Macro- and micro-fractographic analyses by scanning electron microscope as well as material verification tests were conducted in order to understand the failure mechanisms and root cause of the failure. Findings from the fractographic analyses indicated that failure mechanism is fatigue. Crack initiation was identified to have occurred from a point on the top surface near to the front face and to the left side. Two other crack initiation points were also observed, however, these cracks did not propagate. The propagation mode of the fatigue crack revealed that the cyclic loads resulting in crack initiation and propagation were unidirectional bending. Fractographic analyses have also showed that the root cause of the fatigue crack initiation and propagation was loading the part above design stress. Material properties of the part were also verified by chemical composition analysis, microstructural analysis by optical microscopy and hardness tests.

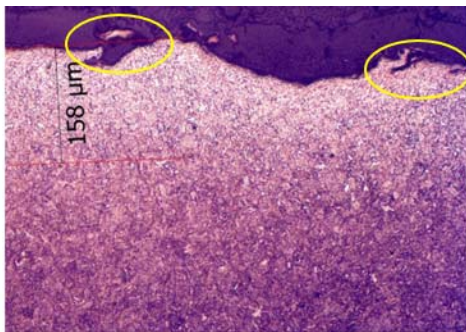
The specified level of decarburization depth of the part is 250  $\mu\text{m}$  at maximum and partial type (Type 2). The observed decarburization type was partial and values of decarburization

depths from the examined region are within a range of 158 to 169  $\mu\text{m}$ ; which describes no abnormal decarburization profile of the part surface.

During microstructural studies, small size of oxidized laps is potentially formed by subsequent oxidation of laps originated during hot rolling process. These surface irregularities were further searched for at the crack origin region whether there is a link to the failure mechanism, during fractographic examinations by SEM and will be discussed on the Micro-Fractography section. Fig. 4 shows a representative micrograph from the surface showing both the decarburization depth of 158  $\mu\text{m}$  and oxidized laps.

Fig. 4 Decarburization extent and surface condition

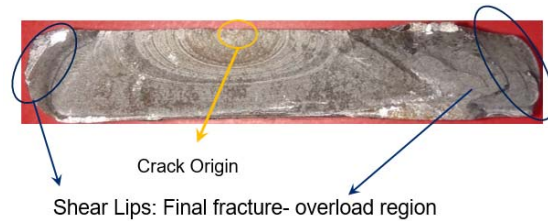
For microscopic examinations, the surfaces were cleaned by ultrasonic cleaning method with the usage of a special cleaning agent. Left-side fracture surface after cleaning is shown on Fig. 5. The thumbnail type of fatigue crack and shear lips at the final fracture region can be differentiated on this figure.

Macro examinations showed that a fatigue crack is present on the failed section. The shear lips and rough surface to the edges describe the final fracture region. Macroscopically observable size of the fatigue crack was found to be

approximately one-fourth of the total cross-sectional area. As the thumbnail shape of the crack is a possible indication of stress-corrosion cracking; further investigations were conducted on the micro-examinations and will be discussed in the micro-fractography section.

Fig. 5 Fracture surface (left-side) after ultrasonic cleaning

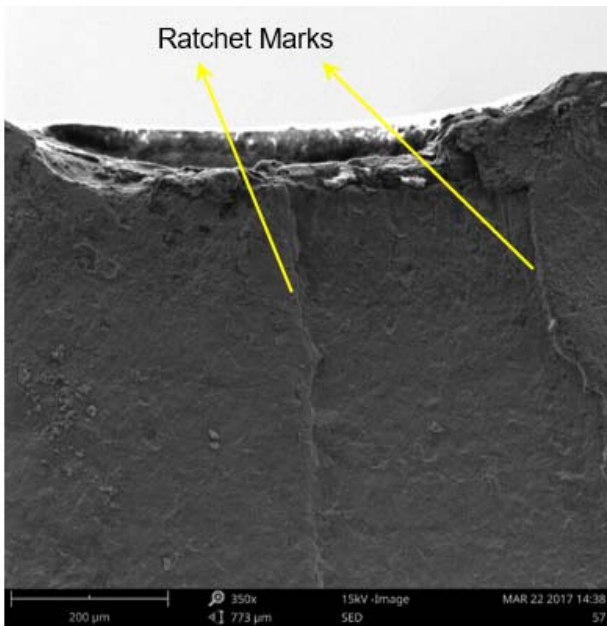
Fig. 7 shows the fatigue crack origin (point a) at X350 magnification. Ratchet marks which are indications of fatigue crack initiation mechanism were observed at the crack origin. Crack has emanated from a surface collapse of  $\sim 500 \mu\text{m}$  which is possibly formed by plastic deformation of the surface during shot peening process. On the other hand, this is accepted as a natural phenomenon as these regions can act as local stress-raisers.

Examinations on crack origin showed that the crack initiation has occurred at single region. Singular crack initiation requires very low stress concentration. Examinations at crack origin region showed that this region is free of pre-existing cracks and metallurgical defects. These findings of low stress concentration and defect-free surface and singular type of crack propagation indicate that the reason of fatigue crack initiation and propagation is high magnitude of cyclic

Fig. 7 Crack origin

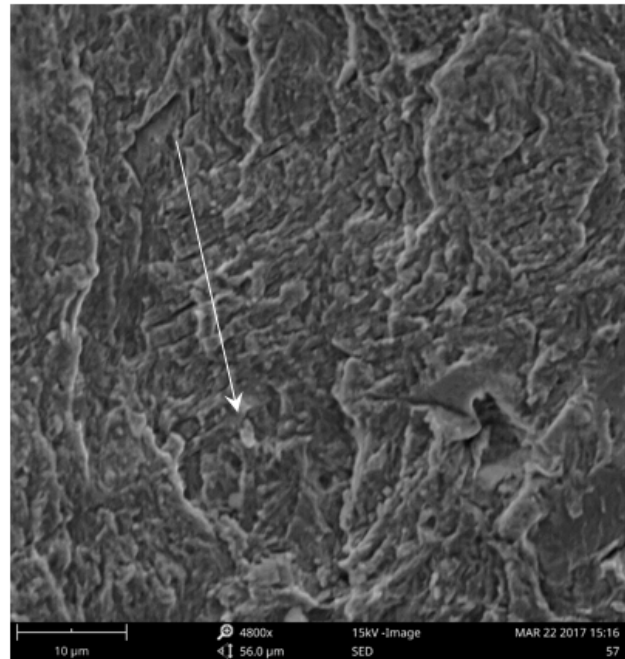
Fig. 9 Fatigue crack propagation direction and striations (point b)

Figs. 9 and 10 show the crack propagation directions. Fatigue striations can also be observed on Fig. 9 which are indications of stable crack propagation.

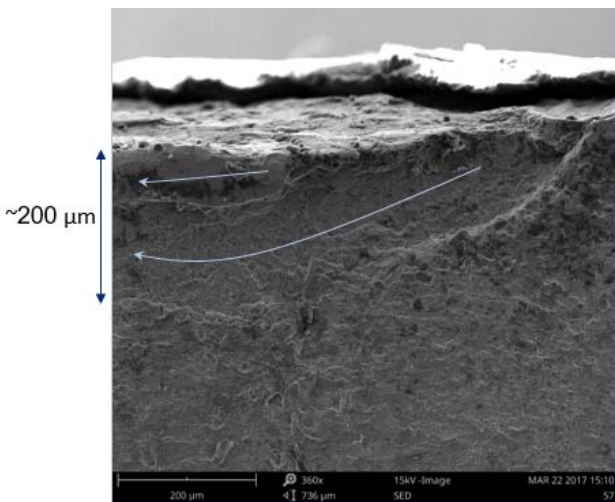
Fig. 8 shows the extension of crack initiations further beyond to the left (point b). However these cracks did not propagate and fatigue cracking continued with initial crack starting from point a.

Fig. 8 Extension of multiple crack initiation

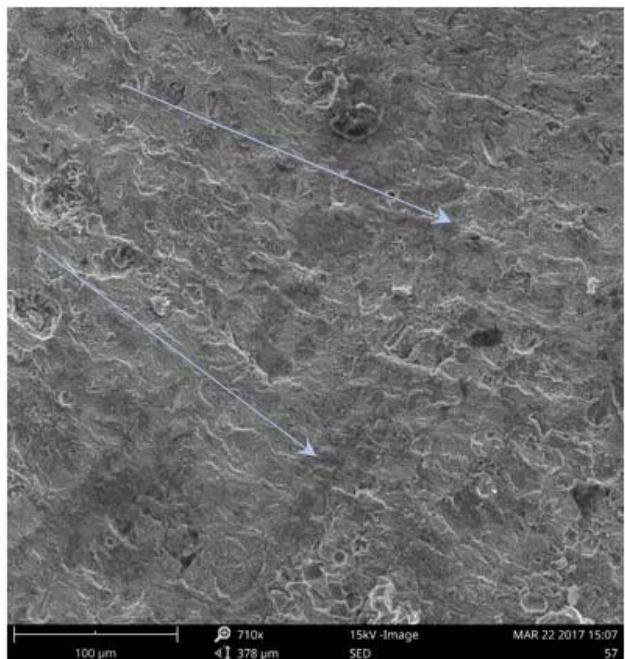
Fig. 10 Fatigue crack propagation directions (point c)

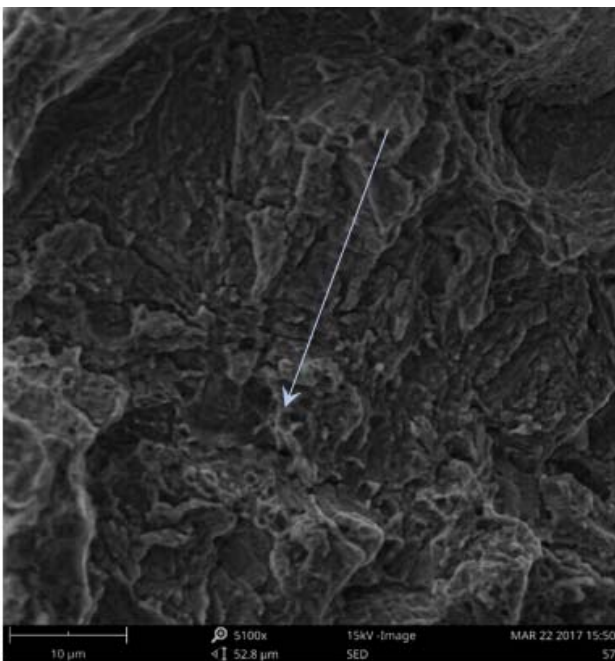
Striations and tear ridges were observed in fatigue region whereas dimples were observed on the overloading region.

Fig. 12 Fatigue striations and tear ridges (e1)
