Ghost Frequency Noise Reduction through Displacement Deviation Analysis

Abstract—Low gear noise is an important sound quality feature in modern passenger cars. Annoying gear noise from the gearbox is influenced by the gear design, gearbox shaft layout, manufacturing deviations in the components, assembly errors and the mounting arrangement of the complete gearbox. Geometrical deviations in the form of profile and lead errors are often present on the flanks of the inspected gears. Ghost frequencies of a gear are very challenging to identify in standard gear measurement and analysis process due to small wavelengths involved. In this paper, gear whine noise occurring at non-integral multiples of gear mesh frequency of passenger car gearbox is investigated and the root cause is identified using the displacement deviation analysis (DDA) method. DDA method is applied to identify ghost frequency excitations on the flanks of gears arising out of generation grinding. Frequency identified through DDA correlated with the frequency of vibration and noise on the end-of-line machine as well as vehicle level measurements. With the application of DDA method along with standard lead profile measur

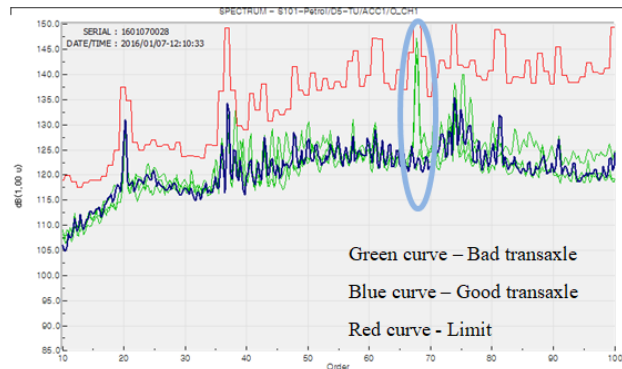
Based on vehicle level findings of whine noise problem, detailed vibration analysis of transmission End of Line (EOL) was conducted. Spectrum analysis of transmission EOL vibration demonstrated appreciable difference in amplitude of relevant ghost frequency of bad vehicle transaxle and good vehicle transaxle as shown in Fig. 3 which correlated with frequency from vehicle level noise and vibration measurements. Transaxle of bad vehicle showed significantly higher vibration of the ghost frequency relative to the good vehicle transaxle which had no whine noise. Also, it was

observed that drive flank EOL vibration response for ghost frequency amplitude of bad vehicle was higher than good vehicle even though the vehicle did not exhibit problem at vehicle level measurements in drive condition.

Fig. 3 (a) Transmission EOL vibration: Order plot: good transmission and bad transmission: 5th Gear drive condition

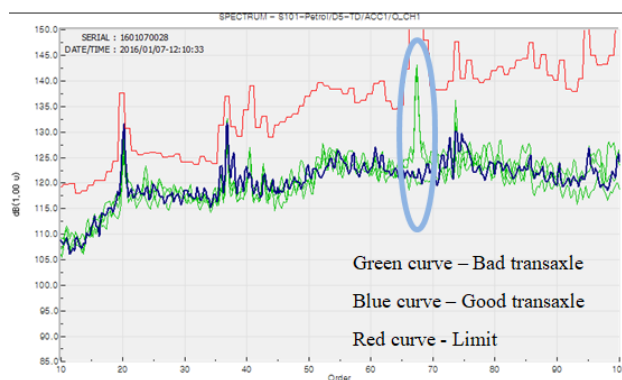
Fig. 3 (b) Transmission EOL vibration: Order plot: good transmission & bad transmission: 5th Gear coast condition

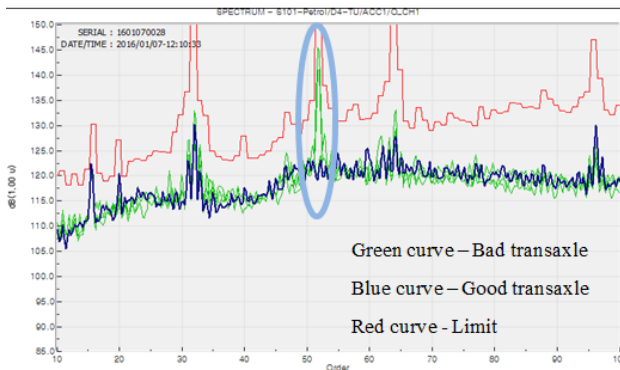
In 4th gear condition, transmission EOL vibration shown in Fig. 4 confirmed the problem order was 51.75 as identified in vehicle level noise and vibration measurements.

Fig. 4 Transmission EOL vibration: Order plot: good transmission & bad transmission: 4th Gear coast condition

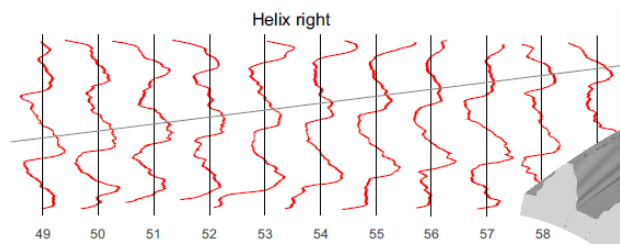
If a ghost frequency is present on gears, the tooth flanks show a ripple with varying phase position, and the form changes from tooth to tooth as shown in Fig. 5.

Fig. 5 Ghost frequency ripple

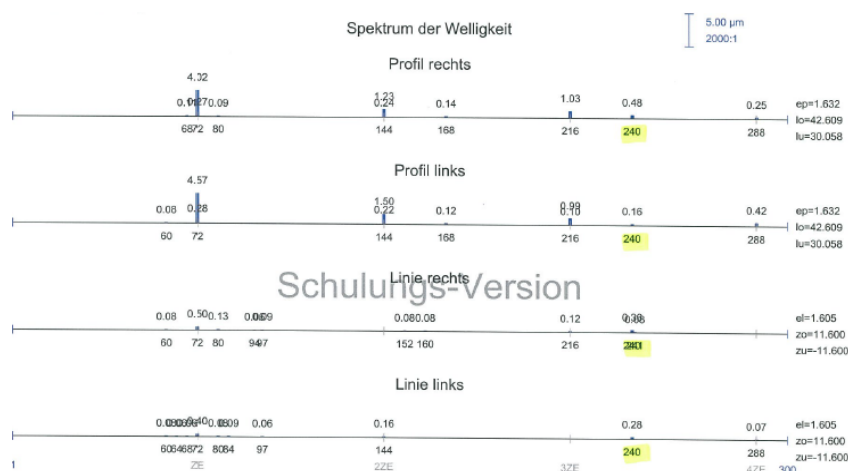
Fig. 6 (a) Deviation analysis: Ring gear: Bad transmission

Analysis of the measurement data shown in Fig. 6 (a) highlighted conspicuous 240 order deviation in bad ring gear which was absent in wave analysis of good gear as shown in Fig. 6 (b). This observation correlated with the problem order seen in EOL vibration measurement as well as in vehicle driver ear noise measurement. This measurement technique to assess gear quality was deployed in production line on batch wise random sampling basis leading to huge cost saving by avoiding repair and refitment cost of faulty gears in transmissions & vehicles.

Ring gear surface undulations were demonstrated to be the excitation forces causing ghost order noise generation at driver ear location in vehicle. Subsequently, gear quality control system was established for controlling the ghost order sensitive parameters at EOL machine. NVH measurements on vehicle level, EOL vibration diagnostics along with deviation measurement techniques helped to eliminate the ghost order noise from gear inside the vehicle.

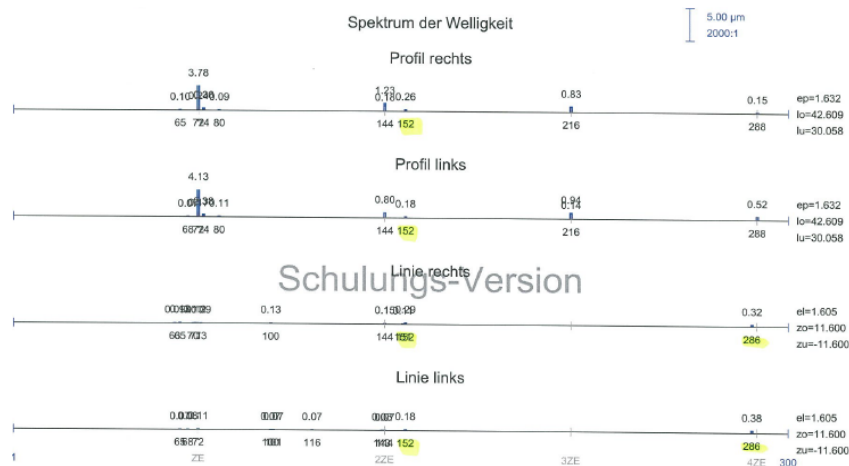
Fig. 6 (b) Deviation analysis: Ring gear: Good transmission
