# Investigating Causes of Pavement Deterioration in Khartoum State, Sudan

Magdi M. E. Zumrawi

**Keywords**— Pavement, deterioration, causes, failures.

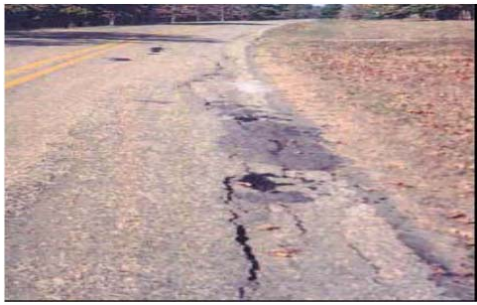
Fig. 1 Longitudinal cracking and failure, [19]

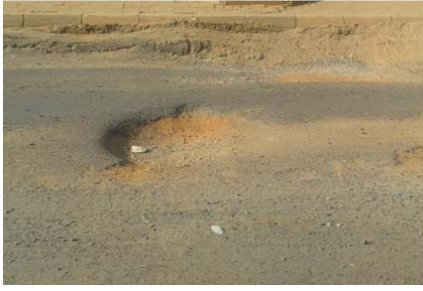
Both the northbound and southbound lanes were examined. On the southbound lanes, the majority of the damage is due to high severity rutting leads to large potholes mostly concentrated to the wheel path of heavy traffic as shown in Fig. 2. There is also significant damage due to medium severity transverse cracking mostly occurring in edge lane.

Fig. 2 Severe rutting leading to large potholes in Algaba road

The results from field survey of the three roads with different defects are presented and discussed here. Fig. 2 shows the photo of pavement having rutting surface and potholes. From figure, the rutting happened to occur on the wheel path and the potholes appeared in the middle of roadway. This pavement receives heavy load traffic every day because it is one of the main routes for buses and trucks. From

field observation, this road experience very poor drainage. The data recorded (as given in Table I) indicated that the faulty pavement design parameters, the paving was designed using underestimated traffic loads, the use of low quality materials in base and subbase construction, inappropriate pavement design procedures were followed. Therefore, insufficient thickness and poor drainage may become the reasons of these defects to occur.

- Slight ruts (< 8mm deep) can generally be left untreated. Pavement with deeper ruts should be leveled and overlaid.
- The optimal treatment of a pothole is a surface patch.

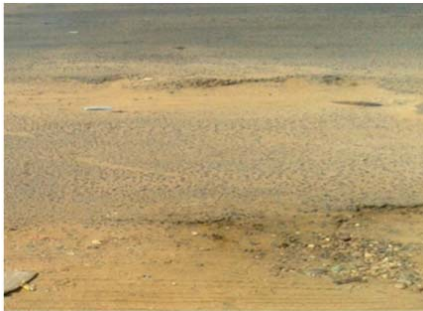
It is a major road located at the western part of Khartoum North. This road has been experiencing considerable pavement failures. The road narrows to one lane in each direction. It was observed that the majority of the damage is large potholes. In addition, there are large areas of moderate fatigue cracking associated with depressions and heave. Most of the cracks and potholes are considered severe and located along the road edges (see Fig. 3).

Fig. 3 Severe potholes and damaged edge in Shambat west road

Fig. 3 is the photo taken from pavement that having bumps, cracks, and edge failures at the middle and side edges of the road carriageway. The defect area is quite large and obstructs the traffic flow. It appears that failures may simply be due to weak subgrade soil. The problems associated with heave and edge failures were likely associated with problems in the subgrade soils along the alignment. Distresses related to expansive soils exist throughout the road alignment, but significant damages concentrations are located in a certain sections of about 1.6 km length. A lack of adequate surface drainage is another critical factor leading to problems with expansive subgrade soils in this road.

- For narrow roads without shoulders, road widening is suggested as a cost-effective edge repair solution than patching.
- For small, localized areas of corrugation or shoving, it is recommended to remove the distorted pavement and patch. Large corrugated or shoved areas are repaired by removing the damaged pavement and overlay.

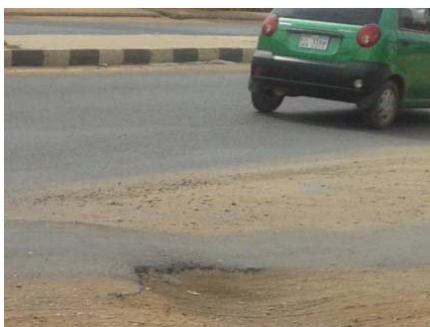
This road connects Omdurman town with Khartoum and is located in the eastern part. The damage was observed mainly in the middle portion of the road length, particularly in the edge lane of the eastern carriage. The majority of the damage was moderate to severe edge cracking. Raveling is also present and appears to be worse. The severe raveling has led to potholes and depression areas where the top surface has delaminated from the road structure as clearly shown in the photograph of Fig. 4.

Fig. 4 Severe surface damage along the edge lane in Alarbeen road

Fig. 4 shows the asphalt layer has delaminated from the top surface of the road structure. This defect area is adjacent to the side drain, shows significant depression. It was observed that the side drain was full with refuse dumps. The inlets on the curb were blocked with soil accumulation as shown in Fig. 5. It is clear that the surface runoff water penetrated through the cracks and potholes cause a progressive inward penetration of the zone of soil movement leading to soil depression and ultimately failure of the pavement. From the on-site observation and the result above, it is clearly seen that the major cause of pavement deterioration is inadequate drainage.

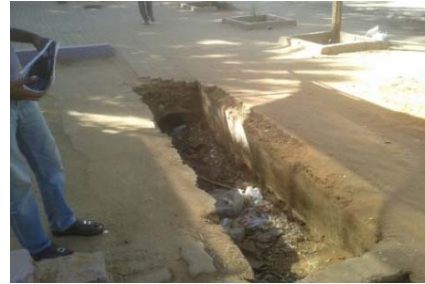
It was observed that the eastern carriageway of the road is connected with side drain. In general, most of the drain is covered with concrete slab and damaged manhole covers. The drain has small cross section of 1m width and not more than 1m depth. The condition of the drain and its structures is very poor and getting deteriorated by the passage of time. The drain suffered from low capacity, natural siltation, absence of inlets, lack of proper maintenance and over and above disposal of solid waste into the drain and the crossing culverts. The drain blocked with silt and sand accumulation, debris and vegetation as shown in Fig. 5. It is clear that the drain being converted to dumpy place and subsequently obstructed the water flow.

Fig. 5 Side drain of damaged cover full with debris in Alarbeen road
