Railway Crane Accident: A Comparative Metallographic Test on Pins Fractured during Operation

Abstract—Eventually train accidents occur on railways and for some specific cases it is necessary to use a train rescue with a crane positioned under a platform wagon. These tumbled machines are collected and sent to the machine shop or scrap yard. In one of these cranes that were being used to rescue a wagon, occurred a fall of hoist due to fracture of two large pins. The two pins were collected and sent for failure analysis. This work investigates the main cause and the secondary causes for the initiation of the fatigue crack. All standard failure analysis procedures were applied, with careful evaluation of the characteristics of the material, fractured surfaces and, mainly, metallographic tests using an optical microscope to compare the geometry of the peaks and valleys of the thread of the pins and their respective seats. By metallographic analysis, it was concluded that the fatigue cracks were started from a notch (stress concentration) in the valley of the threads of the pin applied to the right side of the crane (pin 1). In this, it was verified that the peaks of the threads of the

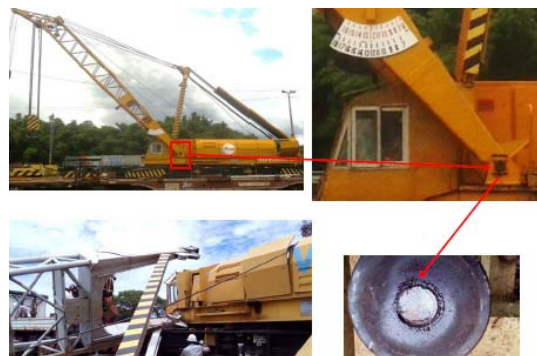
Fig. 1 The accident occurred with the railway crane due to the fall of the hoist by the fracture of the two support pins

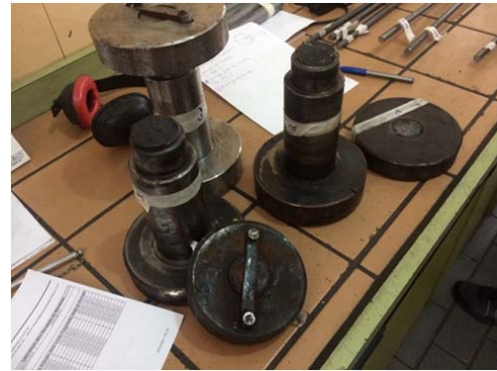
Fig. 6 Samples sent for analysis

The types of analyzes performed and their results will be presented below. Three pins (Fig. 6), with about 400 mm and 50 mm of diameter, were analyzed being called:

- Fractured pin number 1 (right side crane).
- Fractured pin number 2 (left side of crane).
- New pin.

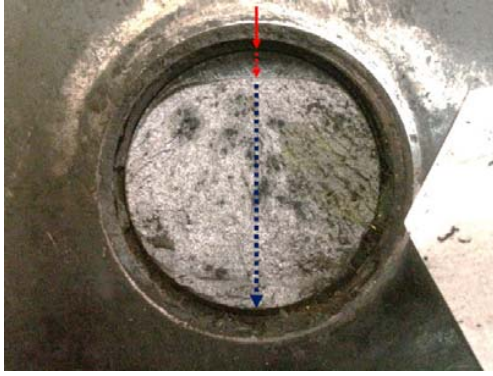
The fractured pin 1 (right side of crane), see Fig. 7, was fractured by fatigue through repeated efforts of unidirectional bending (presence of beach marks). The region of instantaneous and final fracture (about 90% of the cross section) was of the brittle fracture (radial marks).

Fig. 7 The visual inspection of the fracture shows: region of beginning of the fatigue crack (red arrow); beach marks: beginning and propagation of fatigue crack by unidirectional flexion (red dotted arrow); and radial marks: region of instantaneous fracture and final of brittle fracture (blue dotted arrow)

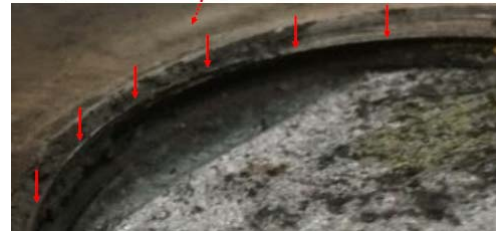
Further, Fig. 8 shows the detection that the screw peaks of the pin seat have no curvature, that is, they have sharp edges (sharp corners). This figure shows the presence of a sharp

corner in the first thread of the screw seat, and the same anomalies in the other threads are also shown.

Fig. 8 Presence of sharp edge (sharp corners) in the peaks of the threads of the seat of the fracture pin 1

- Perform visual tests with magnifying glass and/or non-destructive tests (dye penetrant, ultrasonic, etc.) on all the pins applied on the crane in order to detect notches and/or crack initiation.
- Calculate efforts to determine whether SAE 1045 steel (with or without heat treatment) and/or the entire crane is sufficient for the mechanical stresses imposed by the operation. Same for the seat.
- Elaborate technical drawing of the pin and seat, as well as elaborate technical specification containing various details including the design, material and type of heat treatment.
- Adapt the mechanical forming process of the seat and/or pin threads in order to eliminate sharp edges on the thread peaks.

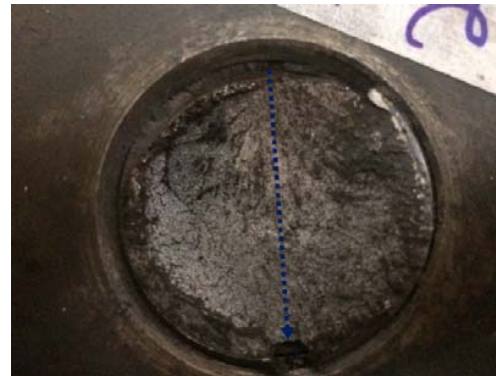
The fracture of pin 2 was of the brittle bending type through a single overload stress (fracture occurred almost instantaneously). Fig. 9 shows the radial marks proving to be a brittle fracture. The results of the chemical composition showed that the steels of the three pins are similar to those specified for the steel SAE 1045.

Fig. 9 Fracture of pin 2 due to bending overload stress generating brittle fracture (radial marks). The blue dotted arrow indicates the direction of instantaneous propagation

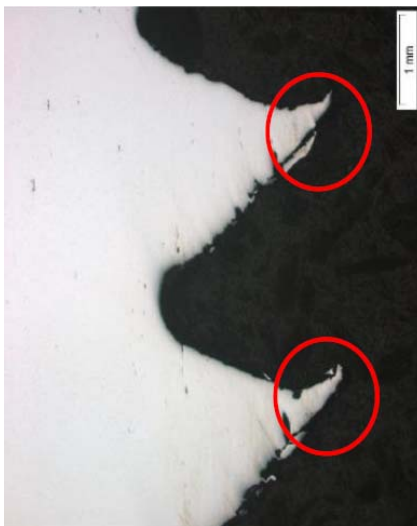
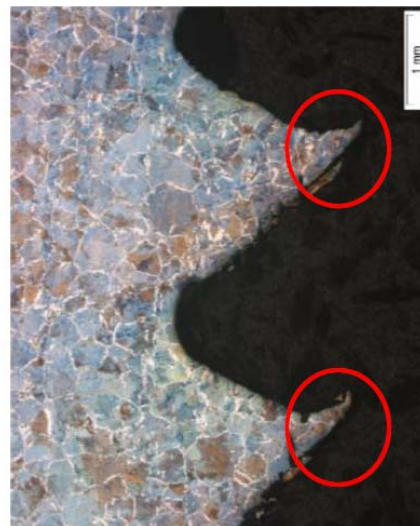
The metallographic examination of all three pins and of the three sites showed is formed by a perlite, as was already expected to be SAE 1045 steel. No irregularities were found in the microstructure. However, the anomaly in the peak of the threads of the seat of the fractured pin 1 was corroborated due to the presence of a cutting edge (Fig. 10). In addition, in the valleys of pin 1 threads several fatigue cracks were found in the beginning of propagation phase (Fig. 11).

Fig. 10 The presence of a sharp edge in the peaks of the threads of the seat of the fracture pin 1

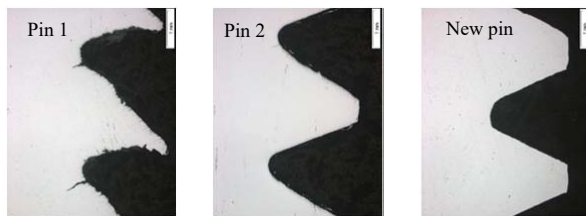
Fig. 12 Pin threads

The threads of the pin/seat 2 and the pin/new seat were shown with thread geometry to the satisfaction (without cutting edge) and without the presence of cracks and/or plastic deformations. An exception is that only a small crack was found in a valley of the pin 2 thread, most likely as a

consequence of the overload imposed after the fracture of pin 1. The comparative table in Fig. 12 shows the comparison

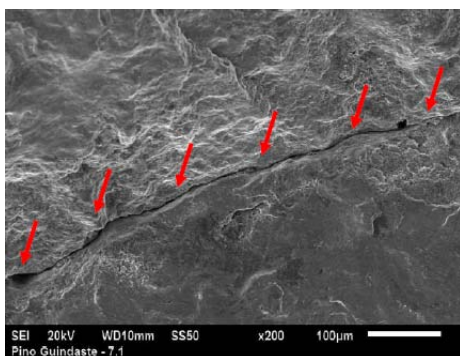
Aiming to verify the presence of notches, the fracture of pin 1 was analyzed in SEM (Scanning Electron Microscope). Fig. 14 shows the existence of notch in the valley of the thread of pin 1. This test was also performed for pin 2, with no notch in the thread.

Fig. 14 SEM analysis evidencing the presence of notch (risk) in the valley of the thread of the fractured pin 1

The main cause of the failure was the notch caused in valley of pin 1 (right side of crane hoist) by the action/contact with the cutting edge contain in the peaks of the seat threads. From these grooves, the fatigue crack was started in pin 1.
