Rock Slope Stabilization and Protection for Roads and Multi-Storey Structures in Jabal Omar, Saudi Arabia

Ibrahim Abdel Gadir Malik, Dafalla Siddig Dafalla, Abdelazim Ibrahim

Abstract—Jabal Omar is located in the western side of Makkah city in Saudi Arabia. The proposed Jabal Omar Development project includes several multi-storey buildings, roads, bridges and below ground structures founded at various depths. In this study, geological mapping and site inspection which covered pre-selected areas were carried out within the easily accessed parts. Geological features; including rock types, structures, degree of weathering, and geotechnical hazards were observed and analyzed with specified software and also were documented in form of photographs. The presence of joints and fractures in the area made the rock blocks small and weak. The site is full of jointing; it was observed that, the northern side consists of 3 to 4 jointing systems with 2 random fractures associated with dykes. The southern part is affected by 2 to 3 jointing systems with minor fault and shear zones. From the field measurements and observations, it was concluded that, the Jabal Omar intruded by andesitic and basal

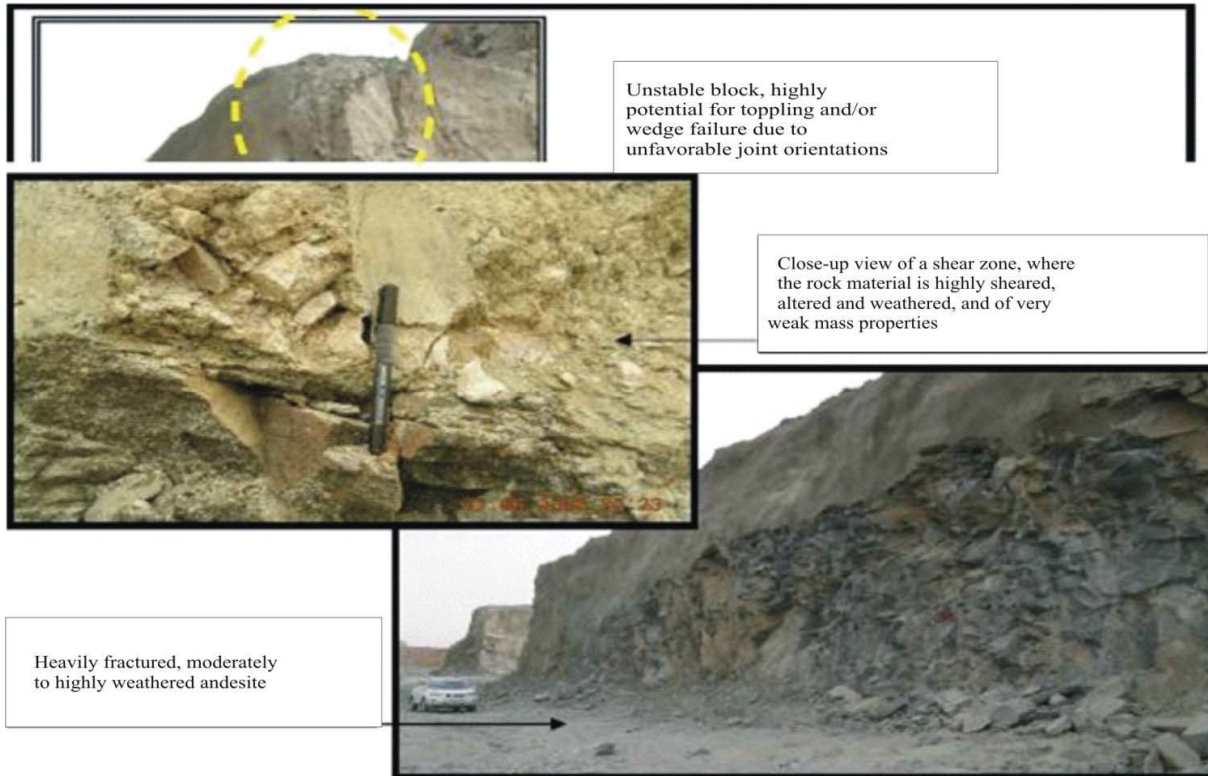
Fig. 1 Some of the common geological features of the rock mass along the Site

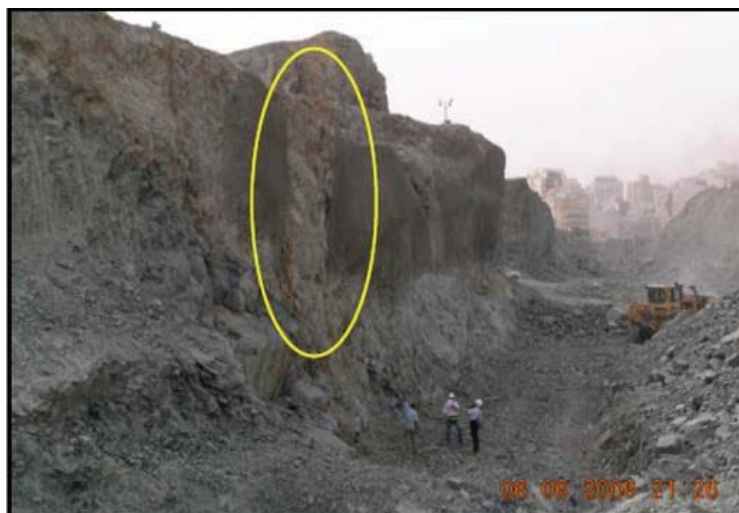
The site was selected as a critical area since the exposed bedrocks by recent rock cutting are generally in very poor condition, heavily jointed and sheared. Based on information from the Resident Engineer on site, rock slope failures occurred recently at the upper portion of the cut slopes which covered by "concrete spray" (Fig. 2).

Fig. 2 View of the site condition of the site, the yellow circle indication the failure section

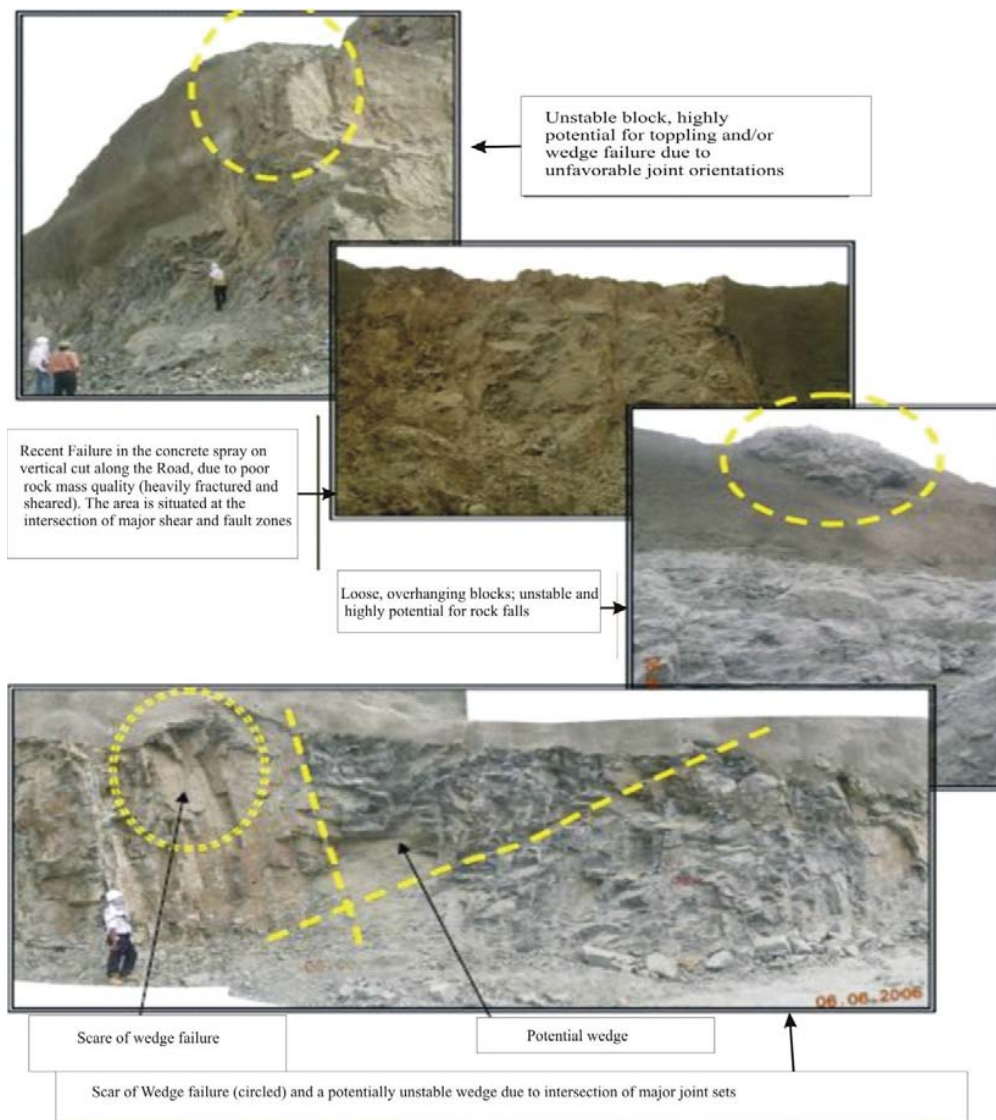
unsuccessful. Wedge failures, rock falls, and tension cracks had since developed, suggesting that the "concrete spray" was inadequate and could not support the vertical cut in poor rock mass and thus some other slope protection measures have to be adopted. From a brief survey, it was also found that the cut slopes along the site Mare potentially unstable and are very likely to fail either in the form of wedge, toppling and/or rock falls. Some of the identified critical spots are shown in Fig. 3.

Fig. 3 Examples of some of the identified geotechnical problems associated with vertical cut in poor rock mass along the site

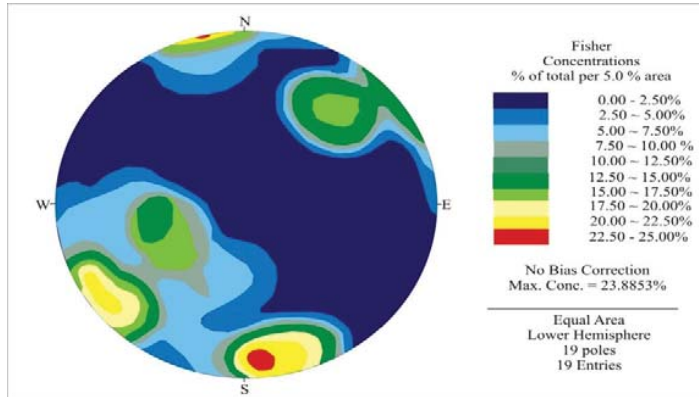
Geological mapping works was carried out in the vicinity of the unstable slope shown in Fig. 3 (a) in order to assess and to verify its stability. The discontinuity data orientation was plotted into lower hemisphere stereographic projections and analyzed (Fig. 4). The results of the analysis (Fig. 5) confirmed the presence of unstable blocks, which is defined by the intersection of three (3) major sets of joints (H: 340/35; J2: 322/90, and B: 256/78). The toppling failure is made possible by the intersection of the steeply dipping J2 with plane H acting as the basal sliding plane. The failure may also take place in the form of wedge due to the intersection of J3 and J1 [6] and [9].

Fig. 4 Stereographic plot the discontinuities of the failed slope

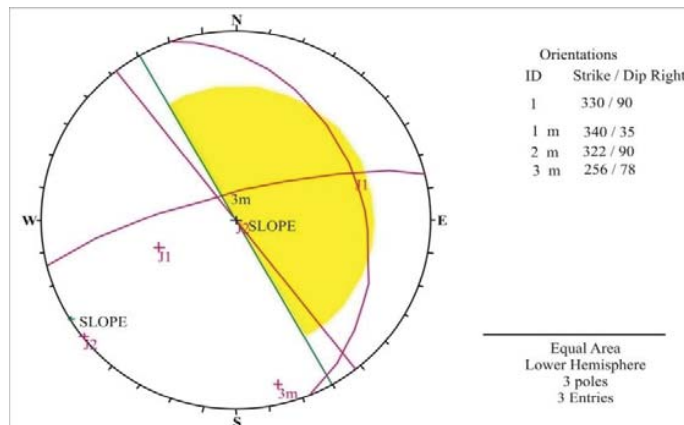
Fig. 5 Kinematic stability analysis of the rock slope at the site, Sta. 0+160

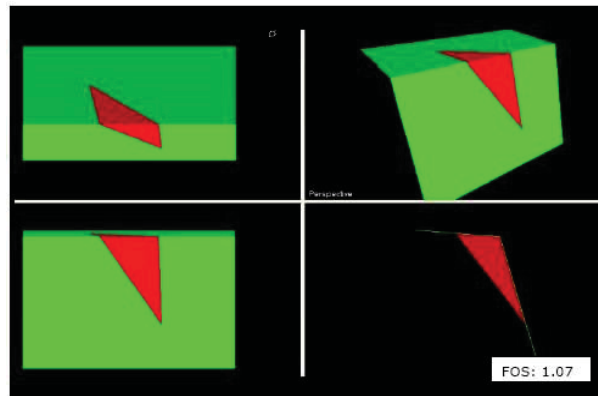
The wedge failure identified from the kinematics stability analysis (Fig. 5) was further modeled by using SWEDGE v4 of Rocscience in order to determine its factor of safety during the failure. In this back analysis, it is assumed that the friction angle along the discontinuity plane is 36° and the failure took place in dry condition. Results of the analysis (Fig. 6) suggested that the factor of safety was 1.07.

Fig. 6 Back analysis modeling of the unstable wedge, by using SWEDGE v4 program

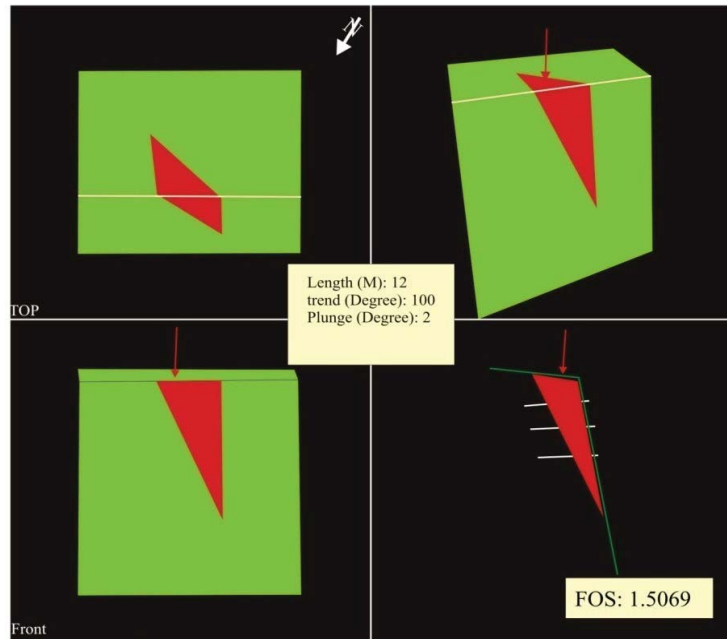
Fig. 7 Detail analysis to determine suitable length of the rock bolts

Detail wedge failure analysis was also carried out in order to determine the best possible methods of stabilization (Fig. 7). Patterned-bolting was proposed as a stabilization measures. The analysis results suggest that the wedge could be stabilized and its factor of safety can be increased to 1.5069 by installing at least 12m long, Y32 bars with capacity of 30 tons of rock bolts.
