# Stress Corrosion Crack Identification with Direct Assessment Method in Pipeline Downstream from a Compressor Station

The assessment covers approximately 7.700 km of gas line as named E-Branch in Ahwaz region with 16" pipe diameter, pipe material 5L-X65, pipe wall thickness 19.05 mm, design pressure 250 BAR and Design temperature 60°C. The pipeline was constructed and commissioned in 1978 and was externally coated with PVC cold wrapping. The pipe line is not piggable, so and located downstream of compressor station.

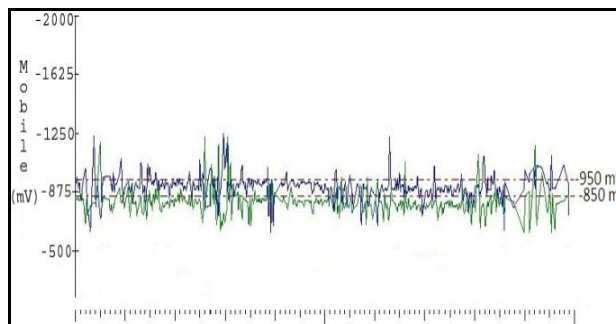
Fig. 1 CIPS results

Inadequate cathodic protection level was detected in through of the pipeline according to the (-850mV) instant-off potential criterion, generally (Graph 1). This graph is a sample of CIPS results in this pipeline.

All the factors discussed in NACE standard are met in this pipe line. In addition, SCC is typically found in locations where CP is shielded from the pipe surface or is inadequate. CIPS results showed that potential is under-protection according to (-850 m.v "off"). So, results of CIPS show that this pipeline is susceptible to SCC.

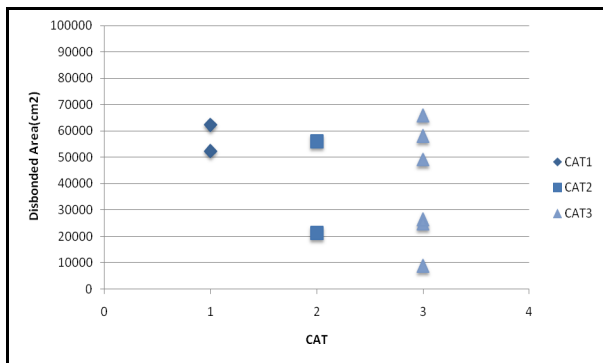
Fig. 2 The extent of disbondment in compare with the coating defect category

Fig. 2 illustrates disbondment area close to coating defects for a pipeline with PVC cold wrap coating and after 38 years from construction year. Extent of disbondment area next to the DCVG category 1 is approximately same in compare with category 3.

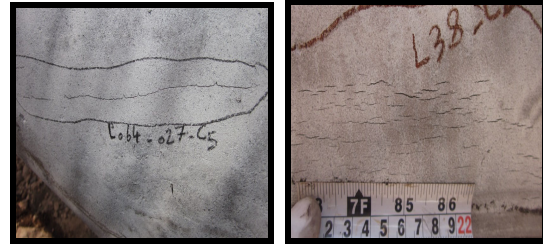
Fig. 3 (a), (b), (c), (d) and (e) Samples of SCC shapes, found place and orientation for E- Branch pipeline

SCC occurred in places with corrosion metal loss. The SCC was typically within areas of general corrosion and/or pitting (Fig. 3 (b)). SCC can occur in individual or colony form. Colonies typically contain from a few to thousands of individual cracks (Figs. 3 (c) & (d)). Cracks are essentially parallel to one-another and oriented perpendicular to the local direction of maximum stress on the pipe. Typically cracks are axially-oriented where the operation hoop stress is the dominant stress. Where external bending loads act on the pipe or where local stress raisers (i.e. dents) are present, the dominant stress directions can shift to the circumferential-oriented or some intermediate angle (Figs. 3 (a) & (e)).

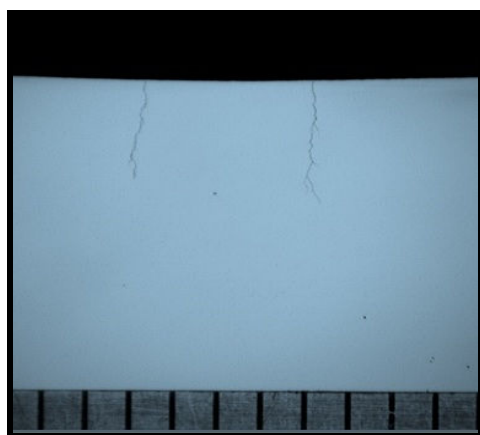
Fig. 4 Morphology of SCC in E-Branch pipeline

standard metallographic techniques and examined using an optical microscopic. Fig. 4 shows these results. Intergranular phenomenon was detected in SCC sample. This type of SCC morphology considered in high-pH SCC. But, there is potential for neutral pH SCC in this pipeline, too.

(a) Macrograph sample section

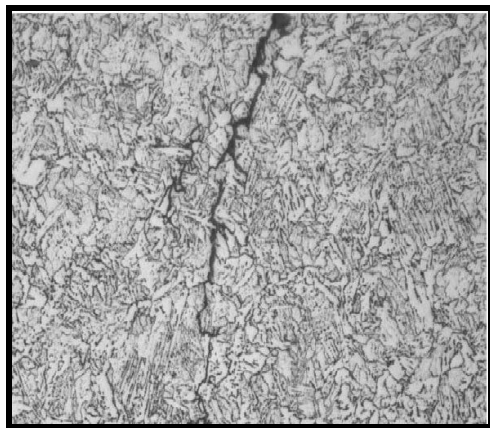
(b) Intergranular phenomenon
