Structural Analysis and Strengthening of the National Youth Foundation Building in Igoumenitsa, Greece

Chrysanthos Maraveas, Argiris Plesias, Garyfalia G. Triantafyllou, Konstantinos Petronikolos

Abstract—The current paper presents a structural assessment and proposals for retrofit of the National Youth Foundation Building, an existing reinforced concrete (RC) building in the city of Igoumenitsa, Greece. The building is scheduled to be renovated in order to create a Municipal Cultural Center. The bearing capacity and structural integrity have been investigated in relation to the provisions and requirements of the Greek Retrofitting Code (KAN.EPE.) and European Standards (Eurocodes). The capacity of the existing concrete structure that makes up the two central buildings in the complex (buildings II and IV) has been evaluated both in its present form and after including several proposed architectural interventions. The structural system consists of spatial frames of columns and beams that have been simulated using beam elements. Some RC elements of the buildings have been strengthened in the past by means of concrete jacketing and have had cracks sealed with epoxy injections. Stati

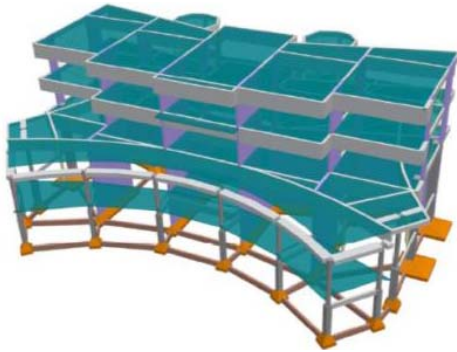
Fig. 4 Illustration of the structural layout of Building II

symmetrical along its North–South axis, as illustrated in Fig. 4. The common methodology of the era was followed, in which concrete slabs were used as surface elements to undertake the vertical actions on each service level of the structure. They carry the vertical loads through a system of beams and then through columns or concrete walls to the ground. The slabs had rectangular cross-sections. Structural meshes of standard dimensions were used as a steel reinforcement. This type of reinforcement is unusual in Greek construction and experiences problems in corrosive environments. Corrosion activity in terms of the residual cross-sections of steel meshes is greater than when other strategies are used, due to the small diameter of the rebar employed (4–6 mm). The slabs were 15 cm-thick, which is considered sufficient for their intended purpose (usual length of 4 m). However, Building II contained slabs that often exceeded 6 m in length. Modern regulations indicate that this thickness is marginal for ensuring the required slenderness. The beams involved had small cross-sections and were reinforced with marginal quantities of steel. This often resulted in under-reinforced elements.

Vertical elements (columns and concrete walls) were placed primarily to satisfy architectural requirements with regard to the arrangement of curved sections on the ground floor for the layout of the stairs. These curved walls were not founded on the ground, but rather were settled on curved beams. In addition, there were small columns on the external perimeter of the building (North–South) that act as point supports and mainly affect the static combinations of actions.

In summary, four strong North–South support lines were created by concrete shear walls on the upper two floors. One characteristic of the support lines was that they presented discontinuities on the ground floor, as their central part was not present. There was no stiffness on the upper floors in the transverse direction (East–West). This contrasted with the ground floor, where diagonally arranged and curved walls placed symmetrically on both sides of the central aisle created two strong pillars of stiffness. These pillars received the majority of the seismic energy from the earthquakes, resulting in significant damage. The selected retrofit measures mainly included the installation of strong shear walls along the East–West direction on the 1st and 2nd floors (four concrete

walls/level). Due to architectural constraints, these walls did not descend to the ground floor and were not founded. As a result, their contribution to the seismic response of the building was improved in terms of increasing the stiffness on the upper floors (reduced efficiency). In addition, not all columns or walls were strengthened as designed, particularly in the basement.

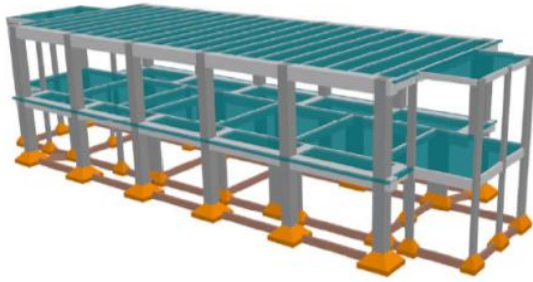
Fig. 5 Illustration of the structural layout of Building IV

Building IV was first designed as a symmetrical RC structure with two symmetrically protruding parts at its eastern and western boundaries, as illustrated in Fig. 5. It is a two-story building with a balcony that acts as a "loft" and that is to be demolished. The layout varies from level to level. Concrete slabs were used as surface elements for transferring vertical actions on each service level of the structure. They carry vertical loads through a system of beams, followed by columns or concrete walls that go to the ground. The slabs have rectangular cross-sections. The slab of the event venue (with a length of approximately 13 m) was a folded concrete slab shell. It was assumed that the vertical elements of the folded concrete slab shell were the beams of the system and the horizontal parts were the small slabs. The behavior of the simulation after the earthquake proved the ineffectiveness of the latter. Structural meshes of the standard dimensions used in Building II had been used as steel reinforcement, producing the problem of cross-section loss in corrosive environments that is mentioned above. The slabs were 15 cm-thick, which is considered sufficient for usual length of 4 m, but for Building IV where slabs often exceeded 6 m in length, this thickness is marginal for ensuring the required slenderness. Beams were reinforced with marginal quantities of steel, which often resulted in under-reinforced elements.

The vertical element structural system consisted of two strong support lines at the floor level that carried the folded concrete slab shell. These support lines consisted of circular columns that behaved unacceptably during the earthquake, failing at their bottoms. These columns were strengthened with concrete jacketing to form an overall cross-section of 75 cm x 75 cm per column. On the ground floor, two additional support lines were constructed with a mixed system of vertical elements (columns and walls) and added to the existing strong columns. Thus, the structural system used to simulate the force imparted by the earthquake was composed of:

The retrofitting techniques of the initial study focused on the installation of strong North–South beams on the ground floor that strengthened the diaphragmatic function of this level even though the connection points with the existing beams did not ensure good function for the nodes. Tensile tendons were installed on the tops of the perimeter columns of the folded concrete slab shell of the ground floor ceiling. Columns were strengthened via concrete jacketing.
