# Structural Monitoring and Control During Support System Replacement of a Historical Gate

Ahmet Turer

**Abstract**—Middle-gate is located in Hasankeyf, Batman dating back to 1800 BC and is one of the important historical structures in Turkey. The ancient structure has suffered major structural cracks due to aging as well as lateral pressure of a cracked rock which is predicted to be about 100 tons. The existing support system was found to be inadequate to support the load especially after a recent rock fall in the close vicinity. Concerns were increased since the existing support system that is integral with a damaged and cracked gate wall needed to be replaced by a new support system. The replacement process must be carefully monitored by crackmeters and control mechanisms should be integrated to prevent cracks to expand while the same crack width needs to be maintained after the operation. The control system and actions taken during the intervention are explained in this paper.

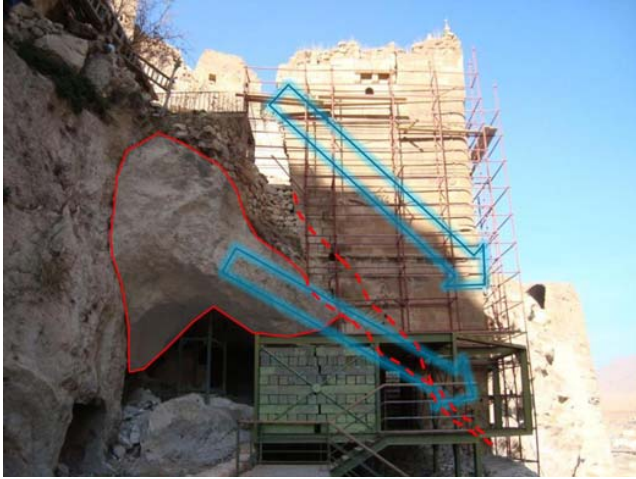
MIDDLE-GATE is located in Hasankeyf, Batman dating back to 1800 BC [1] and is one of the important historical structures in Turkey. The gate is located on a path leading to the upper city which is protected by steep cliffs on all sides and two other gates. The ancient structure has suffered major structural cracks due to aging as well as lateral pressure of a cracked rock which is predicted to be about 100 tons (Figure 1). The existing support system was found to be inadequate to support the load especially after a recent rock fall in the vicinity. Concerns were increased since a large rock block has fallen within close proximity of the middle gate and an existing support system that is integral with a damaged and cracked gate wall was inadequate (Figure 2) and needed to be replaced by a new support system. The support system replacement was a very risky process since the wall and existing support system were in a balance state, removing the existing system would leave the wall vulnerable to immediate damage. Therefore, the cracks needed to be monitored by crackmeters and a control mechanism must be integrated to prevent cracks to expand. Following the replacement of the support system, the new system should maintain similar level of crack on all important locations. Closing the cracks too much relative to their original states should also be prevented since such an action would generate additional stresses and deformations at other places. The monitoring and control system would ensure post replacement condition to be similar to the original state as well.

Fig. 1 Middle Gate general view, cracked rock & force paths, and crack pattern

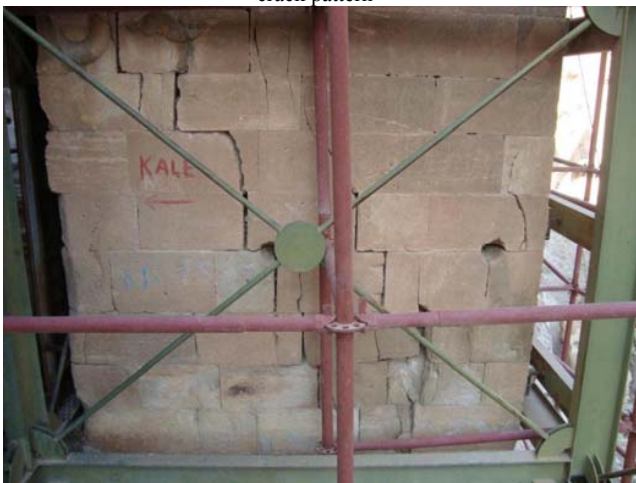
A simple and efficient monitoring system was implemented focusing on the major cracks on the middle gate. The most significant crack was located at the entrance wall on the valley side (Figure 2). The diagonal cracks were clear indication of shear loading exceeding the load carrying capacity of the gate wall. Four crackmeters were placed on the visible cracks of the wall, one at the bottom right corner, two crackmeters at the mid-height of the wall, and fourth gage located on the crack at the top of the wall. The crackmeters were placed in horizontal direction measuring the lateral movement of the upper side of the wall relative to the lower side of the wall separated by a series of diagonal cracks. Two additional crackmeters were located at the cracked rock block behind the middle gate observing movement in the vertical and horizontal directions. The datalogger used for monitoring and control was Campbell CR800 [2] with 6 single ended channels. The system can read 5000mV with 1333 $\mu$ V resolution about 3750 resolution lines or close to 212 which corresponds to 12 bit ADC. Although 16, 18, and 24 bit ADC systems are setting the current standards, 3750 divisions on a 100mm measurement system would provide 0.026667mm resolution. The datalogger programming was made such that each measurement is repeated 500 times with 50 Hz integration frequency to improve the resolution up to 0.0003 mm taking advantage of the random noise on the measurement data vibrating around the actual data. The crackmeters used in the study were potentiometric kind having practically infinite resolution. Therefore, the CR800 system with 6 single ended input channels was the optimum solution for the monitoring project of middle gate. An additional temperature and relative humidity sensor was also integrated to the measurement system to compare, correlate, and compensate temperature induced movement components in the measured long term monitoring data. Temperature and Relative Humidity Probe Model CS215 from Campbell was used which uses SDI-12 protocol to communicate with the datalogger. SDI-12 is a digital communication between the sensor and the datalogger, which permits utilizing digital channels leaving space for the analog sensor channels. Since collected temperature and humidity data is digitized at the sensor, the data can be transmitted over long distances. The sensor can read temperature data between -40° to +70°C with  $\pm 0.4^\circ\text{C}$  ( $+5^\circ$  to  $+40^\circ\text{C}$ ),  $\pm 0.9^\circ\text{C}$  ( $-40^\circ$  to  $+70^\circ\text{C}$ ) accuracy as well as 0 to 100% RH ( $-20^\circ$  to  $+60^\circ\text{C}$ ) with (at 25°C):  $\pm 2.0\%$  (10-90% range),  $\pm 4.0\%$  (0-100% range) accuracy.

Fig. 2 Close view of the middle gate entrance wall on the valley side

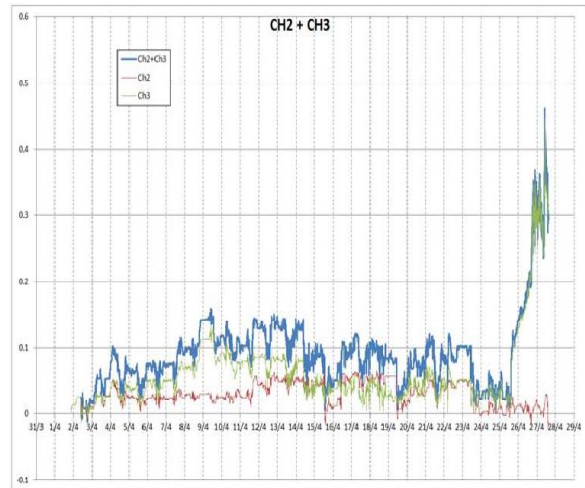
The execution work needed to start with careful considerations and contingency plans if the main planned action would fail. However, the monitoring system gave silent alarms before the actual replacement work has started as a subgroup of workers responsible of the cleaning work unwillingly damaged the existing support system. As the SMS alarm automatically sent by the datalogger was received, a warning was given on site and the new support system had to be rapidly completed as the crack was quickly opening (Figure 3). The new system was completed in less than a day by extra shifts and post-tensioning was applied on the new support system by turning bolts at the end of the new anchors. The system was tightened by hand, and the actual load level existed neither in the old nor in the new support system was known. As the crack width monitoring was continued, the crack width that was rapidly opening before the intervention was observed to be quickly recovering. However, the recovery seemed to be progressing far beyond the original crack width (Figure 4). The over tightening in the new anchorage system was evident from the measured data. The crack was monitored to be closed about 0.2mm more than the original crack width. In order to restore the crack to its original width, the anchor's bolt was rotated backwards. Bolt teeth had about 20 rotations in 73mm distance. The bolt had to be untightened about 1/20 rotation to bring back to original width [3]. The leverage to untighten the bolt had 1m radius. The operator was asked to revolve the end of the leverage about 0.32m to achieve 0.2mm release [3]. The measured data indicates the untightening process bringing the crack width back to its original value (Figure 4).

Fig. 3 Monitoring data of the wall crack for about first 25 days

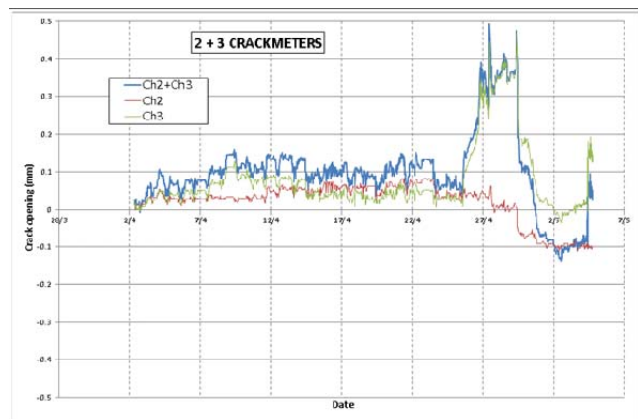
Fig. 4 Crack control by bolt rotation adjustment

Furthermore, the crack width was adjusted back to its original state using the control system maintained by the crackmeters.
