The Effects of Roots Action of Tropical Green Roofs—Replication of German FLL in Singapore

Kian. Kai. Tan, Michael. Yit. Lin. Chew, Nyuk. Hien. Wong

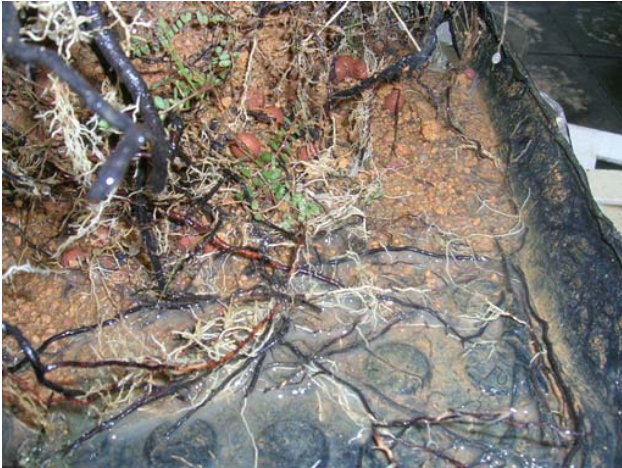
From fig. 5, coverage of secondary roots on the membrane was about 15%. This shows that main roots did not force its way across a membrane; main roots will grow above and do not damage the membrane.

Fig. 5 Secondary roots spreading on membrane surface

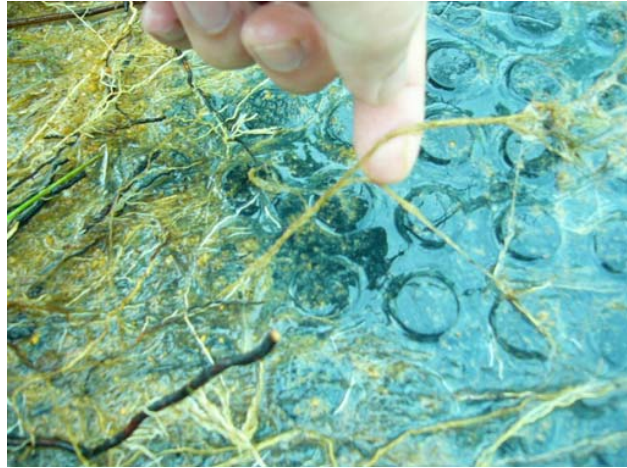
Fig. 7 Roots which seemed to have anchored on the membrane

Further erosion reveals that there were some minor roots which seemed to have grown into the membrane (fig. 7).

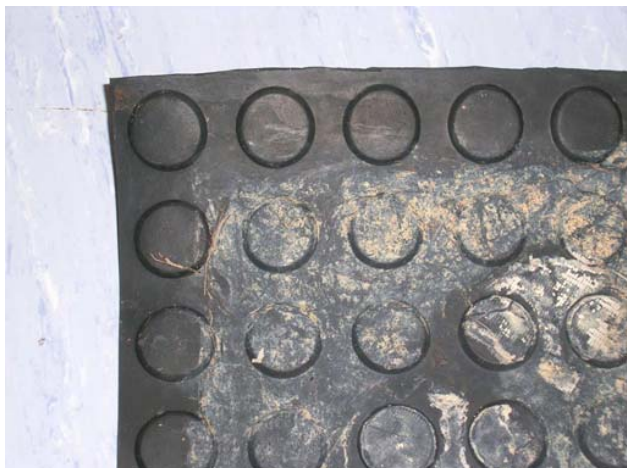
The liquid applied waterproofing was subsequently detached from the sheet membrane and it revealed that no root grew into the joint (fig. 9).

Fig. 9 Clean sheet membrane edges indicate no form of growth between the liquid applied waterproofing and sheet membrane

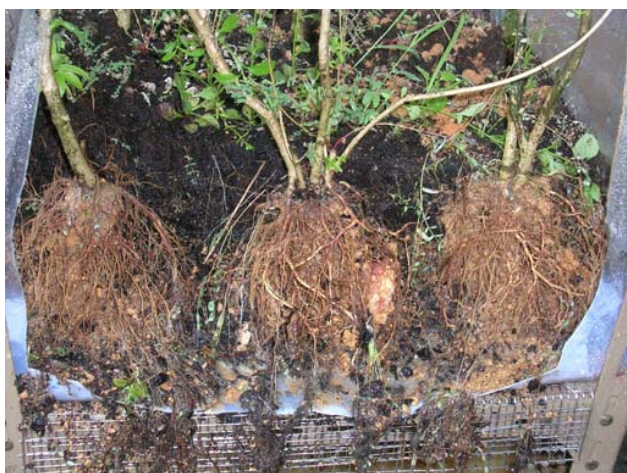
Soil was also removed with a water jet. Upon removal of the first 10mm of soil, substantial root structure was noticed. This again signifies extensive root structure. Further erosion of soil revealed that all the root structures were more well established than those in sample 1, indicating that there was good root growth and the artificial environment created for this sample was conducive for root growth. The root coverage was more than 50% throughout, which was more than sample 1 (15-20%), as seen in fig. 10.

Fig. 10 Vast root structures

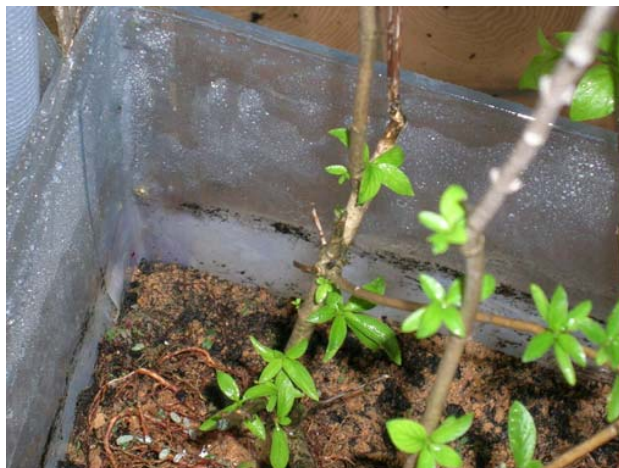
However, the size of roots in this sample was significantly smaller than those in sample 1. This also indicates that though the duration of this sample was sufficient for the root system to grow, the roots might not reach the optimum growth size. From the fig. 11 below, although roots did not anchor in the membrane, it indicates prying action of the roots. This could be due to the improper application of the sealant during the setting-up stage; sealant was not applied to the edge of the joint. The other possibility is simply plant roots poses a challenge to waterproofing systems.

Fig. 11 Growth observed between joints of the membranes

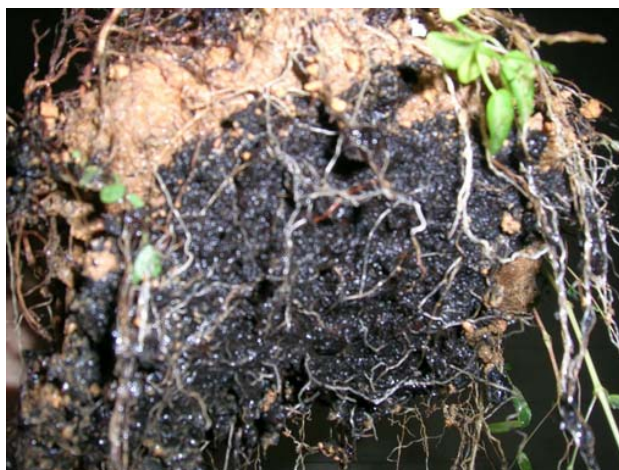
When erosion was sufficient, individual plants, together with some soil, could be lifted. This indicates that was no anchorage of the plants onto the membrane. Furthermore, when observed from the bottom, roots could be seen, implying that roots have grown in and over the fresh plant compound lay below the pre-grown plants (fig. 12). Hence, there is sufficient evidence to indicate that the method of using pre-grown plants to accelerate the sample is viable.

Fig. 12 Roots growing through fresh planting compound

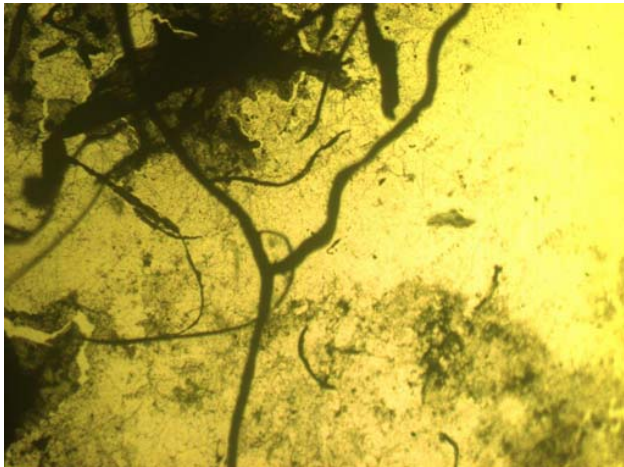
Subsequent erosion of the soil did not reveal other forms of damages inflicted on the membrane by the plant roots. Therefore, the membrane was preserved and studied under a microscope at a later time. Areas where there were significant amount of root growth were studied. These areas were isolated into sections of about 8×8mm. Fig. 13 shows the 2.5× magnification of the area.

Fig. 13 2.5× magnification of typical area (traces of soil seen at top center of fig; algae seen at bottom left of fig)

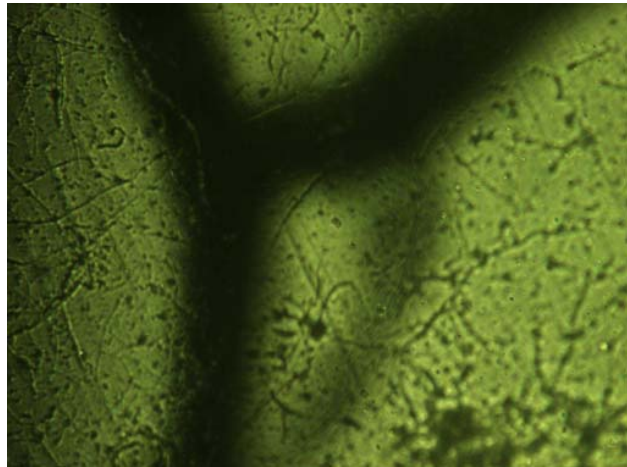
Fig. 15 20× magnification of typical area focusing on the membrane

Fig. 14 shows an area under magnification, focusing at different heights. The top fig. focuses on the root while the bottom fig. focuses on the membrane. This implies that as there was an inability to focus on both the membrane and the root, there was a substantial difference in the level of the root and the membrane. This indicates that the root has not grown deep into the membrane.

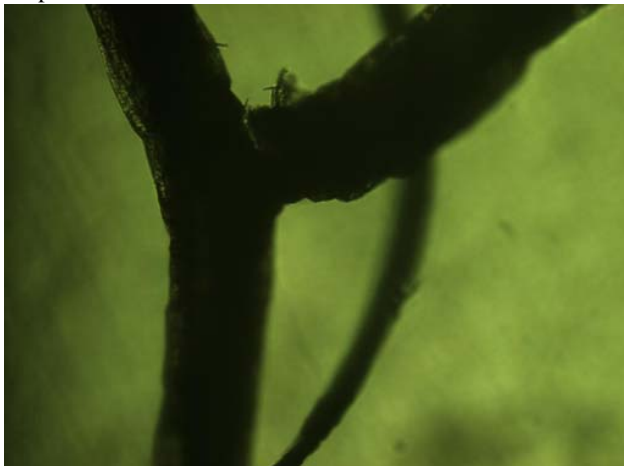
Fig. 14 20× magnification of typical area focusing on the root

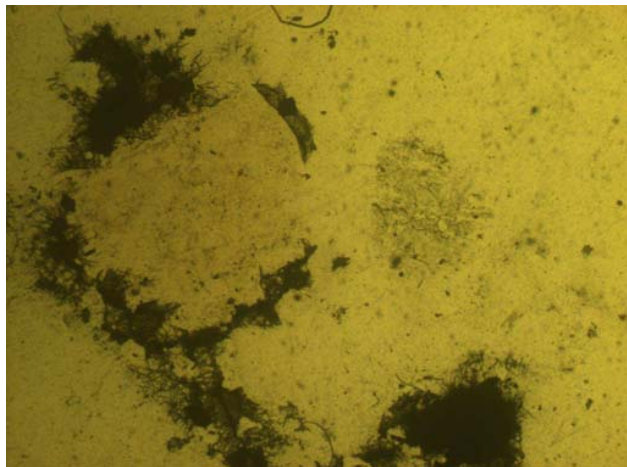
To verify the above inference, the root is removed under a running tap. It was observed that though there was some staining of the membrane under the root growth, there was no root growth mark left on the membrane (fig. 16).

Fig. 16 2.5× magnification of typical area with root cleared
