The High Temperature Damage of DV – 2 Turbine Blade Made from Ni – Base Superalloy

Abstract—High pressure turbine (HPT) blades of DV – 2 jet engines are made from Ni – based superalloy. This alloy was originally manufactured in the Soviet Union and referred as ŽS6K. For improving alloy's high temperature resistance are blades coated with Al – Si diffusion layer. A regular operation temperature of HPT blades vary from 705°C to 750°C depending on jet engine regime. An overcrossing working temperature range causes degradation of the protective coating as well as base material which microstructure is formed by the gamma matrix and strengthening phase gamma prime (forming small particles in the microstructure). Diffusion processes inside the material during exposition of the material to high temperatures causes mainly coarsening of the gamma prime particles, thus decreasing its strengthening effect. Degradation of the Al – Si coating caused its thickness growth. All the microstructure changes and coating layer thickness growth results in decreasing of the turbine blade operation lifetime.

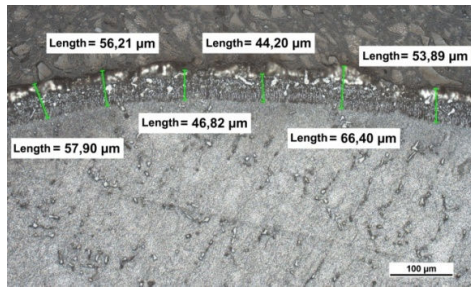
Fig. 4 Al – Si protective layer thickness measurement, non-etched specimen: (a) leading edge with average coating thickness of 50 μm , (b) turbine blade back with average coating thickness of 36 μm , (c) flow edge with average coating thickness of 45 μm

The Al – Si layer on the surface of blade is significantly coarsened and lost its homogeneity due to high temperature degradation and abrasive wearing. Degradation as itself shows in layer thickness increasing. Al – Si layer thickness h depending from spraying thickness at its application and can be easily determined from dependence $h = 0.7\delta$, where δ is for spraying thickness. Then for starting stage Al – Si layer thickness is around $h = 24.5 \mu\text{m}$ (an optimum spraying thickness for annealing at 950°C is up-to $\delta = 35 \mu\text{m}$). The thickness of Al – Si layer is higher in all observed areas what indicates higher temperature of loading than reported 751°C. The highest degree of degradation was observed at three areas from all four observed, namely leading edge with average thickness 50 μm , Fig. 4 (a); turbine blade back with average thickness 36 μm , Fig. 4 (b); and flow edge (in some parts of flow edge was not Al – Si layer identified at all, a huge degradation due to abrasive wearing at high temperatures) with average thickness of 45 μm , Fig. 4 (c).

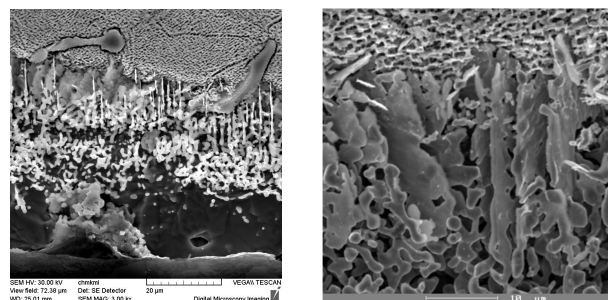
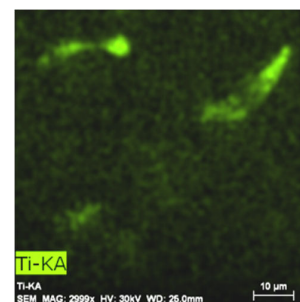
The next problem with Al – Si layer degradation is forming a needle like Cr rich carbides and blocky form of primary Ti rich carbides in layer – base material zone. Fig. 5 reports such carbide formation confirmed also by chemical SEM mapping.

Fig. 5 Chemical analyses of layer – base material zone with Cr and Ti rich carbide formation: (a) overall view, (b) detail of Cr rich carbides, (c)-(d) SEM mapping, etc. MARBLE, SEM microprobe Bruker

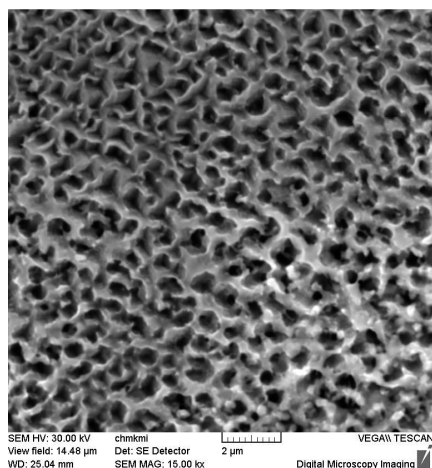
secondary $M_{23}C_6$ carbides formed and lowering creep resistance of base material. The strengthening intermetallic γ' precipitate also degrades by changing its morphology from previous cubic shape like onto coarse spheroidal particles with average size $0.6 \mu\text{m}$, Fig. 6.

Fig. 6 Degradation of γ' precipitate at high temperature ($751^\circ\text{C}/2\text{s}$) loading compared to starting stage microstructure: (a) γ' - phase morphology, initial stage, (b) after $751^\circ\text{C}/2\text{s}$ for 600 hours of loading, etch. Marble, SEM

This shape and size changes cause decreasing creep rupture life of alloy, Fig. 7 [8]. As a matter of a fact, creep at high temperatures is driven mainly by diffusion mechanism and deformation rate increases with higher amount of dislocations and their easier slip, which have been previously blocked by tide distribution of cubic morphology of γ' precipitates. Coarsening and spheroiding of γ' precipitates leads to creation of wider channels between γ' particles and dislocations can easier move, so deformation of base material can propagate.
