The High Temperature Damage of DV – 2 Turbine Blade Made from Ni – Base Superalloy

Juraj Belan, Lenka Hurtalová, Eva Tillová, Alan Vaško, Milan Uhríčik

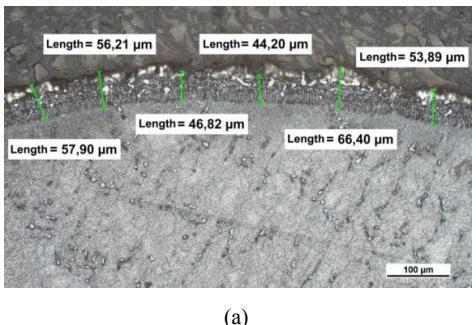
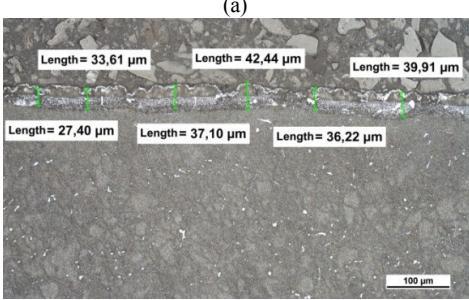
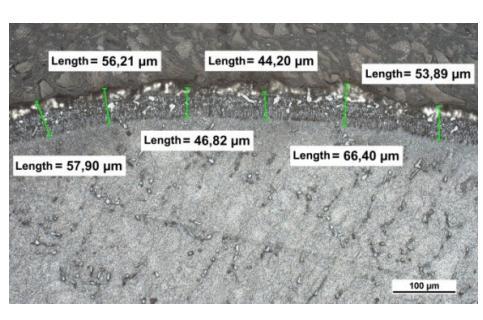
Fig. 4 Al – Si protective layer thickness measurement, non-etched specimen: (a) leading edge with average coating thickness of 50 μm, (b) turbine blade back with average coating thickness of 36 μm, (c) flow edge with average coating thickness of 45 μm

The Al – Si layer on the surface of blade is significantly coarsened and lost its homogeneity due to high temperature degradation and abrasive wearing. Degradation as itself shows in layer thickness increasing. Al – Si layer thickness hdepending from spraying thickness at its application and can be easily determined from dependence $h = 0.7\delta$, where δ is for spraying thickness. Then for starting stage Al - Si layer thickness is around $h = 24.5 \ \mu m$ (an optimum spraying thickness for annealing at 950°C is up-to $\delta = 35 \ \mu m$). The thickness of Al – Si layer is higher in all observed areas what indicates higher temperature of loading than reported 751°C. The highest degree of degradation was observed at three areas from all four observed, namely leading edge with average thickness 50 µm, Fig. 4 (a); turbine blade back with average thickness 36 µm, Fig. 4 (b); and flow edge (in some parts of flow edge was not Al - Si layer identified at all, a huge degradation due to abrasive wearing at high temperatures) with average thickness of 45 μ m, Fig. 4 (c).

- Protective Al Si layer is significantly degraded all around the surface, its thickness on leading edge is average 50 µm, and on the back is 36 µm and flow edge with average thickness 45 µm, so Al - Si layer is inconvenient. A needle like Cr rich carbides and blocky form of primary Ti rich carbides are forming. In this area is a high expectation of crack initiation at further working cycle of blades.
- Base material, Ni base superalloy ŽS6K, also shows significant level of degradation, especially on strengthening intermetallic precipitate γ' , which has formed *rafts* and changes it morphology, from cubic to spheroidal shape. The morphology changing of γ' has influence on creep rupture life of blades due to decreasing of precipitation hardening effect and increasing of γ/γ' mismatch.

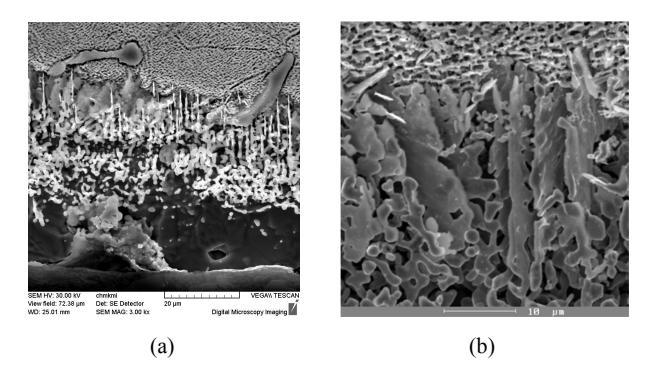
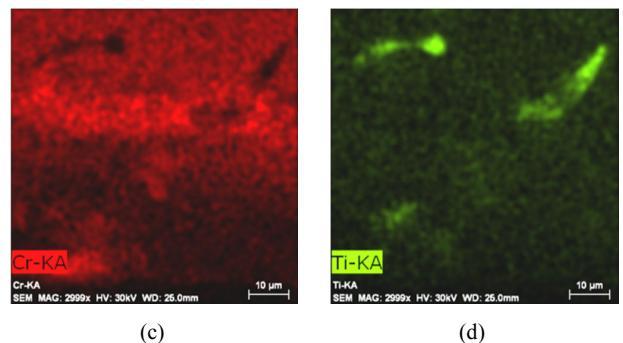
The next problem with Al - Si layer degradation is forming a needle like Cr rich carbides and blocky form of primary Ti rich carbides in layer – base material zone. Fig. 5 reports such carbide formation confirmed also by chemical SEM mapping.

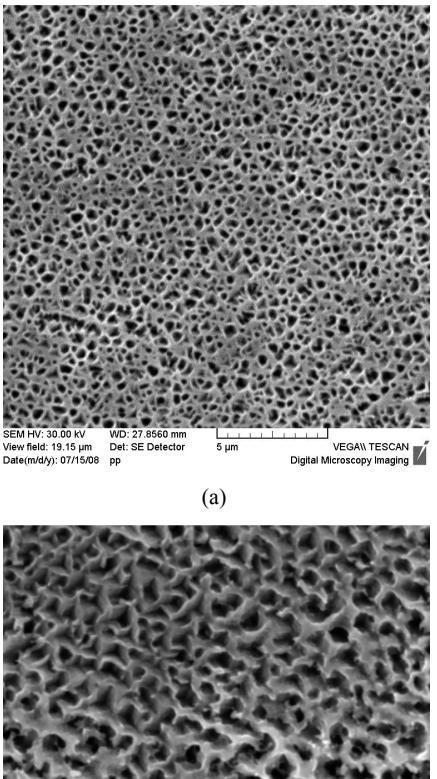
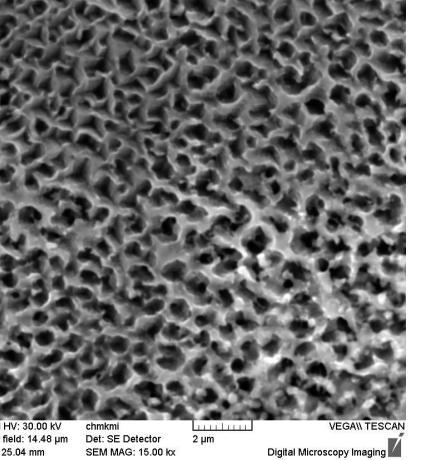
secondary M₂₃C₆ carbides formed and lowering creep resistance of base material. The strengthening intermetallic γ' precipitate also degrades by changing its morphology from previous cubic shape like onto coarse spheroidal particles with average size 0.6 µm, Fig. 6.

Fig. 6 Degradation of γ' precipitate at high temperature (751°C/2s) loading compared to starting stage microstructure: (a) γ' - phase morphology, initial stage, (b) after 751°C/2s for 600 hours of loading, etch. Marble, SEM

This shape and size changes cause decreasing creep rupture life of alloy, Fig. 7 [8]. As a matter of a fact, creep at high temperatures is driven mainly by diffusion mechanism and deformation rate increases with higher amount of dislocations and their easier slip, which have been previously blocked by tide distribution of cubic morphology of γ' precipitates. Coarsening and spheroiding of γ' precipitates leads to creation of wider channels between γ' particles and dislocations can easier move, so deformation of base material can propagate.

All reported changes indicate that temperature of overheating was not 751°C/2s. This kind of degradation occurred after longer time exposition at temperatures close to 900°C
