# Investigation of Failures in Wadi-Crossing Pipe Culverts, Sennar State, Sudan

Magdi M. E. Zumrawi

Keywords—Culvert, erosion, failure, sustainability.

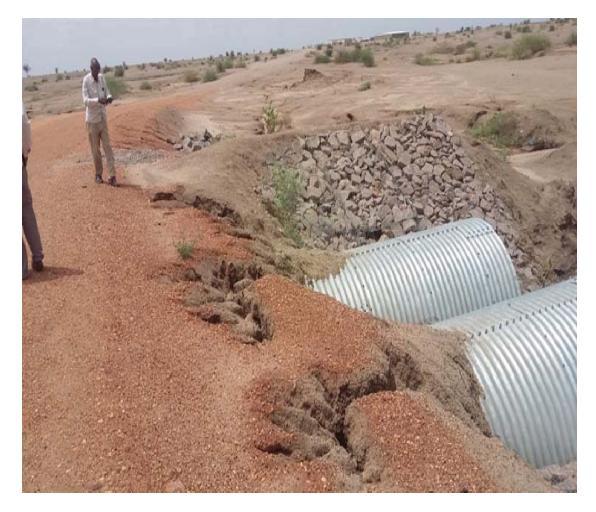
It was clearly observed that the side edges of the top embankments and the head walls of the culvert are much suffered from serious failures due to excessive water erosion.

Severe cracks and potholes were clearly seen on top embankment especially at the edges nearby the pipes inlets and outlets. Also the head walls of the pipes showed severed failures and collapse of the gabion mesh used to protect the embankment around the pipes as shown in Fig. 6. The gabion mesh was placed between the pipes only without any link between them. The gabion mesh was fall down when the embankment failure occurred due to water erosion.

Fig. 6 Severe cracks and potholes on embankment edges due to water erosion

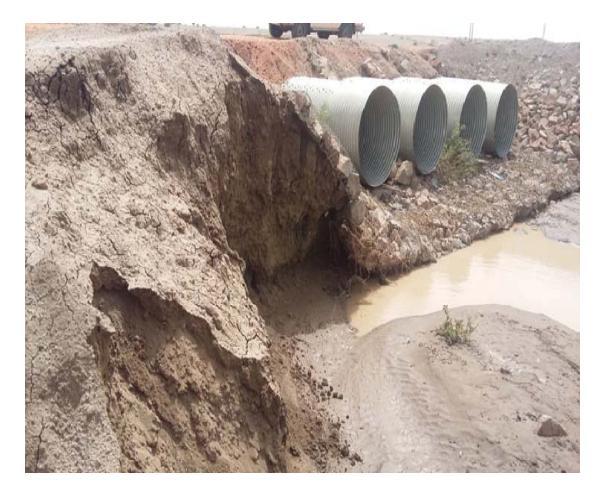
Fig. 7 Collapse and failure of wing walls embankment due to water scouring

It was observed also partial breaching and weakening of the wing wall embankments at inlets and outlets of culverts which may result in complete collapse. This embankment weakening was happening mainly due to scouring effect of the incoming wadi which flows adjacent to the embankment section parallel to the crossing axis. This scouring has caused the embankment slope to get steeper and has increased the wadi depth which has increased the embankment height that can lead to failure. During the rainy season, this steeper section was falling into the wadi where it got saturated and washed downstream. In some crossings, the embankment has changed its original section, dimension and shape throughout the entire length of the crossing where the top embankment is narrowed and the side edges with severe cracks and potholes and the slopes at inlets are flattened in some sections and steeped at others (see Fig. 7).

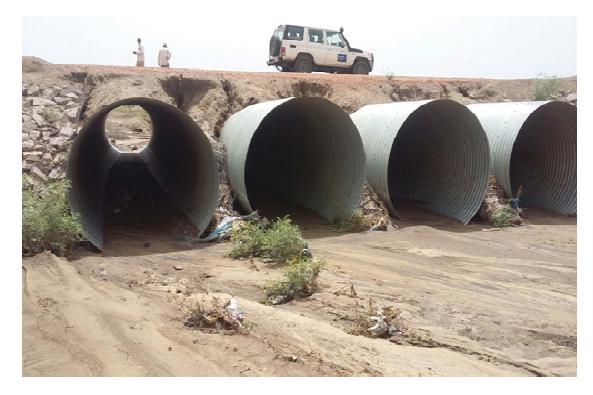
In addition to breaching and weakening of the embankment, the other concern observed in the crossings is sediment deposition and vegetation in the apron area of outlets. The sediment deposition has reduced the storage capacity of the pipes by significant volume. This is mainly due to huge sediment load from the catchment area which leads to reduction in pipes capacity (see Fig. 8).

Fig. 8 Sediment deposition and vegetation in the apron area

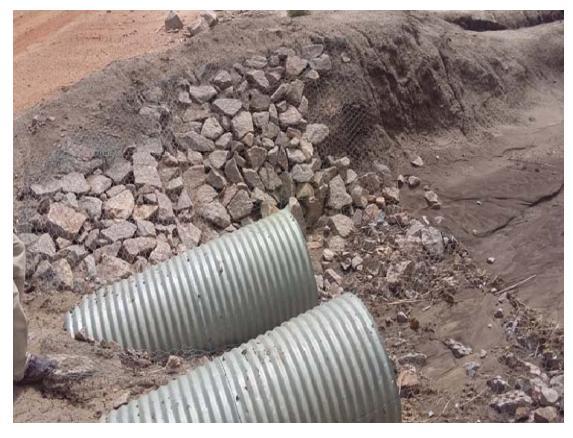
In most crossings, it was observed that the wing walls of the inlets and outlets which are protected by gabion mesh showed better performance than the head walls as shown in Fig. 9. While in very few crossings, the mesh of the gabion missed or opened and some of the stones were thrown away from the walls. This problem may adversely affect the stability of embankment slope.

Fig. 9 The gabion mesh used for lining of wing walls

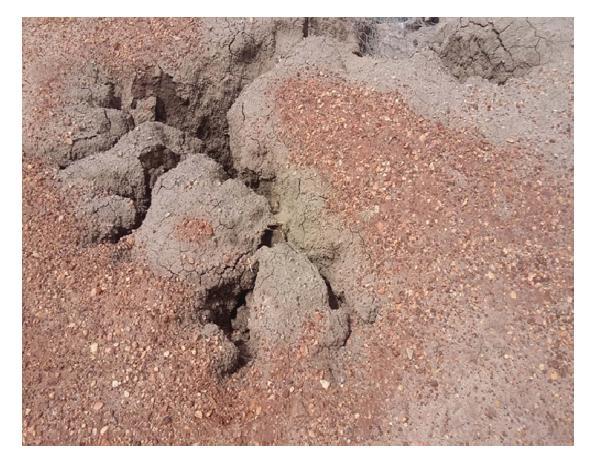
It is clearly observed from Fig. 10 that the subbase layer laid on the embankment is becoming very thin (i.e. thickness less than 20 cm) to support the traffic loading and partially accumulated at the sides. As a result, the underneath embankment of clayey soil suffered from severe cracking and potholes occurred at edges above the pipes inlets and outlets.

Fig. 10 Sever cracks and potholes on Subbase and embankment layers

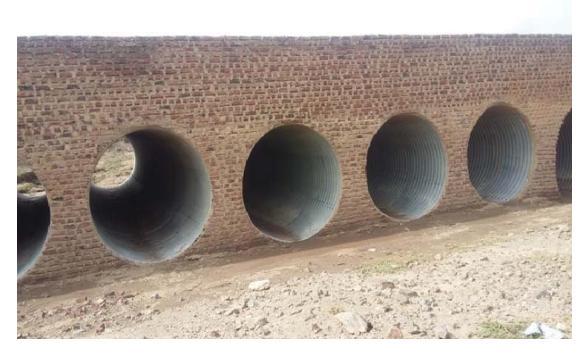
It was noticed that the Fresh crossing in west Aldindir was properly design and constructed. The pipes are protected with a head wall build of brickworks and the side wing walls are lined with stone pitching as shown in Fig. 11. It is clearly observed that the crossing is in a good condition particularly in the inlets and outlets of the pipes.

Fig. 11 Head and wing walls of the Fresh crossing are in good condition
