# Fatigue Failure Analysis in AISI 304 Stainless Wind Turbine Shafts

M. F. V. Montezuma, E. P. Deus, M. C. Carvalho

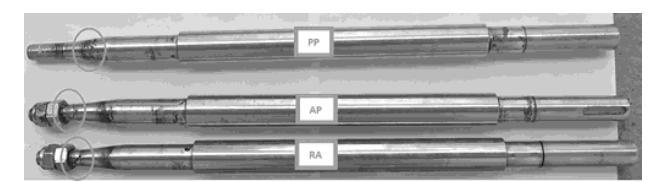
Fig. 2 Wind turbine shafts - Model A1700

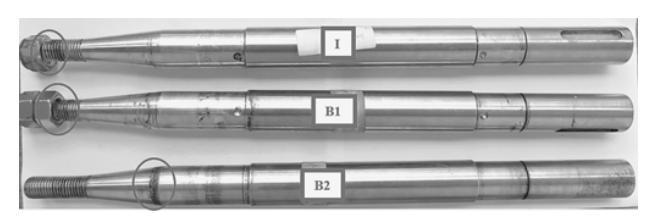
Fig. 3 Wind turbine shafts - Model A3300

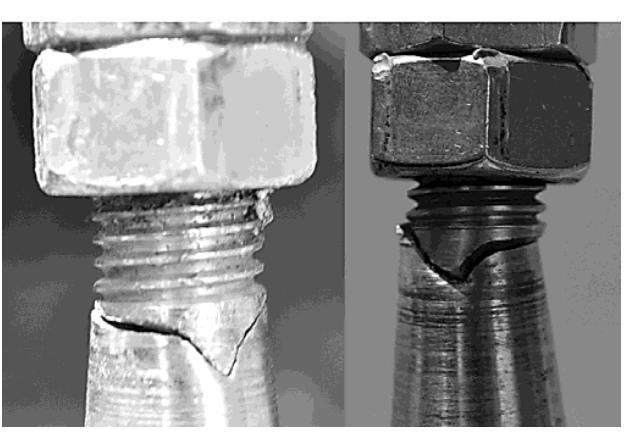
In the visual analysis, different failures morphologies were observed and compared with Metals Handbook [5]. The generator shafts A1700 - AP and RA broke at the beginning of the thread, Fig. 4, with fatigue break marks shown in detail in Figs. 5 and 6.

Fig. 4 AP and RA fractured shafts - Model A1700

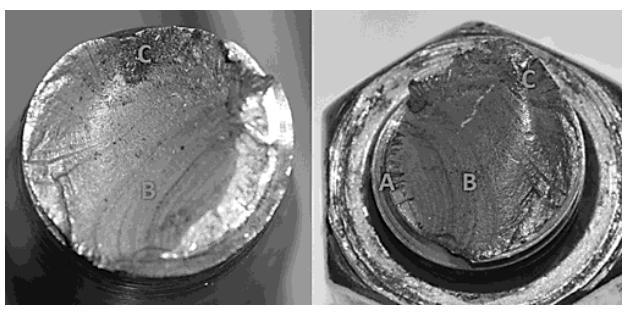
Fig. 5 View of the fatigue fracture region of the RA shaft: A beginning of the fracture, B - beach marks, and C - final region of the fracture

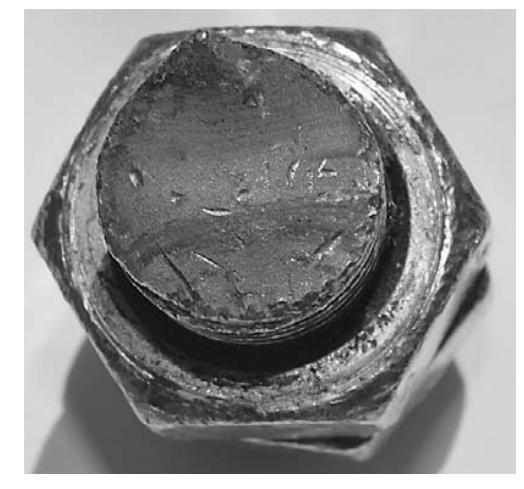
Fig. 6 View of the fatigue fracture region of the AP shaft – verification of beach marks

The visual inspection of the fracture on the AP shaft was compromised due to the numerous tool marks in the fracture regions, Fig. 6. However, it was possible to observe the "beach marks" characteristic of fatigue fracture. Two shafts of the A3300 wind turbine (I and B1) broke in the first thread in contact with the nut or locknut, as shown in Figs. 7 and 8.

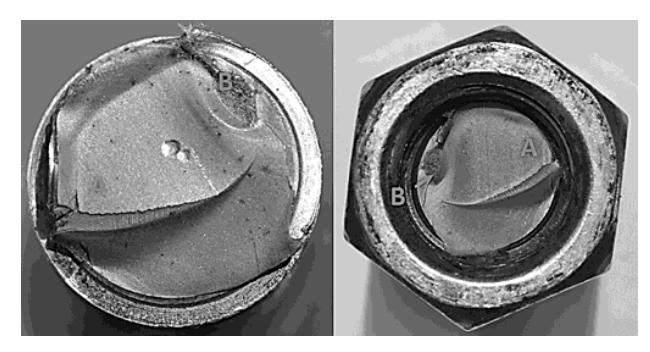
Fig. 7 View of the fatigue fracture region of the shaft I - Model A3300

The shaft I surface observed in Fig. 7 presented a region with a smooth aspect (A), corresponding to the area over which the crack spread slowly, and the smaller area (B) with a fibrous texture corresponds to the region the failure occurred. Quickly (catastrophic), which characterizes a fatigue failure.

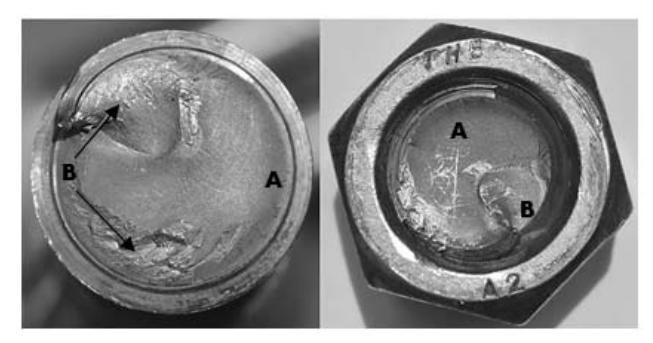
The B1 shaft, Fig. 8, presented two different types of fracture surface. On the right side, smooth surface (A), there is the fatigue zone, while on the other end, rough surface (B), the plastic zone is characterized by the appearance of tearing.

Fig. 8 View of the fatigue fracture region of the B1 shaft - Model A3300

porosity found in the B1 axis demonstrates a possible manufacturing problem, since the presence of gases dissolved in the metal liquid can result both in the presence of various types of oxide inclusions, as well as in the formation of porosities of endogenous origin, that is, metallurgical causes, inherent to the quality of the metal cast in the molds. There are also exogenous origin defects originating from external causes, such as molds and leakage and feeding channel systems [7].

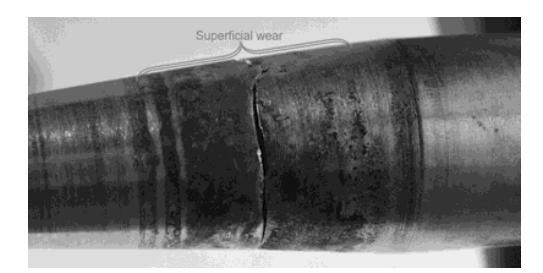
A superficial wear is visible on the PP axis of the A1700 wind turbine, where the part broke in the tapered transition region, favoring the initiation and propagation of cracks and fatigue failure, Fig. 9.

Fig. 9 View of the superficial wear on the fracture region of the PP axis - Model A1700

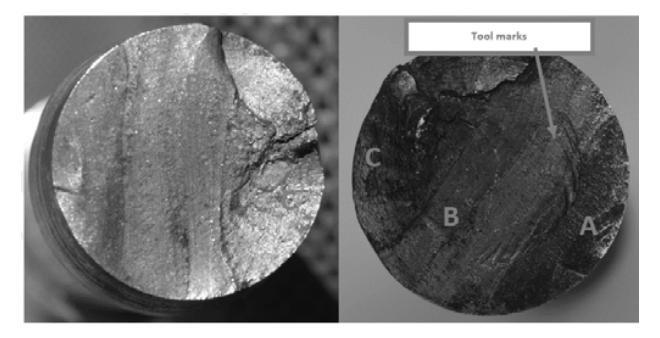
The fracture surface of the PP shaft can be seen in Fig. 10. Point A indicates the beginning of the crack that has spread, leaving "beach marks," indicated by point B and finally point C indicating the final region of the fracture. The fracture or rupture of the material usually occurs with the formation and propagation of a crack that begins at points where there is structural or compositional imperfection or a high-stress concentration, which generally occurs on the surface, as presented in the piece, where the wear marks and the consequent oxidation generated stress concentrating points. The darker coloration at point A shows oxidation and infiltration of contamination during the fracture's relatively long propagation stage.

Fig. 10 View of the fatigue fracture surface of the PP axis - Model A3300

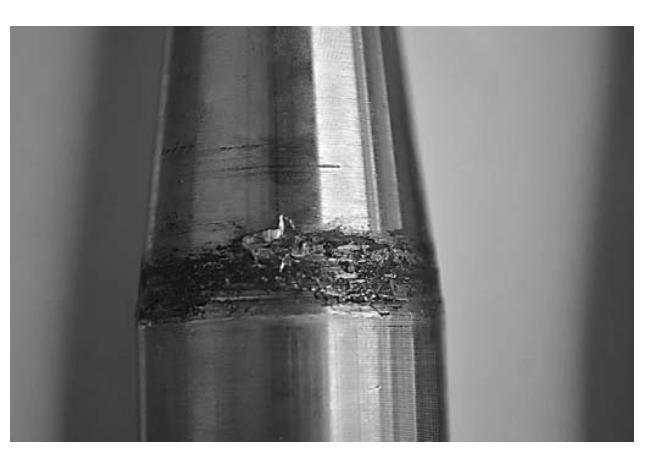
Similar wear was also observed in the B2 axis of the A3300 wind turbine, Fig. 11, and the other axes, however, with less intensity.

Fig. 11 Critical region of axis B2, due to loss of material due to wear (contact marks) and oxidation - Model A3300

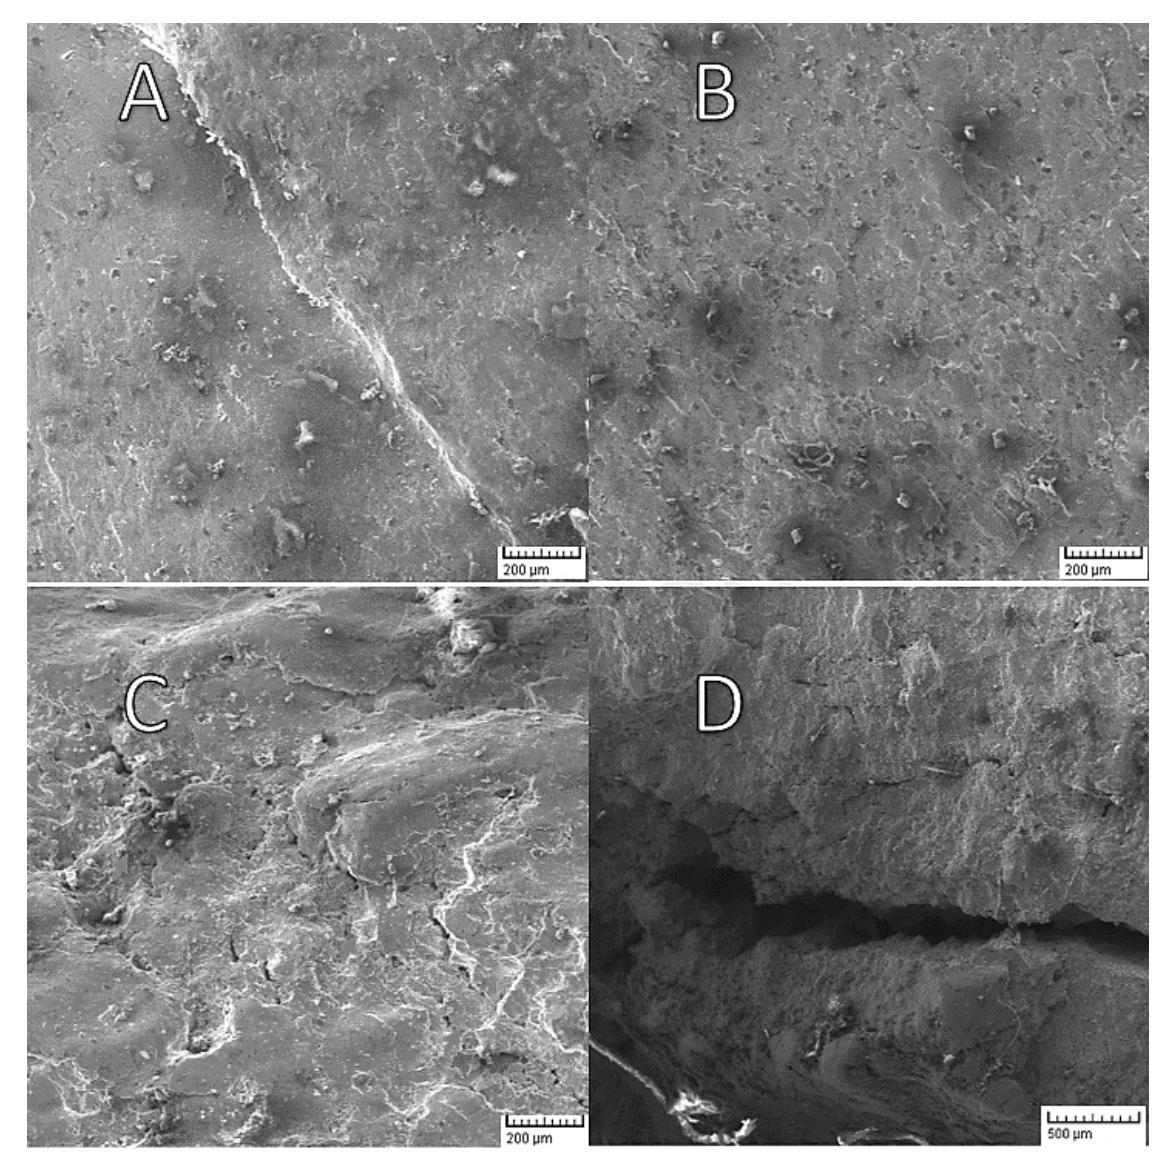
Fig. 12 SEM of the fractured region of the PP axis: A - region of the beginning of the failure, B - a region of the beach marks, C - a region of the catastrophic fracture with several secondary cracks, and D - secondary crack highlighted

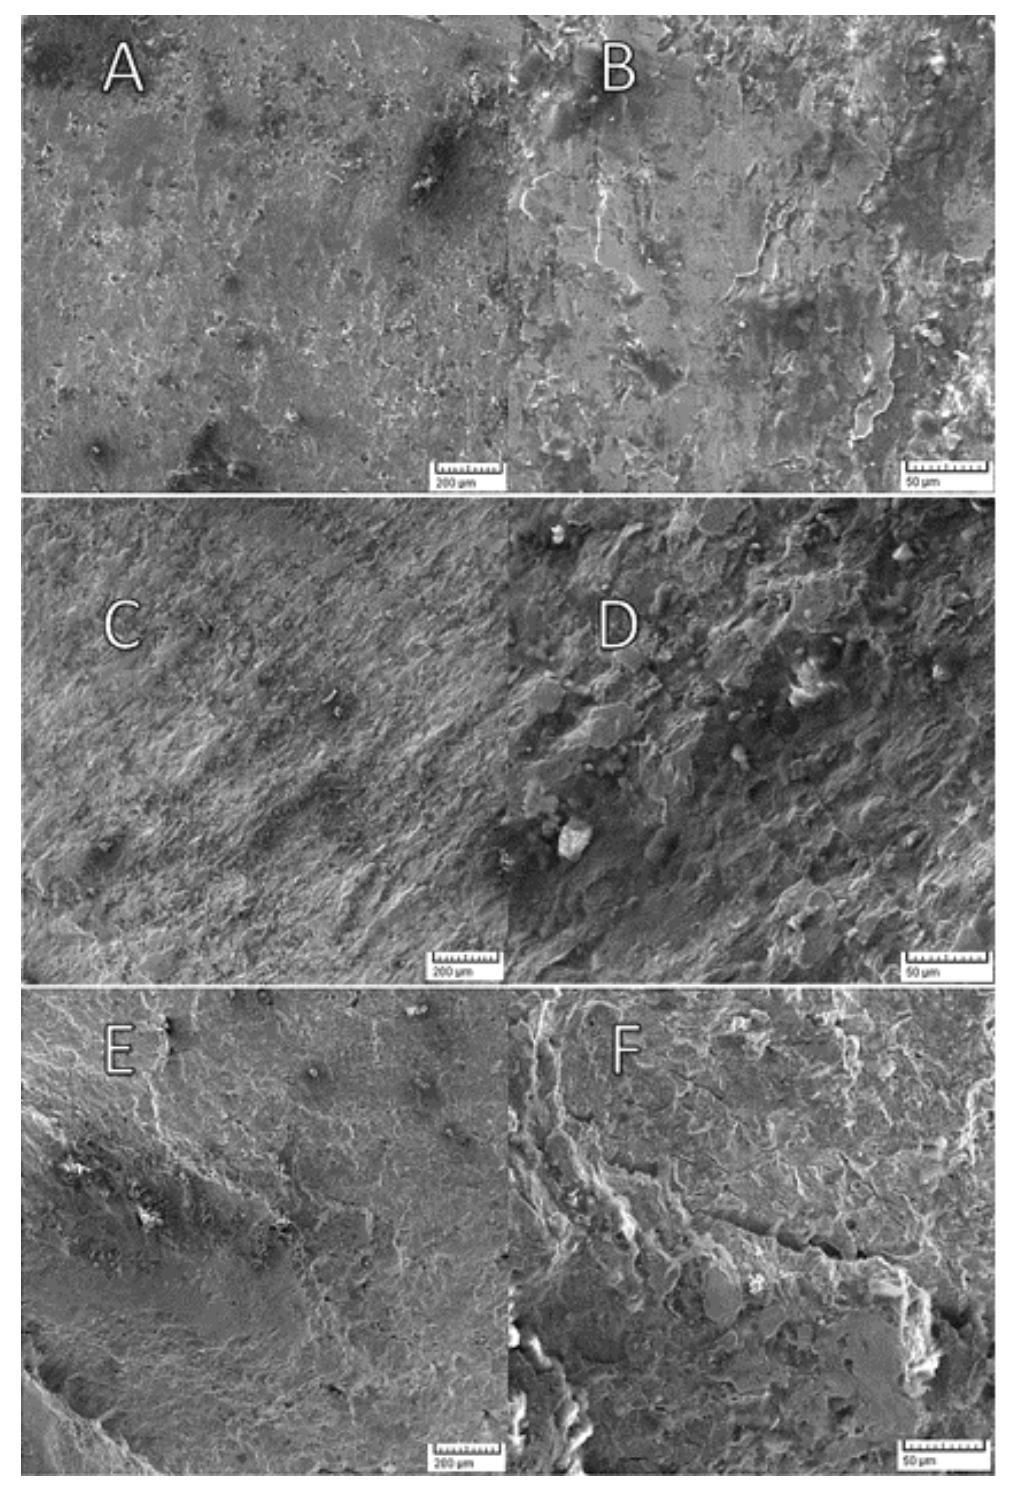
Fig. 13 SEM of the fractured region of the AP axis: A - a region of the beginning of the fatigue failure, B - detail of the region of fatigue in which the crack propagated slowly, C - a region of the beach marks, D - fatigue striation, high rate of deformation, E - catastrophic fracture region with secondary cracks and F - secondary crack highlighted

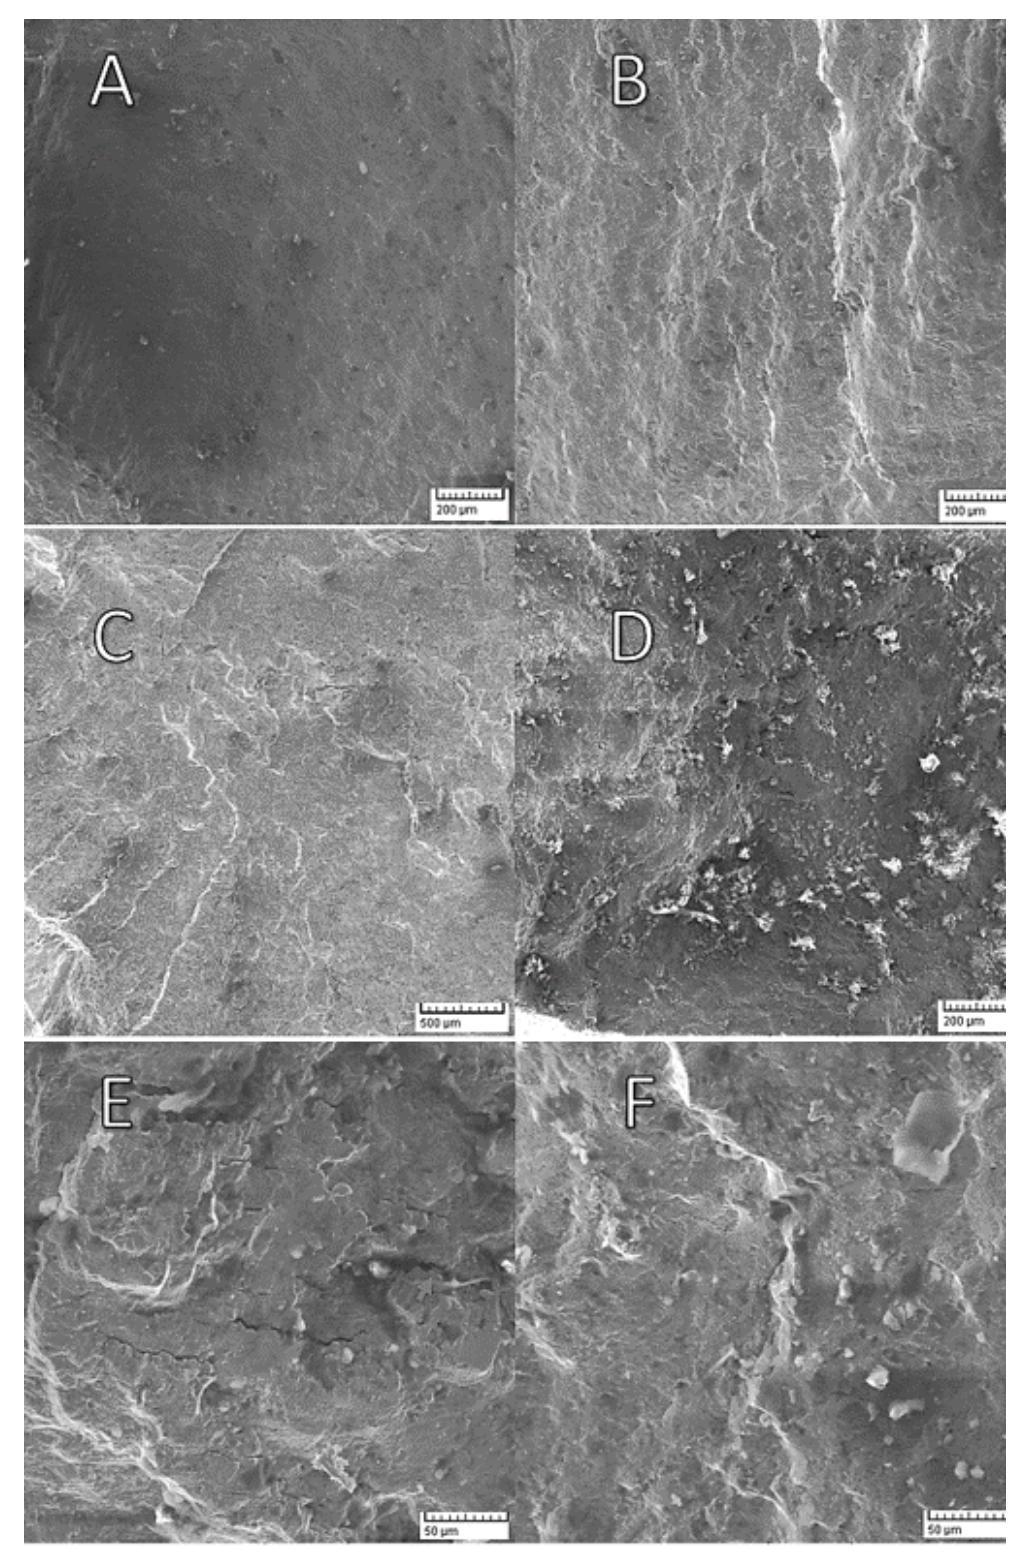
Fig. 14 SEM of the fractured region of the RA axis: A - region of the beginning of the fatigue failure, B - detail of the region of fatigue in which the crack spread slowly, the appearance of beach marks, C- a region of beach marks, D - region beginning of catastrophic fracture, the appearance of secondary cracks, E and F - regions of catastrophic fracture with secondary cracks

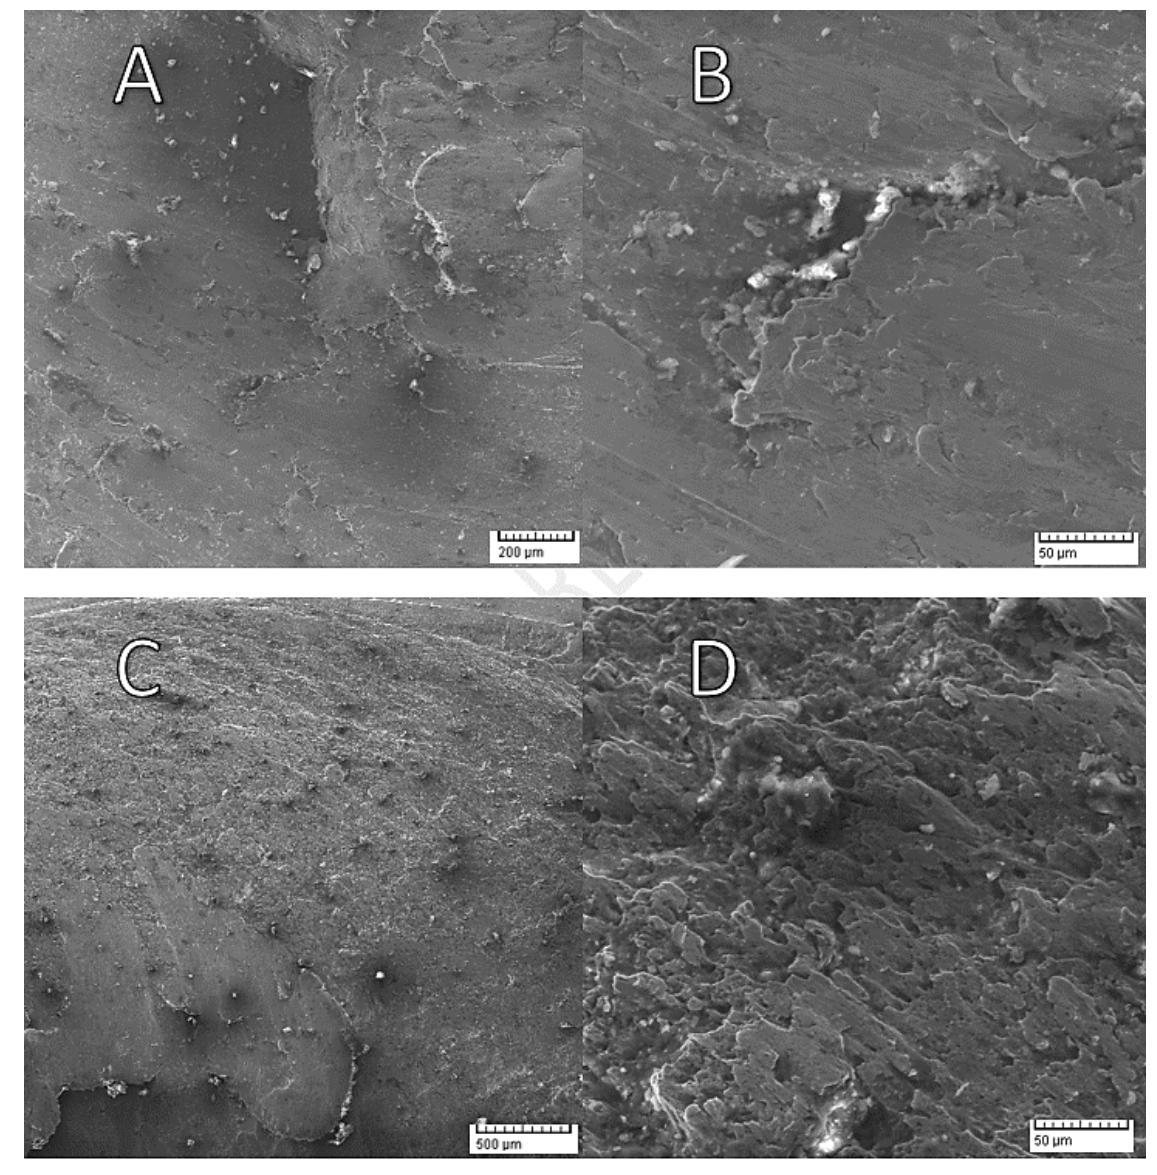
Fig. 15 SEM of the fractured region of axis I: A - region of the beginning of the fatigue failure, B - detail of the region of fatigue in which the crack propagated slowly, C - a region of slow/catastrophic failure transition D - a region of the catastrophic fracture

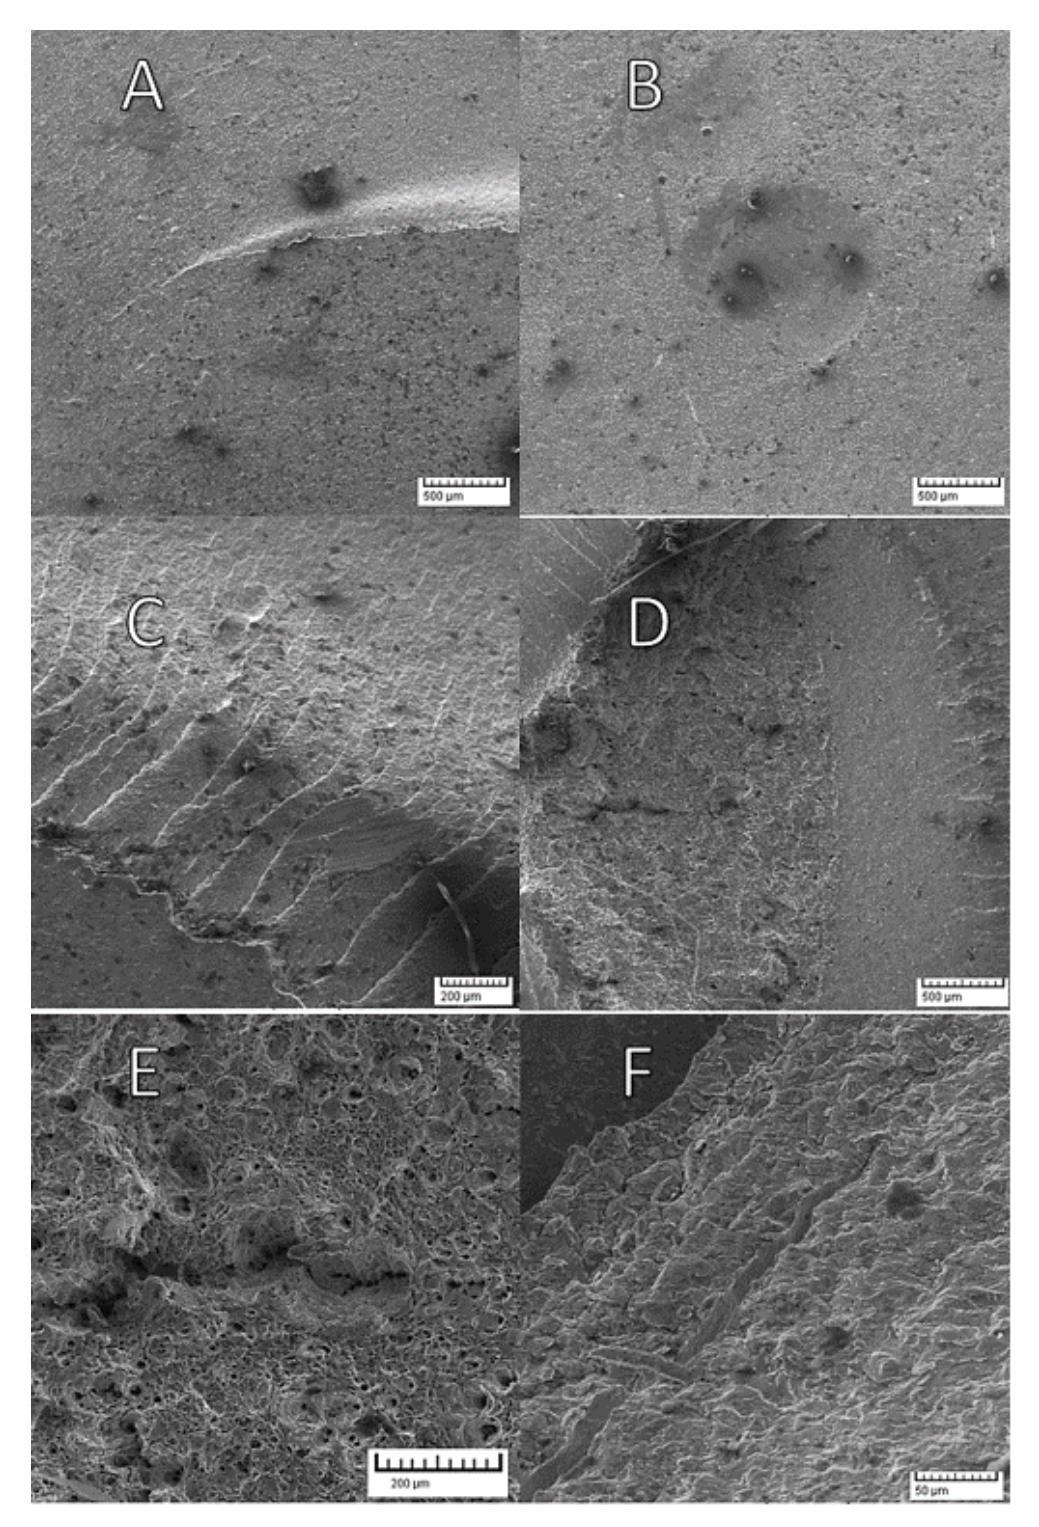
Secondary cracks were observed in all faults and the B1 axis, inclusions, and porosity. Secondary cracks in early growth stages are associated with grain boundaries, sliding bands, and skin contours, regardless of the test medium. In [6], the number of secondary cracks increases with the increase in the level of stress and the aggressive medium. However, the

Fig. 16 SEM of the fractured region of the B1 axis: A - region of the beginning of the fatigue failure, B - Inclusions, C - beach marks, D - a region of the beginning of the catastrophic fracture, the appearance of secondary cracks, E - secondary cracks and porosity and F - secondary crack

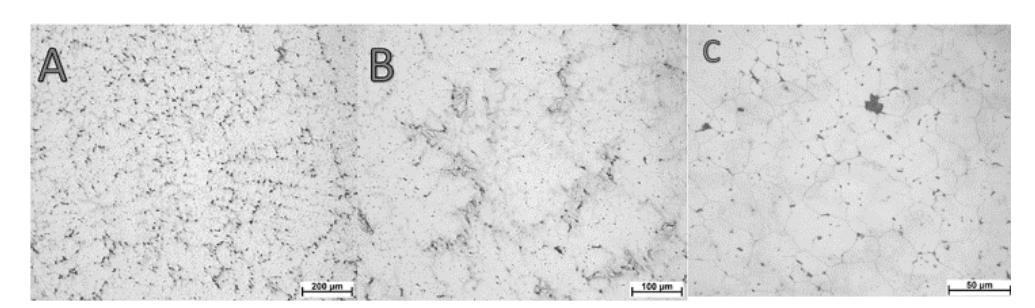
Fig. 17 Metallographic samples of the material

The structure of austenitic steel (stainless steel) with chromium-rich carbides precipitation was observed in the grain boundary region. This type of steel becomes susceptible to intergranular corrosion due to the phenomenon of sensitization, which is a process related to the precipitation of chromium-rich carbides in the grain boundary region, leaving the adjacent region depleted of chromium [8].
