Analyses of Wear Mechanisms Occurring During Machining of the Titanium Alloy Ti-6Al-2Sn-4Zr-6Mo

Abstract—Titanium alloys like the modern alloy Ti 6Al 2Sn 4Zr 6Mo (Ti-6246) combine excellent specific mechanical properties and corrosion resistance. On the other hand, due to their material characteristics, machining of these alloys is difficult to perform. The aim of the current study is the analyses of wear mechanisms of coated cemented carbide tools applied in orthogonal cutting experiments of Ti-6246 alloy. Round bars were machined with standard coated tools in dry conditions on a CNC lathe using a wide range of cutting speeds and cutting depths. Tool wear mechanisms were afterwards investigated by means of stereo microscopy, optical microscopy, confocal microscopy and scanning electron microscopy. Wear mechanisms included fracture of the tool tip (total failure) and abrasion. Specific wear features like crater wear, micro cracks and built-up edge formation appeared depending of the mechanical and thermal conditions generated in the workpiece surface by the cutting action.

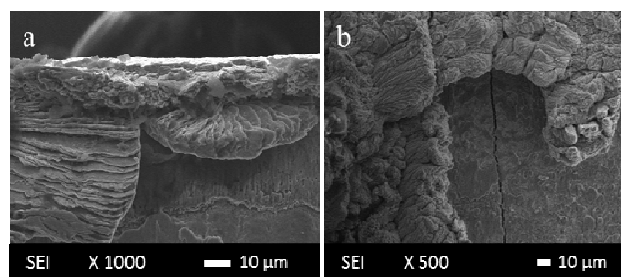
In addition, micro crack formation has been observed on two tools, see Fig. 4b. The related cutting conditions were: $a_p = 0.2\text{mm}$, $v_c = 160\text{ m/min}$ and $a_p = 0.2\text{mm}$, $v_c = 200\text{m/min}$.

Fig. 4 SEM images of different wear mechanisms. a built-up edge formation, b micro crack formation

The build-up edges (material adhesion to the cutting insert) were found on all tools after the cutting experiments. Fig. 3 shows a photo of the flank face of a worn tool with a built-up edge created on the rake face. Details of build-up edge are shown on fig. 4a. Severe built-up edge formation was observed on tools machined in the following conditions: a_p : 0.05mm and 0.1mm at v_c between 80m/min and 200m/min and at a_p 0.15mm and 0.2mm in the complete cutting speed regime investigated here.

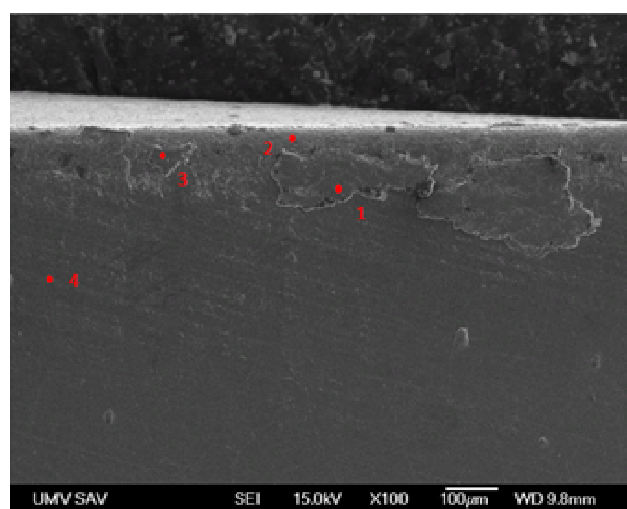
The EDX point analysis of a built-up edge ($a_p = 0.05\text{mm}$, $v_c = 20\text{m/min}$) is shown on Figs. 5 and 6. The related chemical composition is listed in Table 1. As can be seen from Table 1, the EDX data confirmed that the unworn area (point 4) included titanium (approx. 42 at.%), nitrogen (approx. 46 at.%) and aluminum (approx. 11 at.%), the worn area included elements from the workpiece material. Points 1 and 3 represent the zones of built-up edges formation which consisted of Aluminum, Molybdenum and Zirconium and twice more Titanium compared to the unworn areas.

Fig. 5 The EDX point analysis of the worn tool

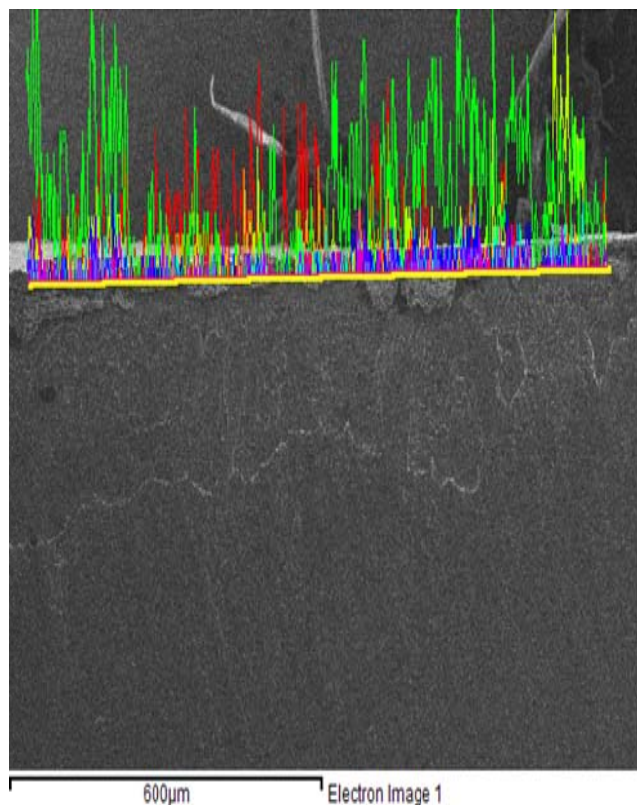
Zones of crater wear (rake face of the worn tool, cutting conditions: $a_p = 0.1\text{mm}$, $v_c = 80\text{m/min}$) were also investigated by EDX. The related EDX line analyses are presented in Figs. 7 and 8. The analysis showed that all elements are almost homogeneously distributed along the worn surface of the tool. Zirconium, Molybdenum, Tin, Titanium and Aluminum represented the Ti-6246 workpiece material. The presence of tungsten and nitrogen indicates a destruction of coating.

Fig. 7 The EDX linear analysis area

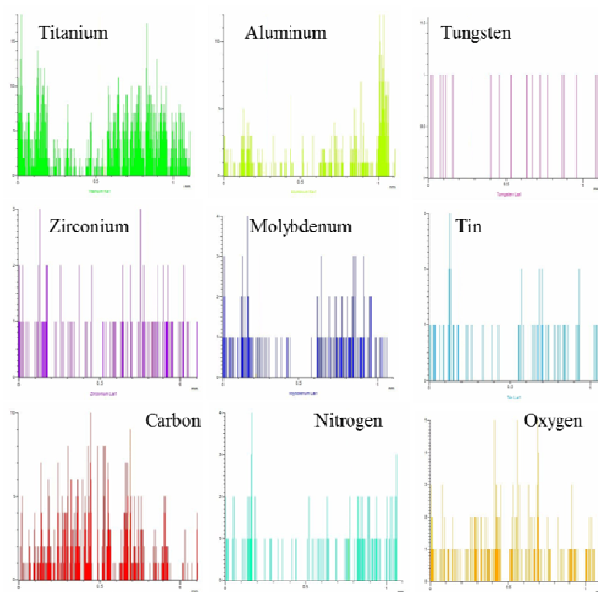
Fig. 8 The EDX line analysis of the worn tool

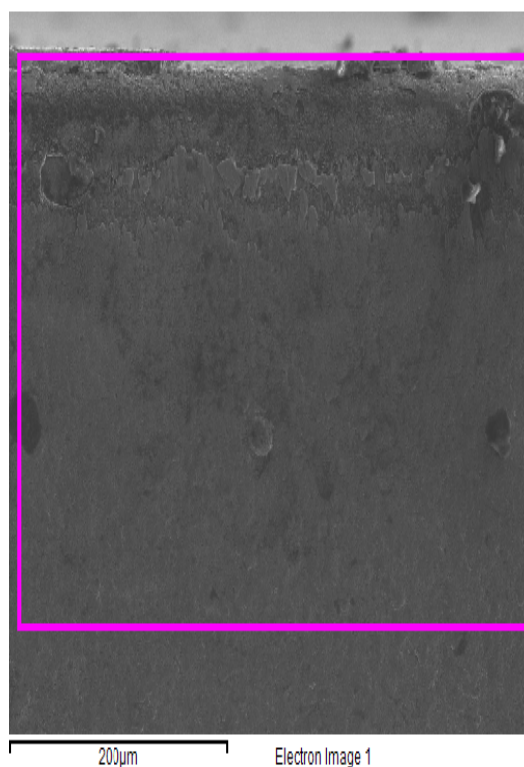
A chemical elements map of worn part of tool ($a_p = 0.05\text{mm}$, $v_c = 20\text{m/min}$) is shown on Figs. 9 and 10. The distribution of the elements tungsten and aluminum again signalizes a destruction of tool coating and a built-up edge formation. Other elements as Molybdenum, Zirconium and Tin were originating from workpiece material.

Fig. 9 The EDX mapping area

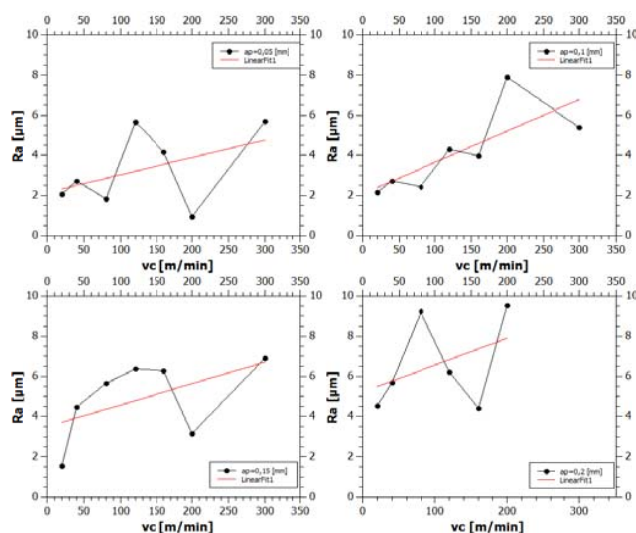
The roughness was measured by a confocal microscope at a distance of 20 μm from the edge of tool. As it is very difficult to analyze surfaces with high portion of sharp edges (larger than 70°), the results presented here are only to be taken as rough approximations. Fig. 11 shows the results of the roughness measurements. It is clearly visible that the surface roughness increases with increasing cutting speed for all cutting depths.

Fig. 11 Indicators of roughness

Flank wear land width increased with increasing cutting depths and cutting speeds. This can be understood by the larger amount of energy introduced by the cutting action leading to higher temperatures in the cutting zone and, hence, to thermal weakening of the tool (as most of the heat produced will be dissipated into the tool due to Titanium's low heat conductivity). In addition, crater wear and build up edge were observed on the tools after all cutting experiments performed. Increasing temperatures in the cutting zone (as a result of the energy dissipation) ease chemical reactions between Ti-6246 and the tool leading to smearing and welding. These effects could be minimized by the use of cooling liquids during the cutting process. The roughness on rake face was increased with increasing cutting depths and with increasing cutting speeds. Due to the relatively low Young's modulus of Ti-6246 in combination with the high strength, large amounts of elastic energy are stored in the surface of the workpiece leading to vibrations and chatter. This results in lower surface quality and increased surface roughness.
