Landslide, Earthquake & Flood Hazard Risks of Izmir Metropolitan City, A Case: Altindag Landslide Areas

Ahmet Kivanc Kutluca, and Semahat Ozdemir

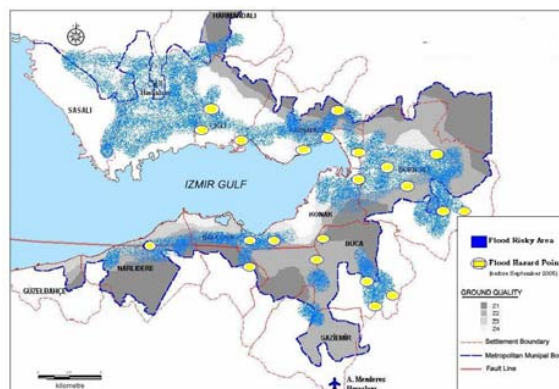
Fig. 4 Flood Risks Areas of Izmir Metropolitan Area

The main issue of the flood in Izmir however can be explained best by the uncontrolled urbanization factors. The population of the city has been rising steadily and already exceeded 2 million people due to migration from other parts of the county. In order to absorb the increasing population new settlements were constructed in the Karsiyaka and Yamanlar district. In between 1987 and 1995, 50.000 new buildings were constructed in the Karsiyaka district. As a result of the increased construction activities in the parts of the Yamanlar and Karsiyaka district, more soil became vulnerable to the storm runoff due to the excavation (see Table II and Fig. 4).

The other important problem about flood hazards was stream position for Izmir built up zone. Poor quality of streams and bridges that most of all caused floods were seen in 1995's disaster. Especially, Büyük Cigli, Bostanli, Yamanlar, Ali Bey and Narlıdere streams affected physical damage in built up zone.

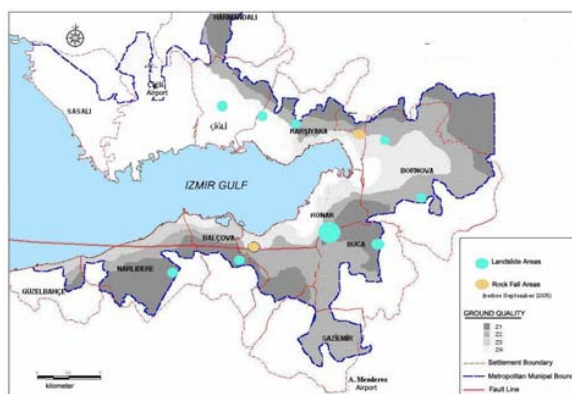
Fig. 5 Landslide and Rock fall areas of İzmir Metropolitan Area

Landslide and rock fall areas are around the metropolitan city, especially, squatter areas are risky regions about them. In İzmir built up area, there are 15 different rock fall and landslide areas that are around the city [7] (see Table III, Fig. 5).
