Performance Evaluation of an Aboveground LNG Storage Tank Cover using Nondestructive and Destructive Tests

Sungnam Hong, Sun-Kyu Park, Jieun Jeong, and Jinwoong Choi

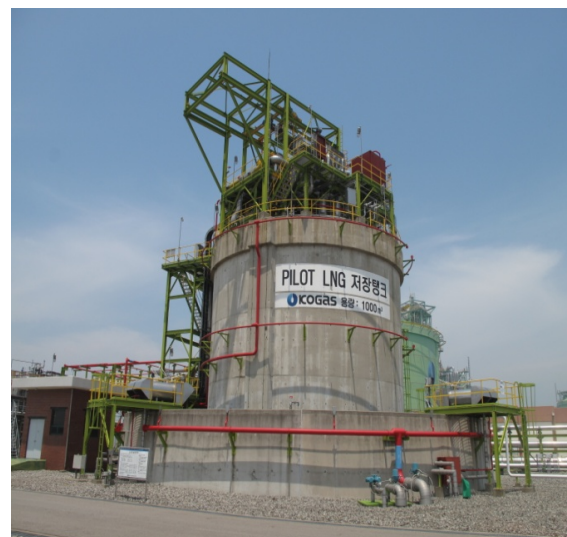
Fig. 1 Pilot LNG storage tank (1,000m⁴)

The object of the tests was the 1,000m³ pilot LNG storage tank located in the Incheon LNG receiving terminal, as shown in Fig. 1. As mentioned, few precedent studies on tests of the concrete cover of LNG storage tanks have been reported. In this study, a concrete cover test procedure is suggested using nondestructive tests and destructive tests [8]-[14], as described in Fig. 2. The suggested procedure can be used for regular performance evaluation of the concrete cover of LNG storage tanks. Before the nondestructive tests were conducted, the LNG storage tank was sectionalized into a front side, a back side, a right column, and a left column. The front and back sides were gridded with a horizontal distance of 27 cm and a vertical distance of 54 cm, as shown in Fig. 3. Numbers were given clockwise at each horizontal intersection, and letters were given in alphabetical order at each vertical intersection from the bottom to the top.

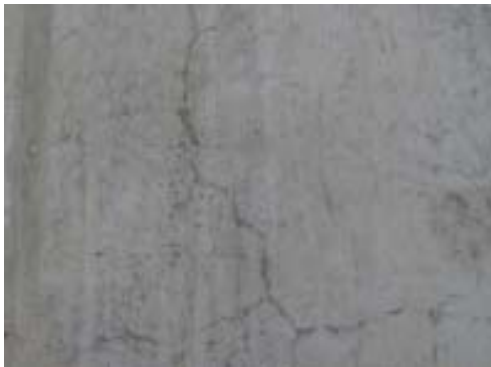
(a) Sector J86

During the visual inspection of the LNG storage tank cover, cracks similar to those shown in Fig. 4 (a) were observed, but they were not considered problems based on their widths and patterns. The cracks observed in sectors A117-C117 and B65 were also thought to have not affected the structure; but considering their lengths, an ultrasonic test was conducted. Other than the cracks and areas with peeling, exfoliation, or steel exposure, no serious anomaly that can result in structural problems was observed during the visual inspection of the LNG storage tank cover.

Fig. 4 Cracks on the concrete wall

(1) Based on the width and patterns of the cracks that were observed during the visual inspection of the LNG storage tank, the cracks were considered non-structural cracks. The concrete strength of the suspected areas that were found through the Schmidt hammer test was estimated using the strength estimation equation. The results showed that all the sections had a higher design strength value of 30MPa, which means they had no anomaly.

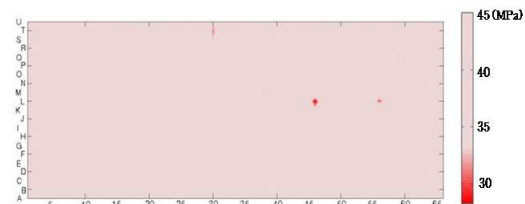
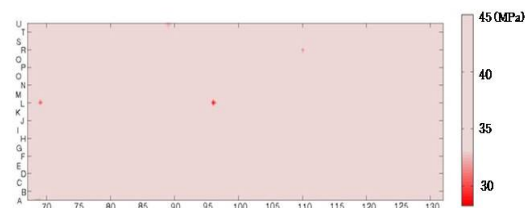
Fig. 5 Schmidt hammer test results

In the preceding equations, F_c represents the estimated compressive strength, and R_0 , the corrected result of the Schmidt hammer test[6]. Equation (1) showed overestimated results with large deviations, compared with the other suggested equations. In contrast, Equation (2) tended to be underestimated with a smaller deviation, compared with Equation (1). Equation (3) showed a compressive strength between that from the two equations with the smallest deviation, from among the three equations. The final concrete compression strength was calculated from the three equations. Fig. 5 shows a contour graph of the results. The estimated concrete strength had a mean of 41.55MPa and ranged from 31.64MPa to 48.80MPa. The estimated compressive strength exceeded the design strength of 30.00MPa, which is the standard for LNG storage tanks. Based on the results of the Schmidt hammer test, the strength of the structure was considered normal.

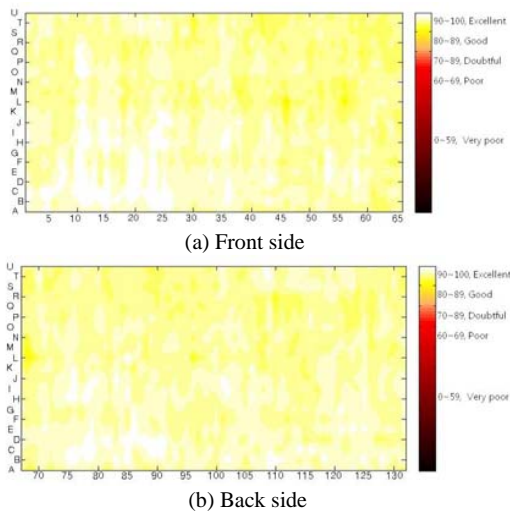
Fig. 6 Combined results of the nondestructive test

The results of the Hammer sounding test, the Schmidt hammer test, and the straight-line ultrasonic tests were combined using Equation (1), and then plotted on a contour graph. The converted marks of the concrete cover of the LNG storage tank, which were calculated using a combination of nondestructive tests, ranged from 88.13 to 100, with a mean of 95.77, which confirmed that they were normal in all the sections. Fig. 6 shows the contour graph of the results of the combined nondestructive tests.
