# Vibration, Lubrication and Machinery Consideration for a Mixer Gearbox Related to Iran Oil Industries

**Abstract**—In this paper, some common gearboxes vibration analysis methods and condition monitoring systems are explained. In addition, an experimental gearbox vibration analysis is discussed through a critical case history for a mixer gearbox related to Iran oil industry. The case history also consists of gear manufacturing (machining) recommendations, lubrication condition of gearbox and machinery maintenance activities that caused reduction in noise and vibration of the gearbox. Besides some of the recent patents and innovations in gearboxes, lubrication and vibration monitoring systems explained. Finally micro pitting and surface fatigue in pinion and bevel of mentioned horizontal to vertical gearbox discussed in details.

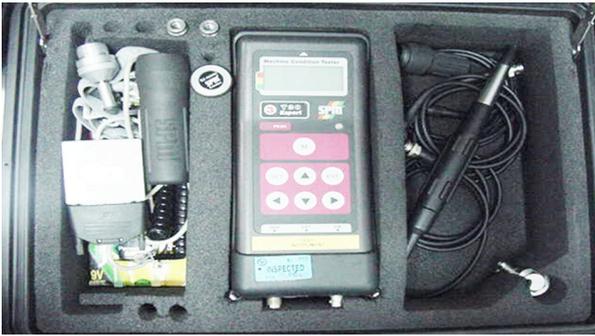
Fig. 2 Shock Pulse Transducer with Probe TRA-22 and a typical SPM data collector

This second phase of the collision is vibration and its frequency depends on the shape, mass, stiffness, and dampening of the metal. Shock Pulse Method filters out this phase of the collision, as the magnitude of the vibration is structure and material dependent. Typical SPM data collector and methodology had shown in Figs. 2 and 3 respectively.

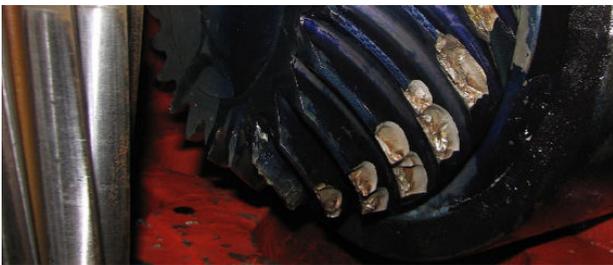
The vibration evidences showed that the pinion damaged seriously and recommended the process to change mixer with spare equipment then the machinery group checked the gearbox pinion and it was damaged in 1/3 of its parts.

Fig. 12 Damaged pinion

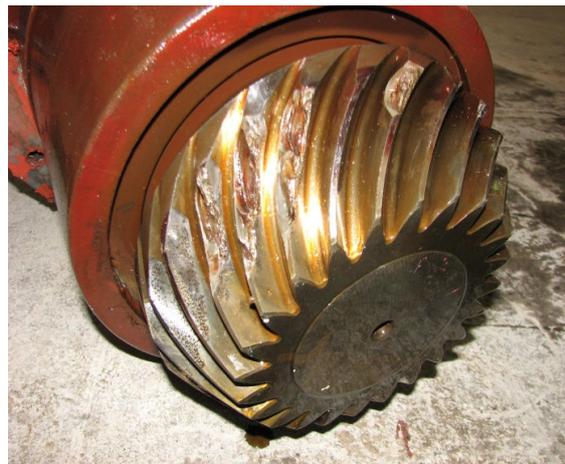
The abnormal noise was increased in gearbox considerably then the monitoring group decided to recommend the machinery to check the gears. Both pinion and bevel was damaged. [17].

Fig. 16 Damaged gear (pinion)

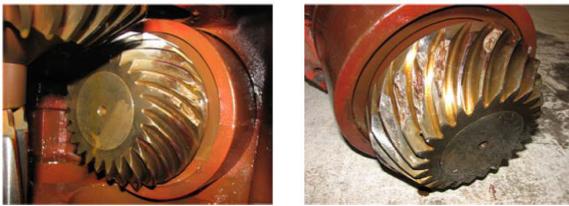
In this part, metallurgical consideration of this horizontal to vertical gearbox and its critical pinion and bevel behavior is discussed in details. By increasing the noise in this gearbox, three teeth of pinion was damaged. In addition, one tooth was damaged in another position. In the damaged parts we had both color metal changing and porosity simultaneously.

Fig. 17 Damage in gears with color metal changing and porosity

Due to the vibration and metallurgical observations better lubricants filtering system should be modified in gearbox. The oil analysis also confirmed this note. Besides, the cleanness of the gearbox oil should be satisfied ISO4406. In addition, the photo catalytic oxidation of Surfactant Hexadecyltrimethylammonium bromide in aqueous diluted solution has been investigated. Surfactants (surface-active agents) can be anionic, amphoteric, polymeric and non-ionic. They are held

Furthermore, the temperature of gearbox oil should be monitored. The higher amount of temperature could cause increasing in micro pitting rate. The machinery maintenance action Performed to this gear box by new pinion and bevel engaged gears, grinding the gear shaft, PT (there was no crack in new gears), coupling treatment, balancing all gear box rotors, shafts run out checks and treatment, measuring housing input shaft, manufacturing two spacer shims for housing bearing, Assembling bearing housing accurately, cover casing cleaning, changing the O-Rings outlet shaft and oil injection.

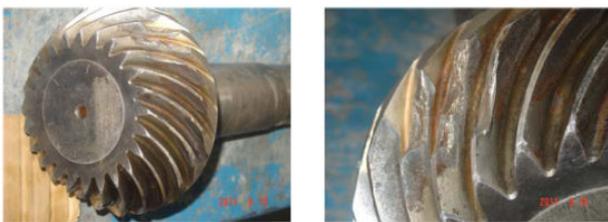
Spare mixer was in rough condition and we had to send that gearbox to machinery workshop. Then we had to continue running of this equipment. The damages developed to other gears teeth with the same mechanical and metallurgical nature and characteristics.

Fig. 18 Damage in gears in the next stage

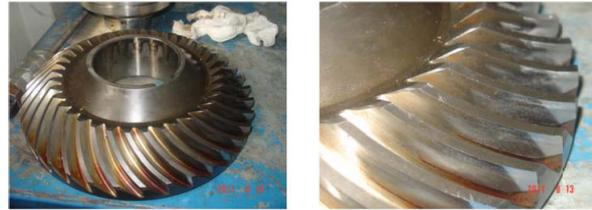
The bevel gear engaged with pinion seemed to be ok but after checking this gear accurately, the microscopic porosities and a light changing in color was visible. That phenomenon was because of higher strength in these kinds of gears [20].

Fig. 19 Bevel gear engaged with pinion
