Effects of Corrosion on Reinforced Concrete Beams with Silica Fume and Polypropylene Fibre

S.Shanmugam, V.G. Srisanthi, and S.Ramachandran

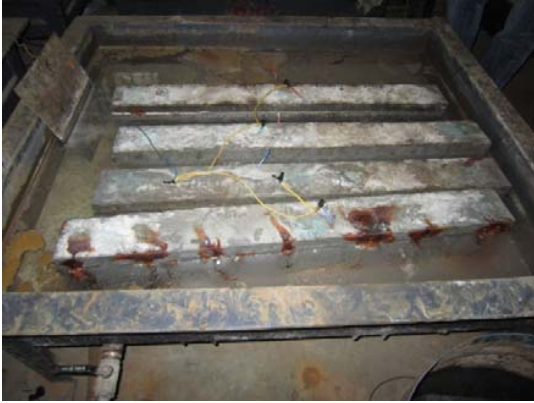
Fig. 3 Accelerated Corrosion Process for Unstressed Condition

Galvanostatic method was used to accelerate the corrosion process. Having the embedded steel as anode and an external stainless steel plate as cathode the beam specimens were impressed a selected current intensity under low voltage conditions for a period of 15 days. The specimens and steel plates were immersed in an electrolyte solution of 3% sodium chloride concentration [2] to simulate the conditions of sea water artificially. The current was applied using a regulated D.C. Rectifier. (Figs. 2 & 3)

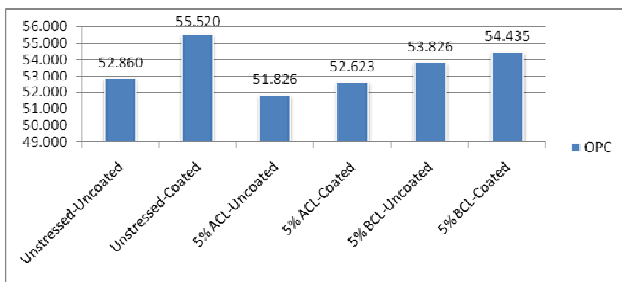
Fig. 4 Load Carrying Capacity for Specimens of OPC (in kN)

The load carrying capacity of the specimens with coated rebars is 5.03 % more than that of the specimens with uncoated rebars.

The load carrying capacity of the specimens with coated rebars is 1.53 % more than that of the specimens with uncoated rebars.

The load carrying capacity of the specimens with coated rebars is 1.13 % more than that of the specimens with uncoated rebars.

In general, the load carrying capacity of unstressed specimens is higher than the stressed specimens subjected to corrosion. Also, the load carrying capacity of the specimens with coated rebars (stressed 5% above crack load & 5% below crack load) is less than the specimens with uncoated rebars.

The load carrying capacities of various specimens are given in Figs. 4 to 7.
