Analysis and Preservation of Lime-Kilns in Corsica

Abstract—The aim of this paper is the analysis and preservation of lime kilns, focusing on the structure, construction, and functionality of vertical shaft lime kilns of the Cap Corse in Corsica. Plans and sections of two lime kilns are presented in detail, providing an overall picture of this specific industrial heritage. The potential damage areas are identified performing structural analysis of a lime kiln using the finite element method. A restoration and strengthening technique that satisfies the directions of the Charter of Venice is presented using post-tensioning tendons. Recommendations are given to preserve and promote these important historical structures integrating them into the custom footpath.

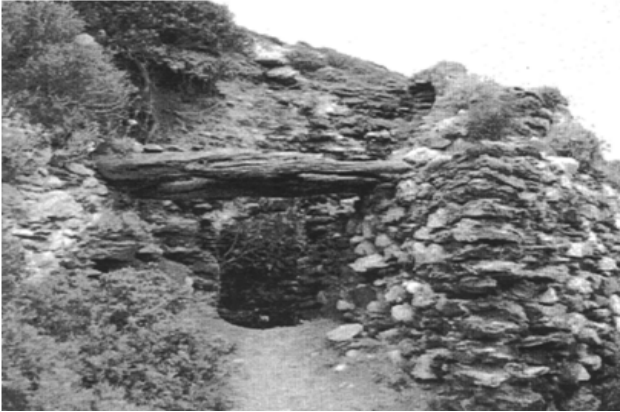
Lime kiln 1 (Fig. 3) belongs to the Community of Rogliano and is located in the Western part of the Pointe of the Cap Corse, beneath two historic mills. This kiln is located at the beginning of the custom footpath and can either be accessed by car, using the D80 until Macinaggio and then via a small path towards the beach of Tamarone, or on foot via the trail that starts at the Northern end of Macinaggio a small distance after the marsh.

Fig. 3 Lime Kiln 1 as seen from the access path

Fig. 3 shows the condition of the kiln today. While the shaft's cylinder subsists completely at the bottom, large parts have collapsed over time from its top. The remaining kiln's height today measures 5.35 m at its highest point (Fig. 5). Its real height, when in use, cannot be estimated. The firing door opening is 1.65 m tall today. At the same height three wooden beams remain, where probably the foyer's roof was constructed on.

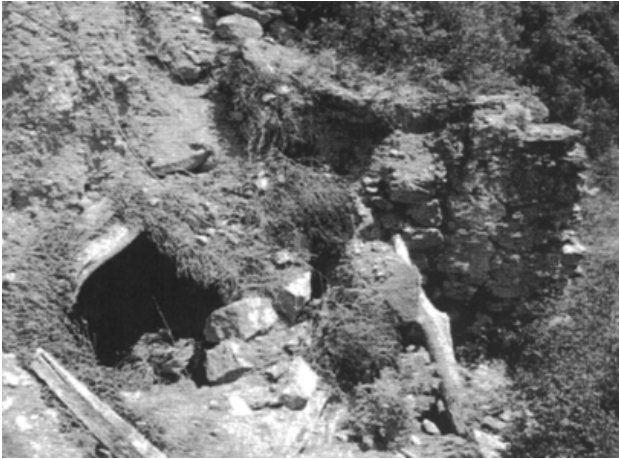
Lime kiln 2 (Fig. 6) also belongs to the Community of Rogliano and is located next to lime kiln 1. This lime kiln is much smaller than lime kiln 1. The inside diameter of the kiln's shaft measures only 3.6 m, and is constant from bottom to top (Fig. 7). This structure has also been partly built into the hillside. The rest of the kiln form walls built with mortar of 1.15 m wide. An entrance foyer is still visible, but not so well maintained. The entrance width is about 3 m and the distance from the corridor to the firing door almost 4.5 m. The firing door is 0.72 m wide and 1.60 m tall and is better preserved than the previous one (Fig. 8). The firing door dimensions of these two lime kilns are similar, although the shaft's dimensions vary considerably. The shaft of this kiln is in good condition in contrast to the outside part of the foyer. The kiln's height is today approximately 5 m. Two wooden beams still exist at the firing door opening. Lime kiln 2 was probably using the same quarry as lime kiln 1. This kiln is also visible and easily reachable from the custom footpath although its outside part is completely covered by maquis.

Fig. 6 Lime Kiln 2 as seen from the access path

Structural analysis was performed on a typical lime kiln using the finite element method. The dimensions used for the model are representative of the dimensions of the lime kilns of Corsica and are based on the dimensions of lime kiln 1. In the finite element model the soil underneath the kiln was considered to extend up to 4 m. The thickness of the soil was 1.5 m at the junction of the thick stone wall with the soil, 10 m in the middle and 4 m next to the entrance (Fig. 9(a)). Extended dimensions of the soil were considered so that the kiln's existence had small influence on the soil at the end of the model where the boundary was considered fixed. A masonry wall of 0.20 m thickness was attached to the soil inside the shaft. Based on observations of the soil and masonry walls of the lime kilns in Corsica, the following properties were used to represent appropriately the materials that compose the lime kilns: the soil's density was 1800 kg/m^3 , the modulus of elasticity 35 MPa, and the Poisson's ratio 0.24. The masonry's wall density was 2100 kg/m^3 , the modulus of elasticity 2500 MPa, the Poisson's ratio 0.24, the compressive strength 2.5 MPa, and the tensile strength 0.25 MPa. The materials were considered homogeneous and isotropic. Only dead load was considered. Static analysis was performed using the structural analysis software Ansys. The masonry and the soil were modeled using a 10 node, 3-D solid element. The results are presented in the form of contour plots of the first principal stress (in Pa). Fig. 9(b) shows that the masonry walls are the most stressed parts of the lime kiln. Most of these high stresses are due to the pressure that the existing soil exerts on the masonry structure. In particular, the most stressed areas are the area around the junction of the thick wall with the soil (extended to the thin wall inside the shaft), and the lower part of the thick masonry wall at the entrance. At these areas the stresses exceed the tensile strength of the wall. These results explain the damages appearing on the lime kilns not only in Corsica but elsewhere also (Fig. 6) where the stones have fallen inside the shaft and the entrance wall has been destroyed.

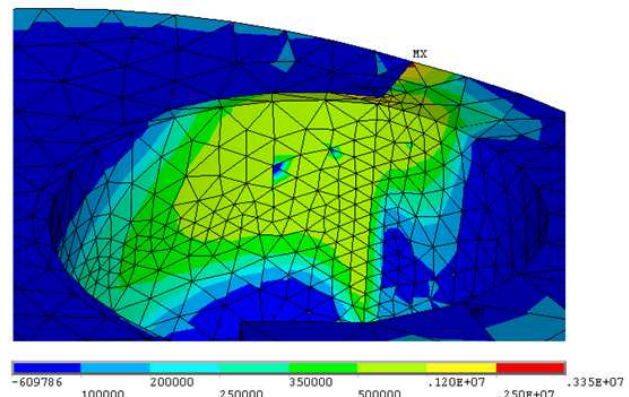
performing finite element analysis on the same lime kiln model considered earlier. A few tendons were applied inside the shaft to tie the thin wall with the soil. The steel tendons used were modeled in Ansys using link elements and had the following properties: modulus of elasticity of 180 GPa, Poisson's ratio of 0.3, total area of 800 mm², and initial strain of 0.00028. Fig. 10 shows the principal tensile stresses at the junction of the stone wall with the soil with the steel tendons. The existence of the tendons reduces drastically the stresses at the area around the tendons. All high tensile stresses will be reduced as more tendons will be applied to tie the stone wall to the soil securely.

Fig. 10 Close-up of the first principal stress (in Pa) around the junction of the thick stone wall with the soil after using post-tensioning at certain locations inside the shaft

Post-tensioning can be applied to all the high stressed areas of the lime kiln considered, especially around the junction of the thick masonry wall with the soil. The usefulness of this method in reducing the high stresses was examined by
