# Beating Phenomenon of Multi-Harmonics Defect Frequencies in a Rolling Element Bearing: Case Study from Water Pumping Station

**Abstract**—Rolling element bearings are widely used in industry, especially where high load capacity is required. The diagnosis of their conditions is essential matter for downtime reduction and saving cost of maintenance. Therefore, an intensive analysis of frequency spectrum of their faults must be carried out in order to determine the main reason of the fault. This paper focus on a beating phenomena observed in the waveform (time domain) of a cylindrical rolling element bearing. The beating frequencies were not related to any sources nearby the machine nor any other malfunctions (unbalance, misalignment ...etc). More investigation on the spike energy and the frequency spectrum indicated a problem with races of the bearing. Multi-harmonics of the fundamental defects frequencies were observed. Two of them were close to each other in magnitude those were the source of the beating phenomena.

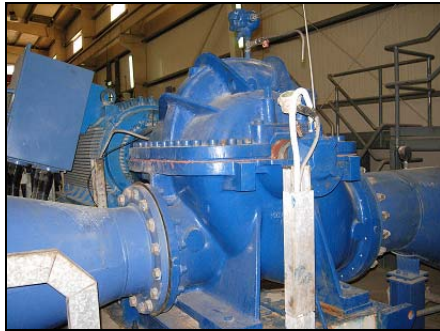
Fig. 2 West Riffa centrifugal pump

A double suction centrifugal pump running at 1480 rpm (24.67 Hz) is installed in West Riffa II water blending station in Bahrain water transmission network as shown in Fig. 2. The main duty of the pump is to pump water from a ground storage tanks to an elevated service reservoir (ESR). The last overhauling of the pump was on May 2008 after which the pump was running smoothly. Fig. 3 shows the vertical frequency spectrum of the Pump-drive end bearing which has an overall vibration of 0.6 mm/s only.

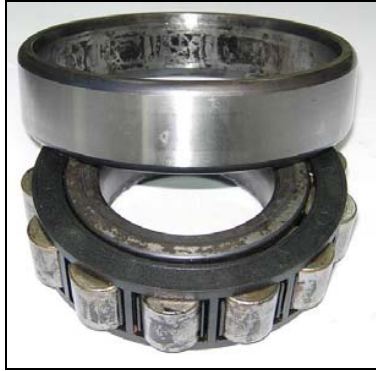
Fig. 12 The bearing after removal. Note the marks in the rollers and the outer race

Hence, a recommendation of dismounting the pump and replace the bearings were sent to the maintenance group. Accordingly, the action was taken and the pump overhauled. We inspected the dismantled bearing to confirm the concluded results. Fig. 12 shows the bearing after dismounting. Clearly, dark marks appear inside the outer race and the rollers. A closer view on the roller is shown in Fig. 13. Several rollers were damaged and worn out.

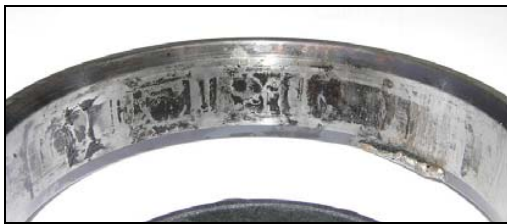
Fig. 14 The defects (dark marks) in the outer race of the bearing

Both outer and inner races were defective as shown in Fig. 14 and Fig. 15. The outer race has a lot of scratches and wear. The same thing could be said about the inner race.
