Preservation of Isparta Yılan Kırkan (Yılan Kıran) Fountain within the Scope of Sustainability

Meryem Elif Çelebi Yakartepe, Ayşe Betül Gökarslan

The restoration decisions of Yılan Kırkan Fountain in Isparta province of Turkey is a good example of the works of sustainable architecture and the preservation of architectural inheritance. It is aimed that Yılan Kırkan Fountain, which is desolate nowadays with no function, to be restored by the local authorities and university, included in the daily life and continue its function.

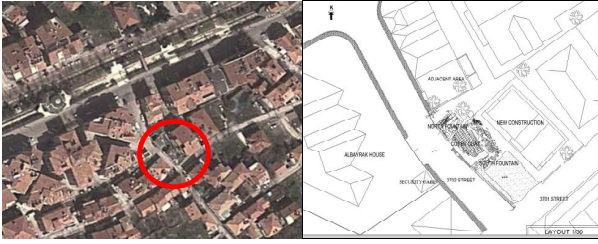
Fig. 2 Yılan Kırkan Fountain location and layout (relief)

Yılan Kıran (Yılan Kırkan) Fountain is located in Isparta Province, Sülübey Neighborhood, İçci Street (street no 3702), in front of the house known to be owned by İlyasoğulları (Fig. 2) It is located in parcel 55 in island 1321. It's also known as "Dolma" or "Çukur" Fountain. It was built by İsa Fakih, son of Mehmet.

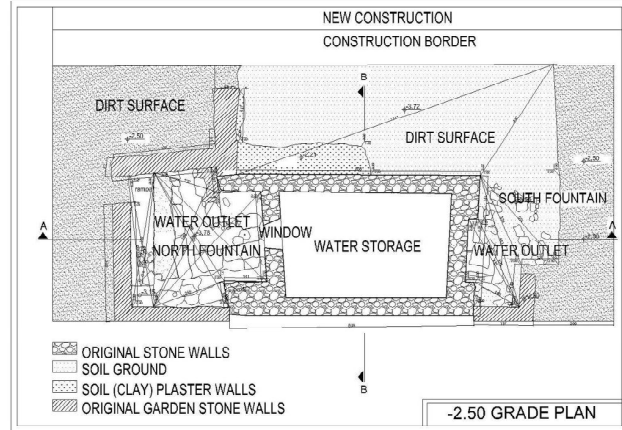
Fig. 5 Yılan Kırkan Fountain's plan (relief)

Yılan Kırkan Fountain consists of a rectangular water reservoir and the fountains to the north and south of this reservoir (Fig. 5). Water reservoir 7.00 m. x 4.60m. It fits on a field and is 4.40 meters high.

Yılan Kırkan Fountain was built with grey local material, known as grey "sav" stone that was common in the area, through using masonry construction technique. The body walls built with debris stone technique was covered with the squared stones.

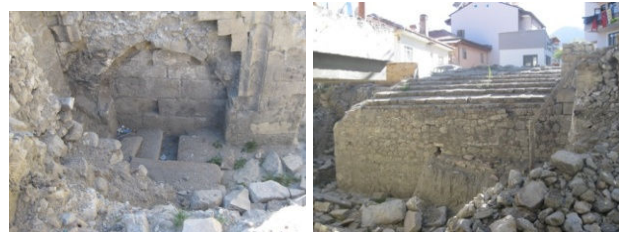
Fig. 6 Fountain's south and east facades

The north and south sides of the fountain consist of niches with semi-circle arch within a rectangular molding. It is known that there were inscriptions in these sides; however, this inscription did not survive to these days. In the north side of the fountain, there is a semi-circle arch window gap opening to the water reservoir (Figs. 6 and 7).

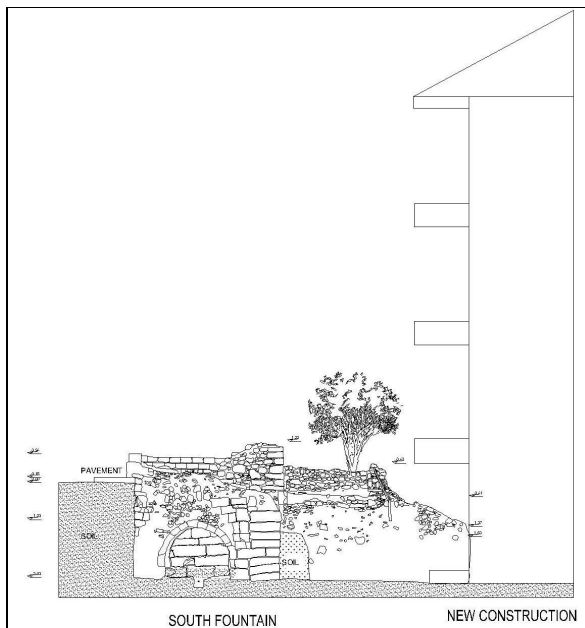
Fig. 8 Yılan Kırkan Fountain's south facade (relief)

Today, the attempts of contractor-style structuring crushes, even destroys many historical constructions. The construction, structuring of which started in the same parcel with Yılan Kırkan Fountain, got too close to the fountain and due to elevation difference, the fountain which went below remained neglected and desolate (Fig. 8 and 9).

The debris removed during the structuring works too close to the fountain was thrown on the historical fountain and while starting the structuring on the fountain yard, the cover coat of the historical fountain was damaged during the cleaning of the debris. Most of the cover stones on the sides of the fountain

It is suggested that the fountain should be moved to an area appropriate for its nature in the town center and repaired, since;

After the historical fountain is moved, the restoration should be completed with reintegration, consolidation and liberating techniques.

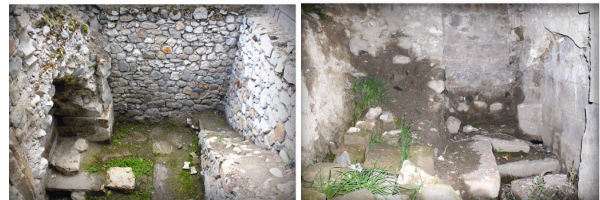
A large portion of the fountain is destroyed; material losses occurred in the north and south sides. There are vegetation problems on the sides and dampness and mossiness problem on the ground. The west side remained under the rising road elevation and the main mass of the structure remained in the construction yard of an apartment that is being built. The distance between the apartment and the fountain is less than 1 meter (Fig. 10).

Fig. 10 Fountain deteriorations (material losses, vegetation on the sides, dampness, mossiness problems from the ground etc.)

historical fountain would be moved to Atatürk Park, which remains in the property borders of the Governorate and is an important public area of Isparta province center. After moving, the consolidation, integration and liberation works of the historical fountain will be made. So, an architectural inheritance will be both moved to a location where the public can perceive and use and the property issues will be overcome.
