Experimental Study on the Floor Vibration Evaluation of Concrete Slab for Existing Buildings

Yong-Taeg Lee, Jun-Ho Na, Seung-Hun Kim, Seong-Uk Hong

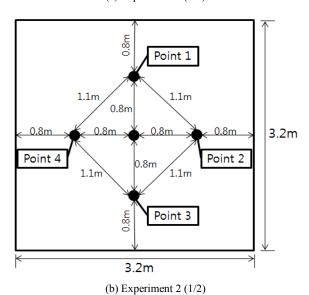
Fig. 2 Point of vibration measurement

As shown in Figs. 2 (a) and (b), the experiment for vibration measurement using accelerometer was divided into 1/4 point of experiment 1 and 1/2 point of experiment 2. Figs. 3 (a) and (b) show data measurement using accelerometer and Table II is the AIJ residential performance assessment criteria [5].

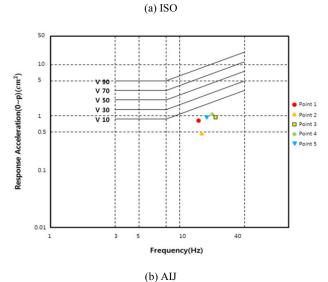
Fig. 4 Compare standard of experiment 1

Serviceability value at which people feel discomfort was based on the recommended value of ISO 2603-2. As in Table III, serviceability limit of office and residential spaces at predominant frequencies of 18.5, 19.6, 22.6, 20.0 and 22.3Hz for Points 1~5 is 0.7, 0.5, 0.9, 1.1 and 0.9% of gravitational acceleration. Accordingly, 0.7, 0.5, 0.9, 1.1 and 0.9% were set as reference values. The highest acceleration amplitudes measured were 0.73, 0.47, 0.87, 1.07 and 0.87%. These values are not close to the recommended values for office and residential spaces. Since the range of vibration was 18.5%~22.57%g, there is no problem in terms of serviceability. Figs. 4 (a) and (b) comparatively analyze the measurements results of experiment 1 with the criteria of ISO and AIJ. Figs. 5 (a) and (b) show the frequency value of Point 5 among experimental values of experiment 1.

- 2) As a result of conducting the experiment at different measurement points, maximum acceleration was 0.47~1.07%g and maximum frequency was 18.5~22.57Hz for experiment 1 (1/4 point). Maximum acceleration was 0.32~0.51%g and maximum frequency was 19.2~23.5Hz for experiment 2 (1/2 point). Maximum frequency of experiment 1 was relatively higher than that of experiment 2. Attenuation point differs according to the measurement position of vibration wave, and as a consequence, acceleration and frequency of vibration wave were changed. Slab floor with thickness lower than the current standards used in old apartment houses creates living noise at level that does not exceed the standard range, but the noise is sufficient enough to make people feel uncomfortable.
