Experimental Study on the Floor Vibration Evaluation of Concrete Slab for Existing Buildings

Keywords—Vibration, Frequency, Accelerometer, Concrete slab.

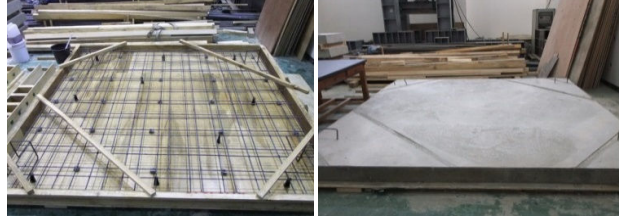
Fig. 1 Specimen of vibration measurement

Design strength of the specimen for floor vibration assessment of concrete slab is 24MPa, and the specimen was manufactured pursuant to KS F 2865 and JIS A 1440-2 with size of 3200X3200X140mm [7],[8]. D13 rebar was arranged for 28 days of atmosphere curing. For the experiment, a 70kg adult male was allowed to jump from the center every second to

inflict impact on the floor, and measurement was done at each point. Measurement as done using accelerometer, and Fast Fourier Transform was performed for comparative analysis with the vibration assessment criteria. Figs. 1 (a) and (b) are mold of floor vibration and specimen of floor vibration.

(a) Mold of floor vibration (b) Specimen of floor vibration

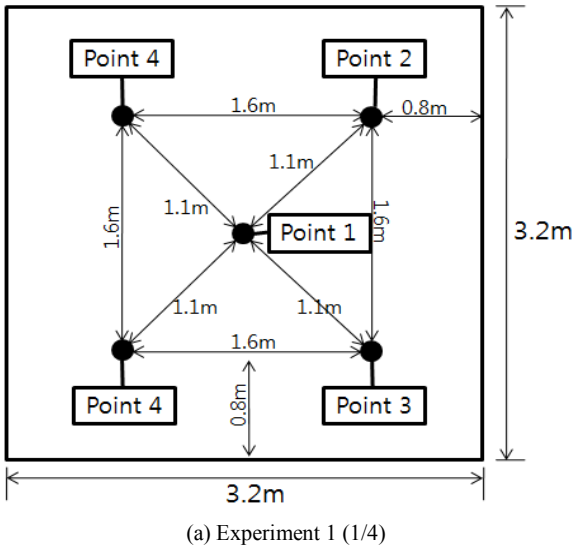
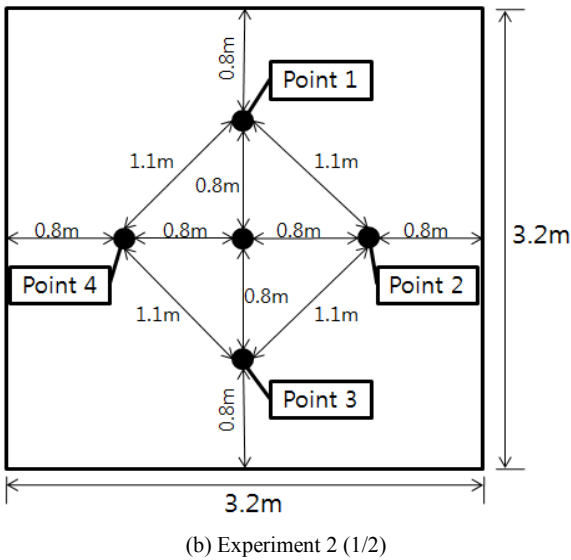
Fig. 2 Point of vibration measurement

As shown in Figs. 2 (a) and (b), the experiment for vibration measurement using accelerometer was divided into 1/4 point of experiment 1 and 1/2 point of experiment 2. Figs. 3 (a) and (b) show data measurement using accelerometer and Table II is the AIJ residential performance assessment criteria [5].

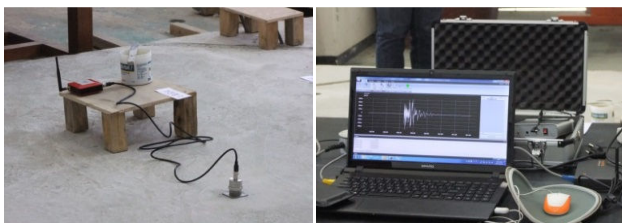
Fig. 3 Data measurement by accelerometer

In vibration measurement, selection of an appropriate sensor is the most important aspect. For selection of sensor, dynamic range which includes expected frequency domain of the measurement subject, resonance frequency, signal sensitivity under measurement conditions, and noise level of the sensor must be taken into account. The sensor was installed according to the basic guidelines to maintain horizontality, and it was fixed to an accurate position so that the response axis agreed with the direction of measurement. In addition, since the sensor can be affected by temperature, magnet and electricity, a place that does not receive external influence like nearby high-tension power line was selected for installation. Table I shows the specifications of accelerometer.

(a) Accelerometer (b) Data measurement

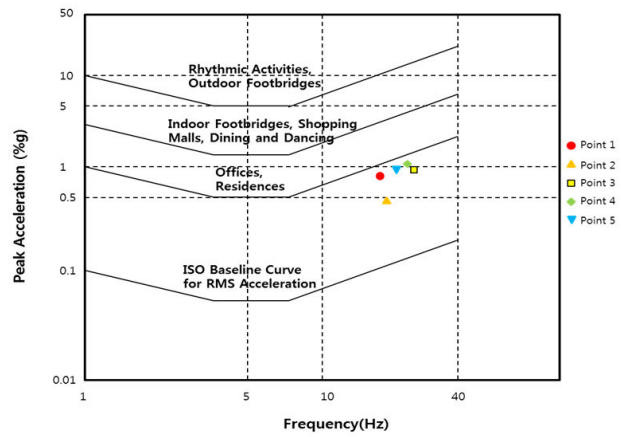
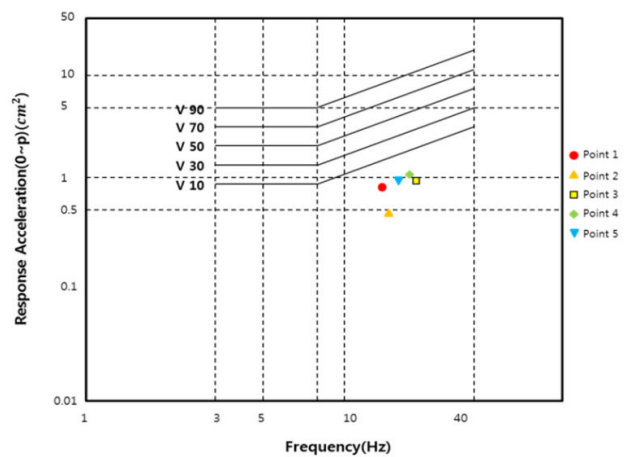
Fig. 4 Compare standard of experiment 1

(a) ISO

(b) AIJ

Serviceability value at which people feel discomfort was based on the recommended value of ISO 2603-2. As in Table III, serviceability limit of office and residential spaces at predominant frequencies of 18.5, 19.6, 22.6, 20.0 and 22.3Hz for Points 1~5 is 0.7, 0.5, 0.9, 1.1 and 0.9% of gravitational acceleration. Accordingly, 0.7, 0.5, 0.9, 1.1 and 0.9%g were set as reference values. The highest acceleration amplitudes measured were 0.73, 0.47, 0.87, 1.07 and 0.87%. These values are not close to the recommended values for office and residential spaces. Since the range of vibration was 18.5%~22.57%g, there is no problem in terms of serviceability. Figs. 4 (a) and (b) comparatively analyze the measurements results of experiment 1 with the criteria of ISO and AIJ. Figs. 5 (a) and (b) show the frequency value of Point 5 among experimental values of experiment 1.

- 1) When the vibration measurement results using accelerometer are compared with the vibration assessment criteria of ISO and residential assessment guidelines provided by Architectural Institute of Japan, vibration currently does not exceed the damage limit or serviceability limit of building. Looking at a cluster of natural frequencies of floor slab clustered around the same range, temporary vibration was found to occur.

- 2) As a result of conducting the experiment at different measurement points, maximum acceleration was 0.47~1.07%g and maximum frequency was 18.5~22.57Hz for experiment 1 (1/4 point). Maximum acceleration was 0.32~0.51%g and maximum frequency was 19.2~23.5Hz for experiment 2 (1/2 point). Maximum frequency of experiment 1 was relatively higher than that of experiment 2. Attenuation point differs according to the measurement position of vibration wave, and as a consequence, acceleration and frequency of vibration wave were changed. Slab floor with thickness lower than the current standards used in old apartment houses creates living noise at level that does not exceed the standard range, but the noise is sufficient enough to make people feel uncomfortable.

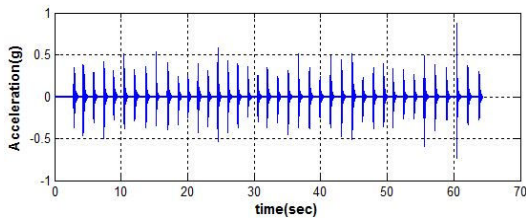
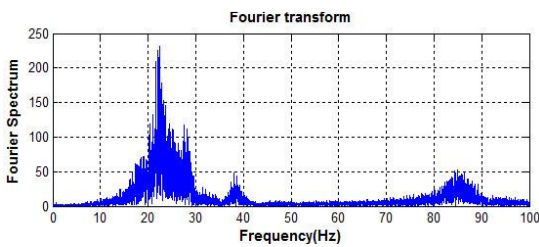
Fig. 5 Frequency value of experiment 1

(a) Peak Acceleration of Point 5

(b) Peak Frequency of Point 5

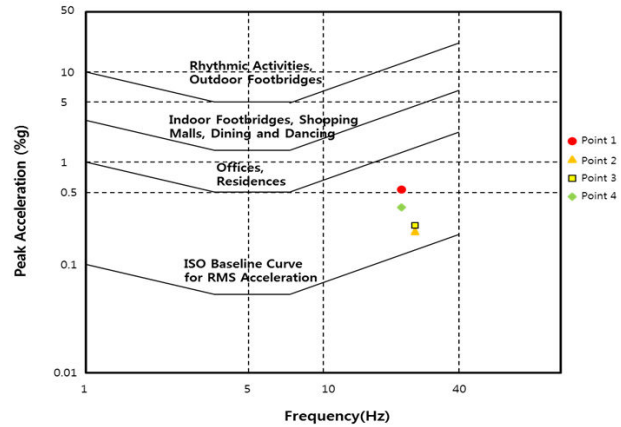
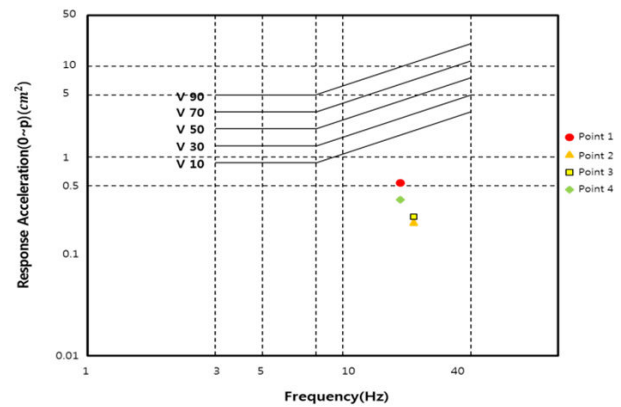
Fig. 6 Compare standard of experiment 2

Figs. 6 (a) and (b) compare the measurement results of experiment 2 with the standard criteria. As in Table IV, acceleration values were 0.51, 0.32, 0.35 and 0.41% at predominant frequencies of 19.2, 23.4, 23.5 and 19.5Hz for Points 1~4. Accordingly, 0.5, 0.3, 0.3 and 0.4%g were selected as reference values. The highest acceleration amplitudes measured were 0.51, 0.32, 0.35 and 0.41%, which are further away from recommended values for office and residential spaces than primary measurement. Since the range of vibration was 19.2%~23.5%g, there is no problem in terms of

(a) ISO

(b) AIJ

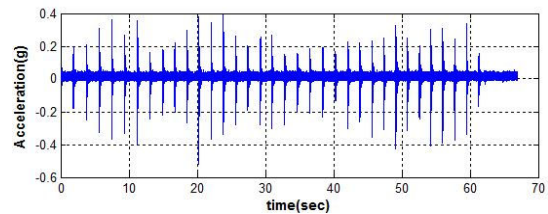
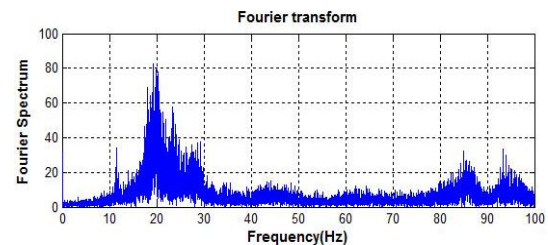
Fig. 7 Frequency value of experiment 2

(a) Peak Acceleration of Point 1

(b) Peak Frequency of Point 1

serviceability. Figs. 7 (a) and (b) are the frequency values of Point 1 among experimental values of experiment 2.
