# Influence and Interaction of Temperature, H<sub>2</sub>S and pH on Concrete Sewer Pipe Corrosion

Anna Romanova, Mojtaba Mahmoodian, Morteza A. Alani

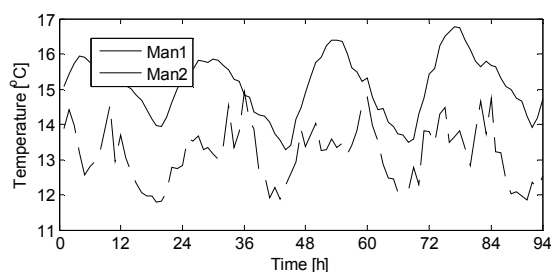
Fig. 1 Effluent temperature for Manhole 1 and Manhole 2 for a period of 4 days in the beginning of April shown in hours

The effluent temperatures for both manholes were found to follow very similar daily trend, however each of them has individual hourly pattern. Fig. 1 represents the data of effluent temperature recorded at a manhole 1 and manhole 2 in 5 days period in the beginning of April, where zero is set at 10am.

The data on Fig. 1 and for all other graphs was resampled to represent an average value for each given hour. Overall, in Feb-Apr the temperatures measurements minimum, maximum and mean for Man1 and Man2 were, 10.8°C, 17.1°C, 13.2°C and 11.6°C, 17.6°C, 15.1°C, respectively. In general the temperatures in Man2 are found to be higher and this is thought to be influenced by a closer location to the rising main, pumping station and generally the industrial sector which have larger use of hot water.

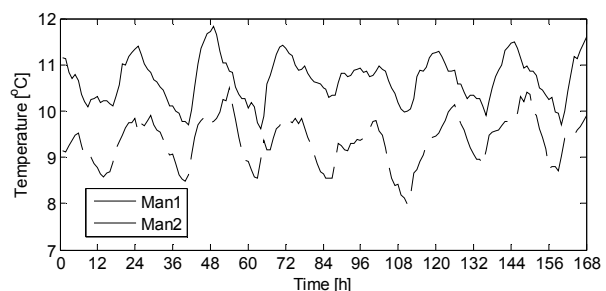
Fig. 2 Ambient temperature for Manhole 1 and Manhole 2 for a period of 1 week in the beginning of March shown in hours

The ambient temperatures for both manholes were found to follow overall an identical pattern. The general pattern of this behavior for both manholes is illustrated in Fig. 2, with zero set at midnight. From Fig. 2 it can be noted that the temperature in Man 1 is generally slightly lower for that compared with Man 2, with mean temperature values of 9.3°C and 10.6°C, respectively. Overall, in Feb-Apr the temperatures measurements minimum, maximum and mean for Man1 and Man2 were, 7.6°C, 12.9°C, 10°C and 8.7°C, 13.8°C, 11.2°C, respectively. The temperatures increased over the day with peak times at 11pm-4am after which they declined. This coincided with the discharge of overflow in the pumping station which generally takes place at midnight or when the chamber is full. However each manhole had manhole-specific minor pattern which is thought to be governed by house hold and industry activity in the area.

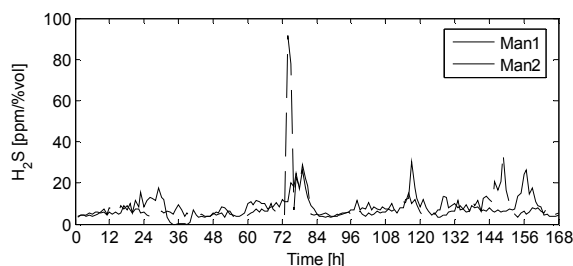
Fig. 3 Hydrogen sulphide concentration for Manhole 1 and Manhole 2 for a period of 1 week in the beginning of March shown in hours

The concentration of hydrogen sulphide for both of the manholes was measured with the sensor being placed in the middle of the manhole at 600mm above the effluent. The measurements of  $H_2S$  are presented on Fig. 3, where the data is shown for the same time period as in Fig. 2. From the figure it can be noted that the pattern of  $H_2S$  concentration is similar for both manholes even though they were located far apart and governed by different rising mains and pumping station conditions. Although, it should be noted that the operational time for all pumping stations in experimental area is the same. Graph identified large peak of  $H_2S$  at Manhole 1 at 91ppm/ % vol, where manhole 2 identifies only 29ppm/%vol. A similar peak tends to appear app. every 48h closer to midnight.

Overall, in Feb-Apr the measurements of the  $H_2S$  concentration minimum, maximum and mean for Man1 and Man2 were, 3, 134, 12 and 0, 168, 12, respectively. Even though the minimum and maximum values of both of the manholes varied, the mean of 12ppm/%vol was observed in both, whereas in most of the times a value of 3-5ppm/%vol was recorded.

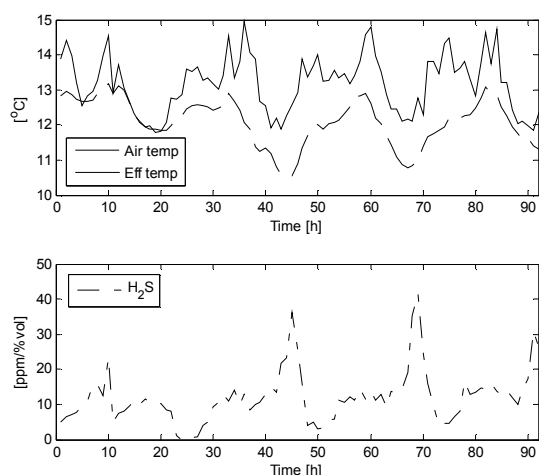
Fig. 4 Temperatures and hydrogen sulphide concentration for Manhole 1 for a period of 4days in April shown in hours

The interaction between parameters of ambient temperature, effluent temperature and concentrations of hydrogen sulphide was investigated. Fig. 4 demonstrates the recorded data for the above for first four days in April for Manhole 1, with zero starting at 10am.

The data suggests that there is a relation between the ambient and effluent temperatures as they follow the same hourly pattern (which is governed by the effluent temperature, which in turn is related to domestic and industrial activities) and daily trend (governed by effluent temperature and general temperature of air outside the manhole). Furthermore, it can be noted that the  $H_2S$  level peaks together with the general decrease in temperature inside the manhole in late evening and early morning hours (during this time the general household and industrial activity is minimal, the flow levels are low to

moderate which allows for gas build-up). Furthermore, there is an apparent 10h shift in  $H_2S$  level increase and decrease behavior compared to temperatures. The above findings were confirmed for both of the manholes during Feb-Apr period.
