Relining of Domestic Piping System with Rubber Filled Epoxy and Reinforced Polyester Composites

Abstract—Pipe failure and leakage is a problematic issue and the traditional solution of replacing the pipes is costly and time consuming. Rehabilitation by relining materials based on polymer composites is an alternative solution towards the degradation problem of the old piping. This paper provides a brief summary of advances in technology, methods and materials for relining as well as a summary of the degradation analyses of the two main composite materials used for relining, rubber filled epoxy and reinforced polyester baltoflake when they are exposed in deionized water and elevated temperature up to 80°C for a duration of 2-14 months in the laboratory.

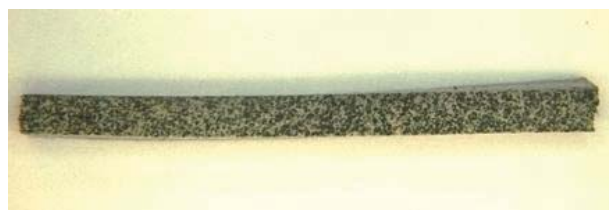
Fig. 3 A strip of the epoxy modified with rubber sample after 2 months exposure to deionized water at 80°C and complete drying

As it can be seen from Figs. 3 and 4, epoxy material exposed to water at 80°C did not show the same degradation as the polyester based relining.

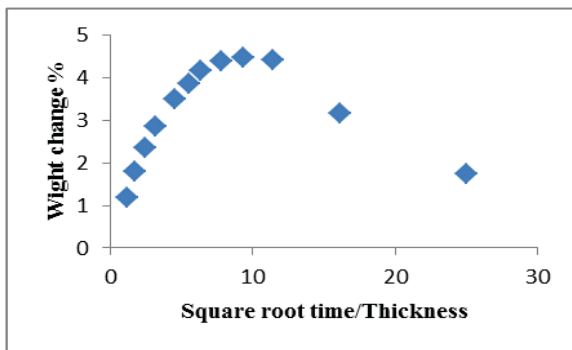
Fig. 6 Absorption curve for polyester baltoflake immersed in water at 60°C in oven during 14 months

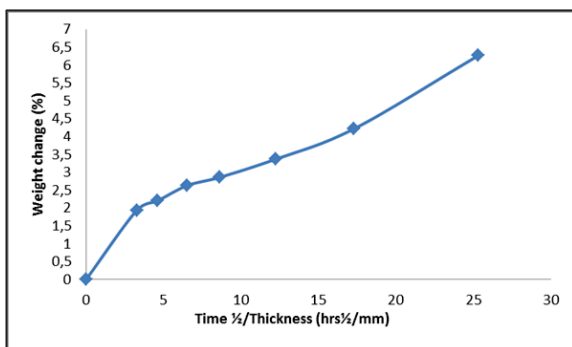
Fig. 7 A typical sorption curve for a coupon of epoxy modified with rubber immersed water at 60°C

Water sorption measurements were carried out by immersion of material with the dimension of 4 X 4cm in deionized water at different temperatures (22°C, 40°C, 60°C and 80°C). None of the coupons exposed to water at elevated temperature reached the equilibrium and the water absorption was continuing. A typical sorption curve for a coupon exposed to the water at 60°C is shown below. This sample showed the weight change of 6,26% after 2 months.
