# Diagnostics of Existing Steel Structures of Winter Sport Halls

**Abstract**—The paper deals with the diagnostics of steel roof structure of the winter sports halls built in 1970 year. The necessity of the diagnostics has been given by the requirement to the evaluation design of this structure, which has been caused by the new situation in the field of the loadings given by the validity of the European Standards in the Czech Republic from 2010 year. Due to these changes in the normative rules, in practice existing structures are gradually subjected to the evaluation design and depending on its results to the strengthening or reconstruction, respectively. Steel roof is composed of plane truss main girders, purlins and bracings and the roof structure is supported by two arch main girders with the span of  $L = 84$  m. The in situ diagnostics of the roof structure was oriented to the following parts: (i) determination and evaluation of the actual material properties of used steel and (ii) verification of the actual dimensions of the structural members. For the solution the non-destructive methods have been used for in situ measurement. For the indicative determination of steel stren

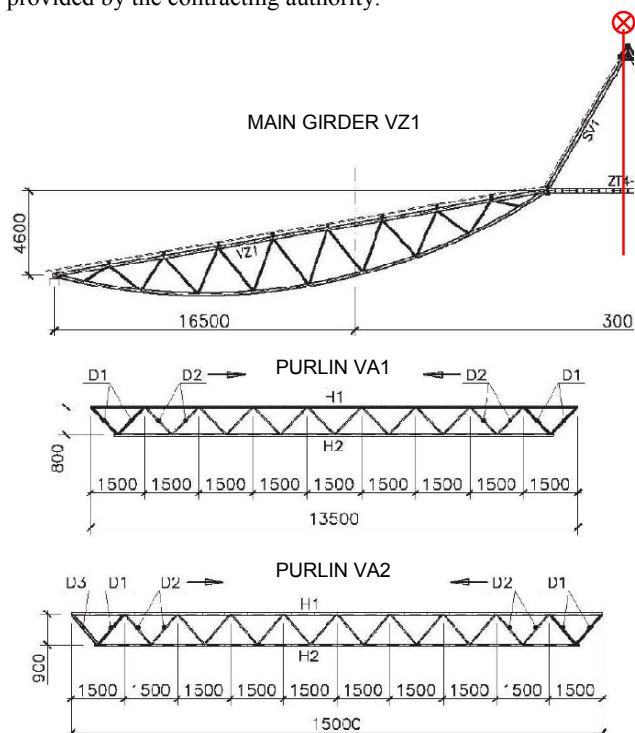
Fig. 1 Main roof girder VZ1 and purlins VA1, VA2

The roof structure is composed of plane truss main girders, purlins and bracings (see Figs. 1, 2) and the structure as a whole is supported by longitudinal arch main girders (Fig. 3).

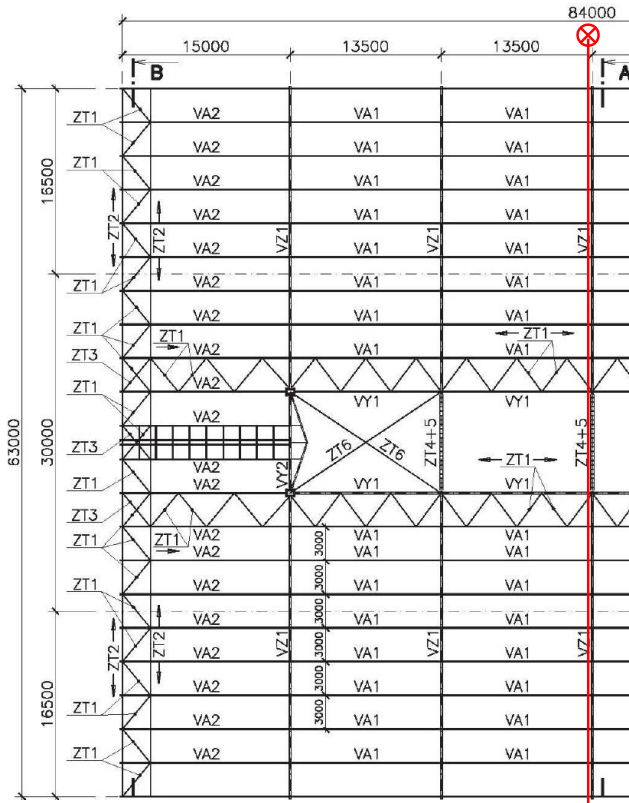
Fig. 2 Roof structural system: plan

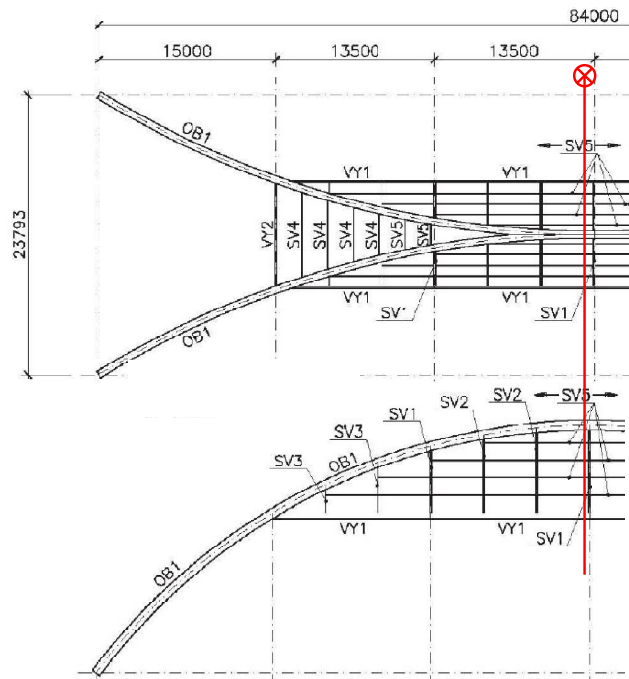
Fig. 3 Arch main girders: plan and side view

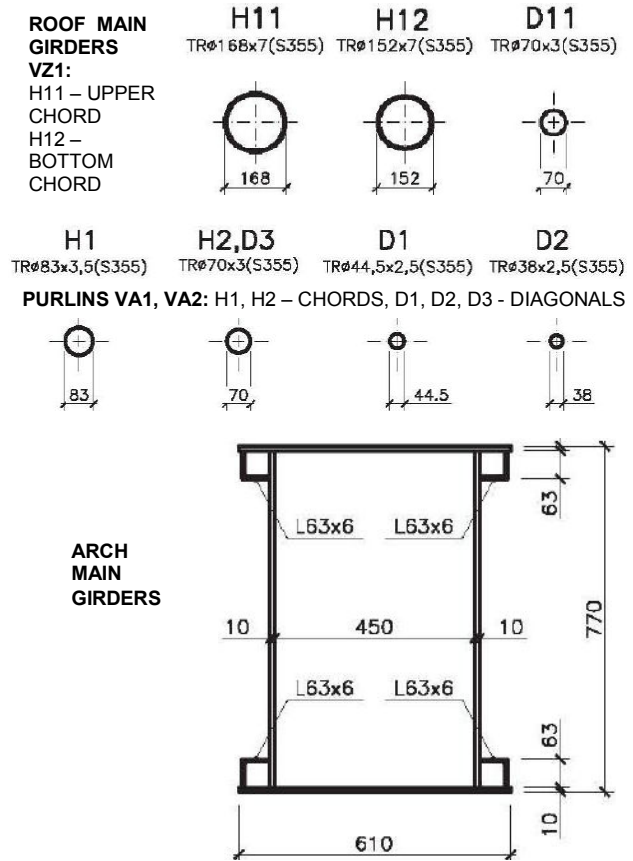
The typical cross-sections (including their dimensions) of the main structural members, that means main roof girders, purlins and arch girders, are shown in Fig. 4.

Fig. 4 Cross-sections of main structural members

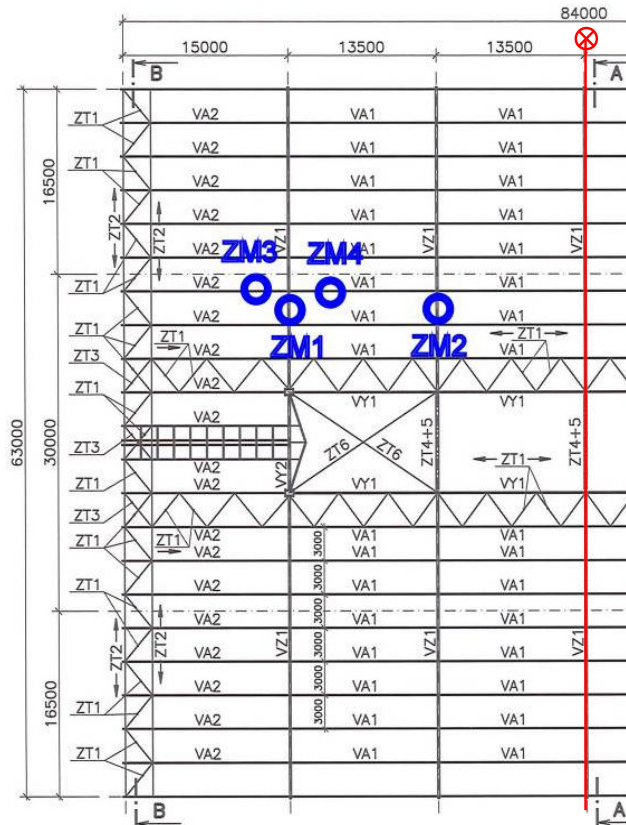
Fig. 5 Tested locations: main roof girders VZ1 – locations ZM1, ZM2, roof purlins VA1, VA2 – locations ZM3, ZM4

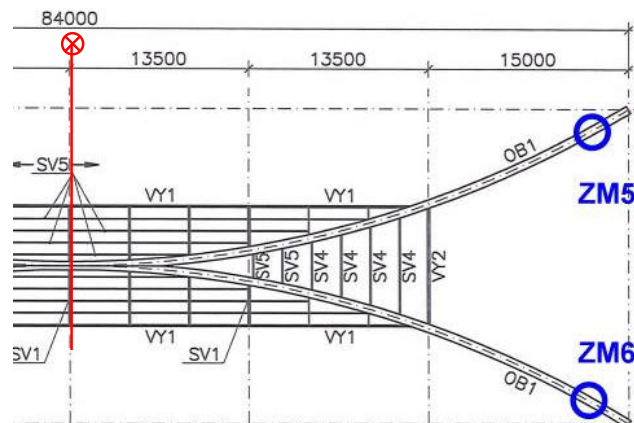
Fig. 6 Tested locations: arch main girders OB1 – locations ZM5, ZM6

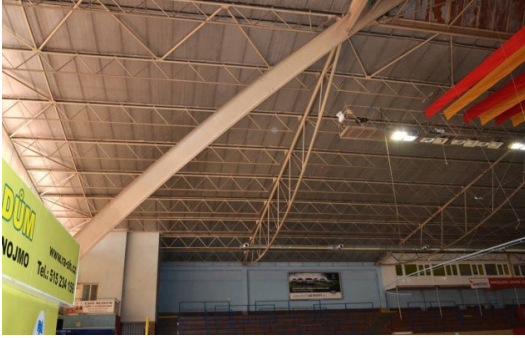
Fig. 7 Part of tested structure: truss main roof girders, truss purlins, bracings, arch main girders

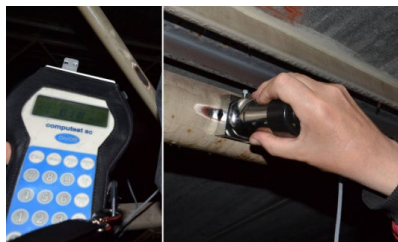
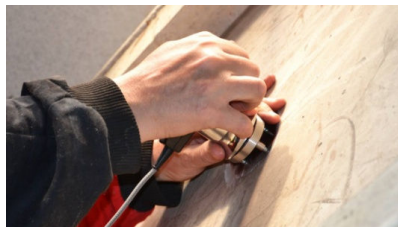
Before the measurement by “COMPUTEST SC” apparatus it was necessary to remove paint layers and to prepare surface (see Fig. 8 (a) left). The distance of the measuring tip has always been calibrated using the special dipstick (see Fig. 8 (a) right). For measuring on the rounded surface the V-shaped product (see Fig. 8 (b)) has been used; on the flat surface the three-point magnetic product (see Fig. 8 (c)) has been applied.

Fig. 8 Measurement by “COMPUTEST SC” apparatus: (a) prepared tested location on rounded surface (left), calibration of measuring tip distance on rounded surface (right); (b) measurement on rounded surface using V-shaped product; (c) measurement on flat surface using three-point magnetic product

Before measuring the colour layers have been removed and the surface has been aligned to be the smoothest (see Figs. 8 (a) or (b), for example). On each measuring base of the area of  $30 \times 30$  mm, minimally 3 measurements of the wall thickness have been always performed and subsequently the mean values have been calculated. The results of the measurement of the thickness  $t$  of steel members are listed in Table II.

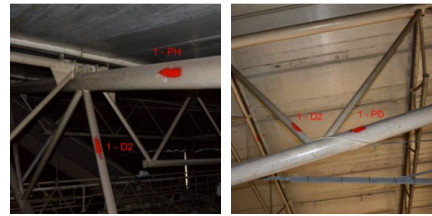
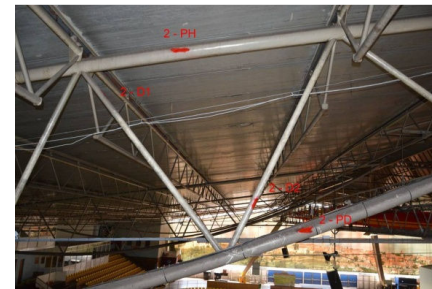
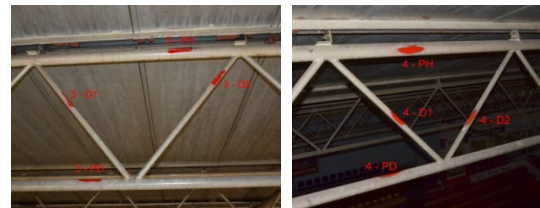
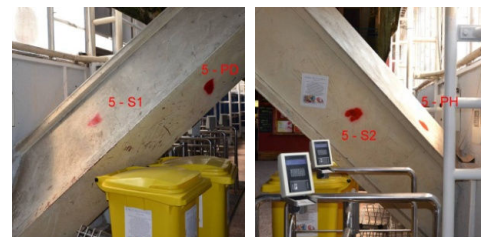
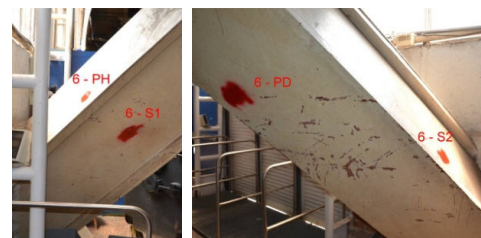
In total 22 tested locations have been verified on the upper chords PH, bottom chords PD and diagonals D: 8 measured locations on 2 main roof girders – upper chord, bottom chord, 2 diagonals; 8 measured locations on 2 roof purlins – upper chord, bottom chord, 2 diagonals; 6 measured locations on 2 arches – upper flange, bottom flange, 2 webs. Individual tested locations are documented in Fig. 9.

Fig. 9 Tested locations: (a) truss main roof girders; (b) truss roof purlins; (c) arch main girders

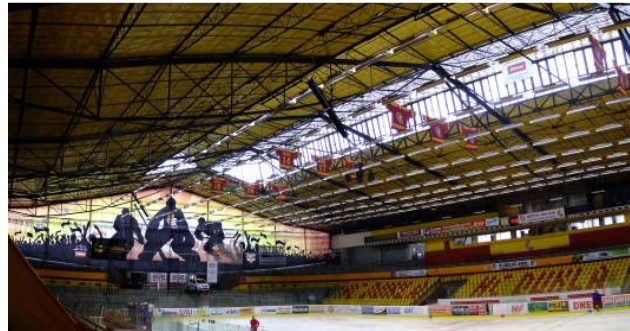
This roof structure is composed of plane girders – garland truss main roof girders with ties, parabolic truss purlins and bracing system (see Fig. 10). The stadium was built at the turn of the 60<sup>th</sup> and 70<sup>th</sup> years of the 20<sup>th</sup> century. The width and length of the roof structure in the plan are  $60 \times 100$  m.

Fig. 10 Roof structure of winter sports stadium in Jihlava city

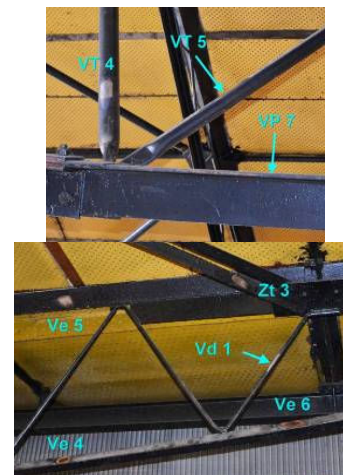
important members for the measurement (see Fig. 11). The following total numbers of locations have been measured: 7 locations on the chords (VP) and 7 locations on the diagonals (VT) of main girders, 6 locations on the chords (Ve) and 2 locations on the diagonals (Vd) of purlins and 3 locations on the members of bracings (Zt).

Fig. 11 Tested locations: main girders – VP, VT; purlins – Ve, Vd; bracings – Zt

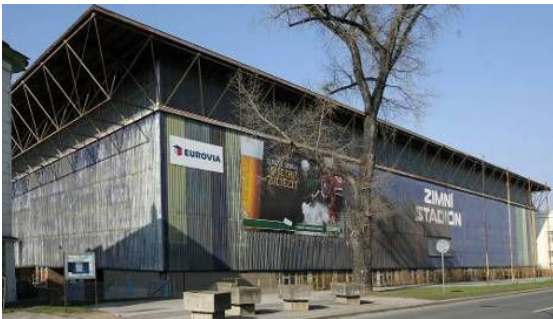
This roof structure is the spatial truss grid consisting of steel circular tubes connected by spherical joints (see Fig. 12). The stadium was built in the 6<sup>th</sup> decade of the 20<sup>th</sup> century. The main dimensions of the roof truss grid are following: the width and length in the plan are  $68 \times 100$  m, the grid height is 4 m.

Fig. 12 Roof structure of winter sports stadium in Olomouc city

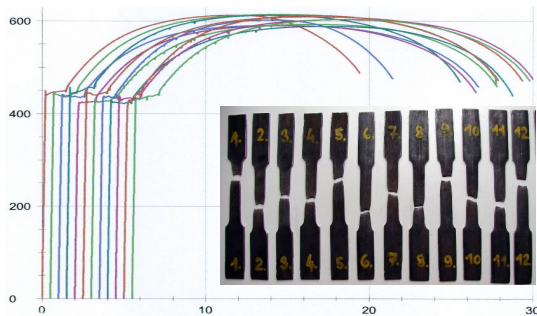
Fig. 13 Failed test specimens and corresponding tensile diagrams

grid has been used. In total 12 test specimens for tensile tests have been manufactured from this structural member. Failed specimens and tensile diagrams are shown in Fig. 13.

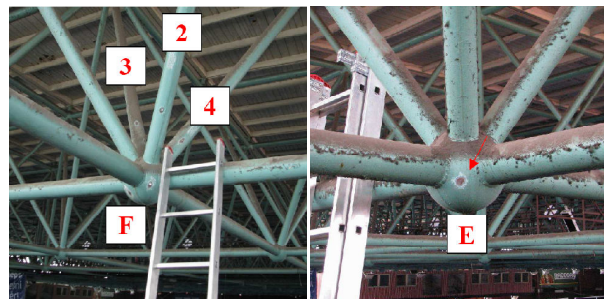
Fig. 14 Illustration of tested locations: diagonals and bottom chord spherical joints

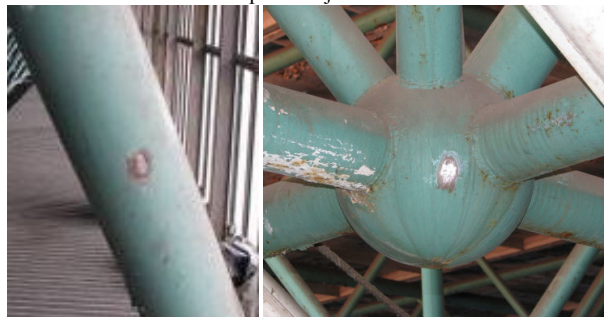
Fig. 15 Illustration of structural members with tested locations prepared for subsequent measuring

On each verified member 3 measuring bases have been prepared (see illustration in Fig. 15). On each measuring base of the area of 30 × 30 mm, minimally 3 measurements of the thickness have been always performed and subsequently the mean values have been calculated. Applying 10 MHz ultrasound probe and precise preparation of the surface the measuring accuracy of ±0.4 mm has been achieved. Based on the results of the measurement and available documentation of the roof structural system, it can be deduced, that the actual thicknesses of particular selected members, which have been measured, correspond with the thicknesses mentioned in drawing documentation.
