Fundamental Research on Factors Affecting the Under-Film Corrosion Behavior of Coated Steel Members

T. Sakamoto, S. Kainuma

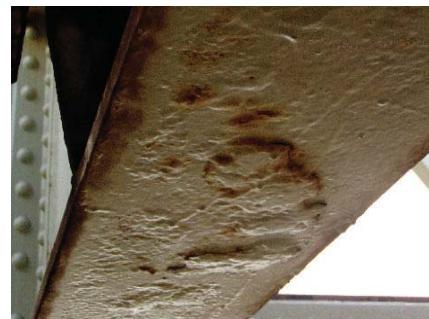
Fig. 1 Appearance of Under-film Corrosion

impossible to completely protect the environmental factors such as water vapor and oxygen; therefore, the coating film covered on the rust is degraded by the progress the under-film corrosion due to various corrosive factors. Thus, in order to inhibit the under-film corrosion, it is important to understand the relationship among corrosive factors, remaining amounts of the rust and coating durability. Fig. 1 shows under-film corrosion of a steel structure.

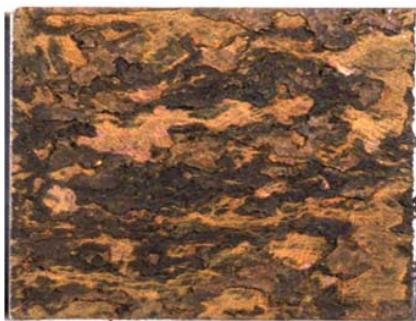
Fig. 7 Appearance of Corroded Surface before Painting (840 h SST, wire brushing)
