# Application Problems of Anchor Dowels in Reinforced Concrete Shear Wall and Frame Connections

Musa H. Arslan

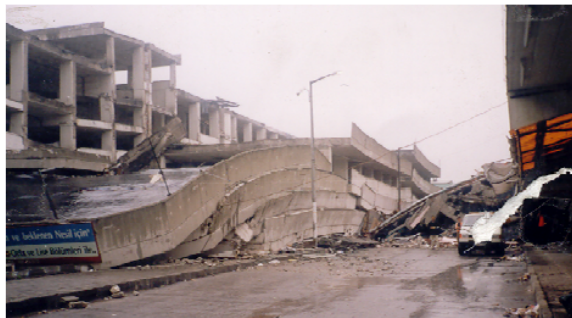
Fig. 1 A seriously damaged RC building in Marmara region

The seismic performance analysis of the buildings, which was lastly renovated in 2007, is conducted in accordance with the Turkish Earthquake Code (TEC – 2007, hereafter) [4] regulations. Structural performance outputs of the buildings are obtained immediately with this analysis. If the performance of the structure is not sufficient for the related seismic effects, strengthening or demolition orders are given by the engineers. In Figs. 1 and 2, a seriously damaged RC

building in Marmara Region of Turkey and the effect of strengthening are given, respectively.

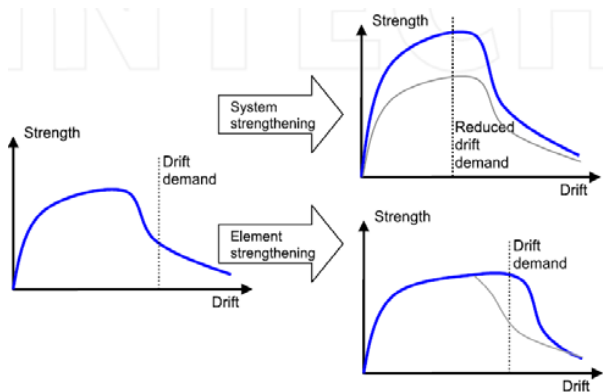
Fig. 2 Effect of strengthening [6]

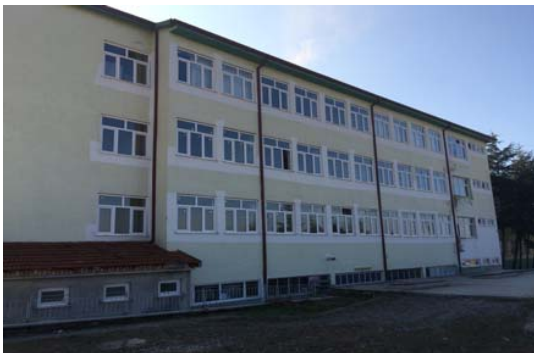
The building data given in Fig. 3 below are from a school building in Turkey, which is planned to be reinforced. The structure consists of two blocks. Block A is composed of Ground Floor + 2 Normal Floors, and Block B is composed of Basement + Ground Floor + 2 Normal Floors. The structure was completed in 1978. The structure is in first seismic zone according to the zoning map of Turkey. The load carrier system is a RC frame system. According to the concrete core samples taken from the load carrier system of the structure, the average concrete compression strength has proven to be 5.2 MPa (52 kg/cm<sup>2</sup>). Based the analysis carried out in accordance with the TEC-2007 [4] principles, a strengthening project was prepared since the current situation remains inadequate for the seismic performance.

Fig. 3 Weak framed typical school building in Turkey

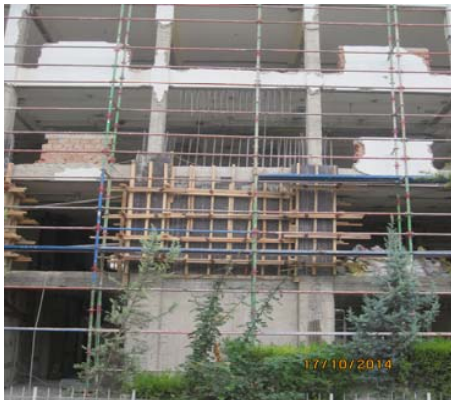
Fig. 6 A typical anchorage details in RC shear wall and frame connection

It is expected that, since the concrete strength of the structure is too low, some problems will occur related to the application of the anchorages and the anchorage performance mentioned in the project. The proposed anchorage details of shear wall-frame connection are given in Figs. 5 and 6. Also a typical anchorage application of a foundation is also given in Fig. 7.

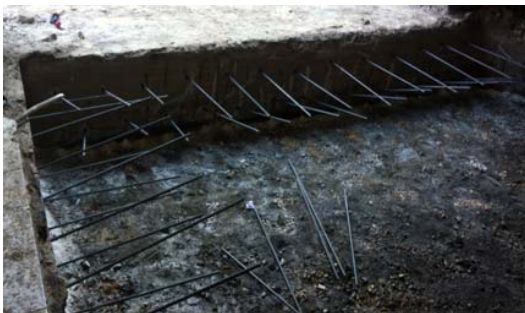
Fig. 7 A typical anchorage details in RC foundation connection

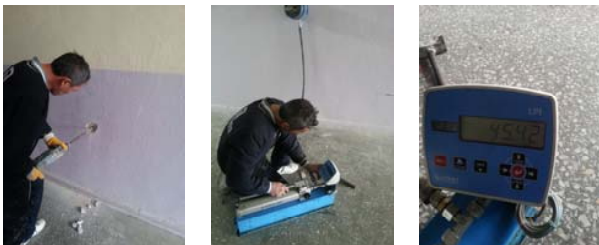
Fig. 8 Anchorage pull out test

The sample anchorage bars are inserted by rotating, to the hole filled with the brand "A" epoxy. After the placing, one day later, the pull-out test was conducted. Some steps of the

operation are given in Fig. 8. The test results showed that all fittings were stripping out before reaching to the required strength. According to the tests carried out, since the concrete strength is considerably low in this building, the operating of the steel anchorages placed on both foundation and beams-columns at the desired capacity will be prevented. Anchorages will be stripped out before reaching the capacity.

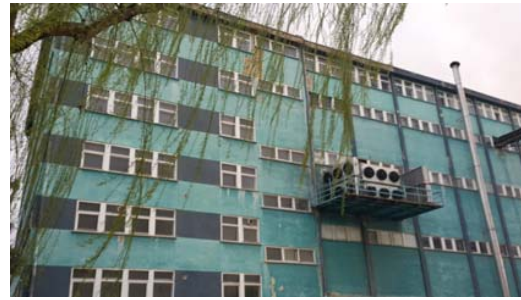
Fig. 9 Weak framed typical official building in Turkey

As for the tests carried out in another building given in Fig. 9, in Turkey with the same compression strength (average value of the compressive strength of concrete is 5.5 MPa), a brand "B" epoxy was used instead of the brand "A" one. The anchorage placement procedure is the same as the first example. As a result of the anchorage placing operation, it has found that the anchorages were able to hold the load to the desired capacity.
