Self-Help Adaptation to Flooding in Low-Income Settlements in Chiang Mai, Thailand

Nachawit Tikul

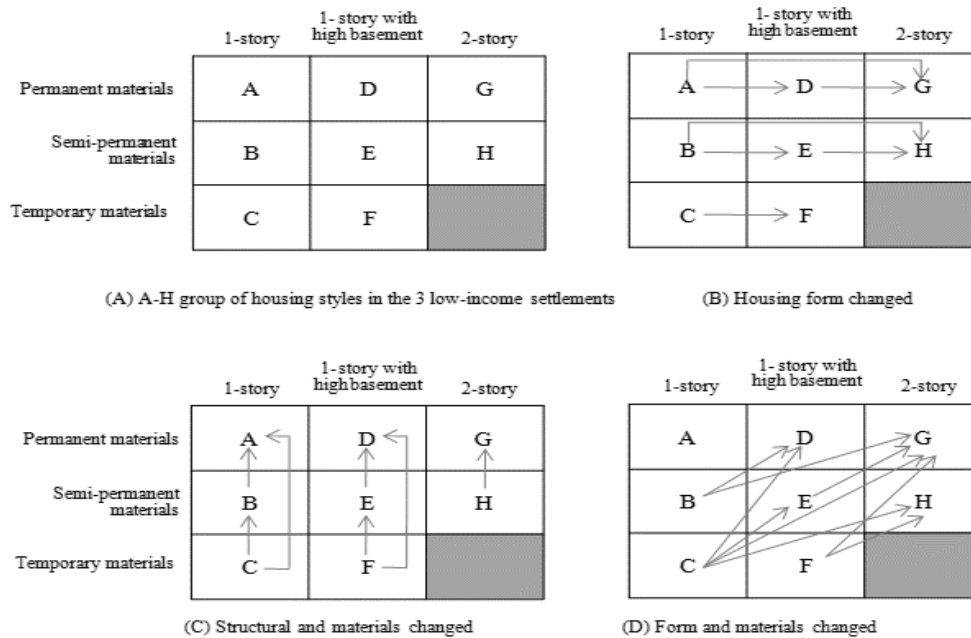
Fig. 4 Housing styles and improvement

In spite of their low income, the slum residents still try to protect their houses according to their ability by learning from problems. From the survey, existing housing styles can be divided into eight groups (A-H) by determination of the building materials' duration and the number of stories as

shown in Fig. 4 (A). The most popular housing style is a 1-story house with permanent building materials (A-style), such as reinforced concrete, concrete block and hard wood, which is durable, low cost, and available at building material retail stores around low-income settlements.

The third group was the most popular in Kampangam by changing F-style to H-style housing and C-style to E-style housing, but the second group was the most common in Bansanku by changing C-style to A-style housing. This explains why C-style houses cannot be found in Bansanku at the present. Only one household in Bansanku used the third method of both changing the housing form and the materials, and the first method was not found there. This is consistent with the improvement methods used in Samukeepattana, where the second group was the most popular means by changing to E-style housing. The first and the third group had similar improvement rates. The housing was likely higher than the highest flood levels in each community. Permanent structural materials and temporary architectural materials were usually selected for housing in Samukeepattana, permanent structural materials and architectural materials for the first floor of housing in Bansanku and almost all temporary materials for housing in Kampangam. Inexpensive and repairable building materials which can be found near the communities were selected.

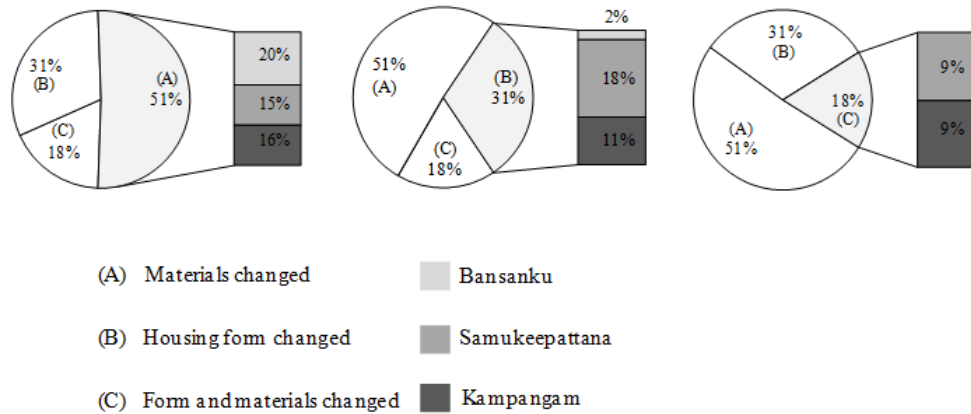
Fig. 5 Self-help improving methods

In the past 10 years, many households in the three communities were improved. Household style and building materials were changed in 88.5% of households in Samukeepattana, 47.6% of households in Bansanku and only 29.7% of household in Kampangam, while the others just repaired their old houses. Therefore, the self-help improvement information can be divided into three categories, the first of which is changing only the housing form, such as transforming a 1-storey house with permanent structural and building materials (A-style) to an elevated 1-storey or 2-storey house with permanent structural and building materials (D- or G-style) as shown in Fig. 4 (B). The second group changed only structural and building materials, such as non-permanent structural and building materials to permanent structural and building materials, for example, C-style to B- or A-style, as shown in Fig. 4 (C). The third group updated both housing form and materials, as shown in Fig. 4 (D), which required building reconstruction such as from a 1-storey house with non-permanent structural and building materials (C-style) to an elevated 1-storey with permanent structural and building materials (D-style). The second group was the most popular within the three low-income settlements, which was used in about 51% of the total number of housing renovations, followed by the third group, which was 31%, and the first group, which was 18%, as shown in Fig. 5.
