# Non-Chronological Approach in Crane Girder and Composite Steel Beam Installation: Case Study

**Abstract**—The time delay and the structural stability are major issues in big size projects due to several factors. Improper planning and poor coordination lead to delay in construction, which sometimes result in reworking or rebuilding. This definitely increases the cost and time of project. This situation stresses the structural engineers to plan out of the limits of contemporary technology utilizing non-chronological approach with creative ideas. One of the strategies to solve this issue is through structural integrity solutions in a cost-effective way. We have faced several problems in a project worth 470 million USD, and one such issue is crane girder installation with composite steel beams. We have applied structural integrity approach with the proper and revised planning schedule to solve the problem efficiently with minimal expenses.

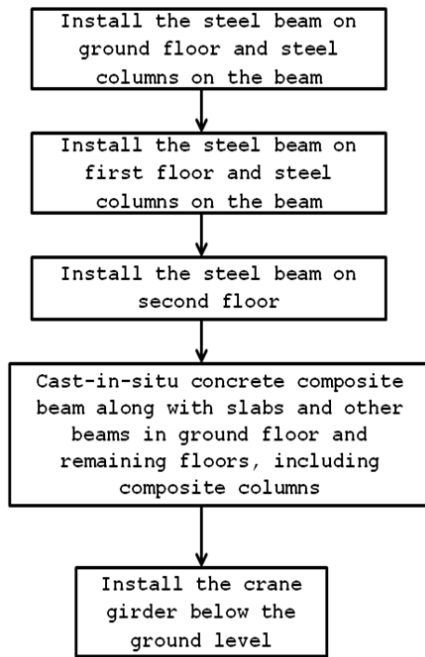
Fig. 3 Proposed non-chronological procedure

After careful study of the actual situation, the following sequences of work activity (as illustrated in Fig. 3) decisions were taken with pre-measure activities.

We started with the installation of steel beams and steel columns starting from ground floor based on our proposed approach, as illustrated in Fig. 3. The steel beams are of 400 X 1400 mm, 400 X 1700 mm, and 400 X 2000 mm. The columns are of 400 X 1600 mm, 400 X 1400 mm, and 400 X 1000 mm. The overhead crane girder is of 19 m long.

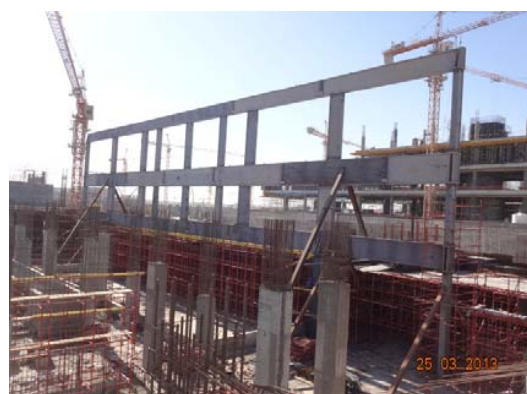
Fig. 4 (a) Installation of steel beams and columns (basement view)

The installation of steel beams and steel columns from ground floor view is illustrated in Figs. 4 (a) and (b). The complete structure after the installation of overhead crane girder is illustrated in Fig. 5. The spacing between the top of the overhead crane girder and the bottom of the beam is 250 mm.
