Non-Destructive Testing for Evaluation of Defects and Interfaces in Metal-Carbon Fiber Reinforced Polymer-Hybrids

H.-G. Herrmann, M. Schwarz, J. Summa, F. Grossmann

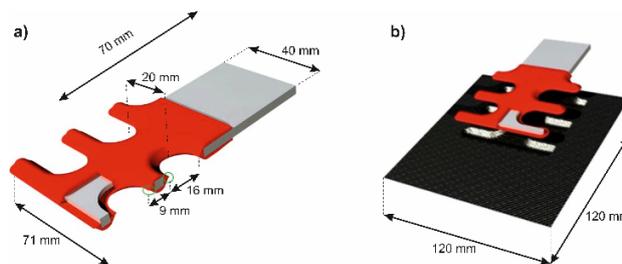
Fig. 1 (a) shows the geometric parameters of the 4-mm thick aluminum insert encased with a 2-mm thick PP layer. Fig. 1 (b) illustrates the positioning of the insert between the middle plies of the 1-mm thick CFRP-laminate.

Fig. 1 a) Geometric specification of the aluminum-PP insert, b) insert positioned between the CFRP-laminate [7]

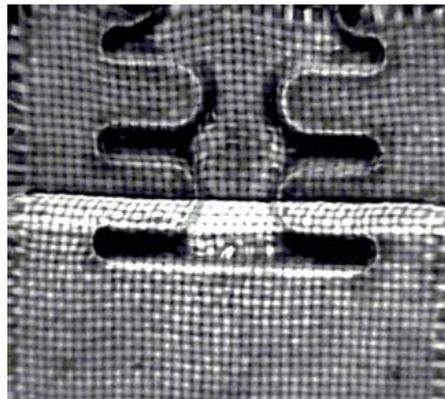
By using active thermography, hybrid samples are checked for defects. These measurements are performed after a quasistatic tensile test. In Fig. 3, a hybrid sample is shown 7 ms after flash excitation. In the infrared image, a bright area between the lower and the middle arm can be seen. This bright area represents an artificial induced pleat defect in the upper CFRP-layer. Additional impairment is not detectable at this time after flash excitation.

Fig. 3 Hybrid sample with artificial induced pleat defect, 7 ms after flash excitation

In Fig. 14, a correlation of the force and the area of a pleat is shown. It is expected that, by increasing the pleat-defect, the force decreases. But as depicted in Fig. 14, the force increases while the area of the pleat is increased. This circumstance can be explained by looking at Fig. 3. The pleat defect is above an aluminum arm of the insert which is the location for the most stress to occur. Due to the pleat, the area to relieve the tension increases. Furthermore, we get an additional layer which enforces the hybrid.

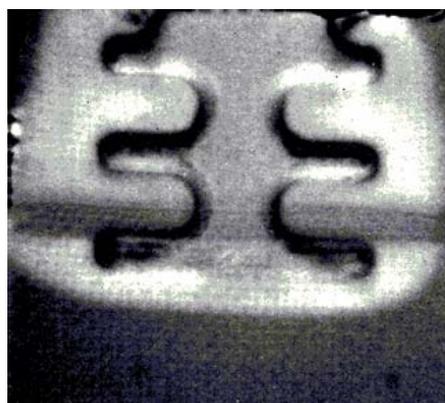
In Fig. 4, the same sample as in Fig. 3 is shown. The infrared image has been recorded 1.4 seconds after flash excitation. In addition to the pleat defect, a bright area around the aluminum insert can be detected. This bright area can be characterized as delamination between CFRP and thermoplastic.

Fig. 4 Hybrid sample with artificial induced pleat defect, 1.4 seconds after flash excitation

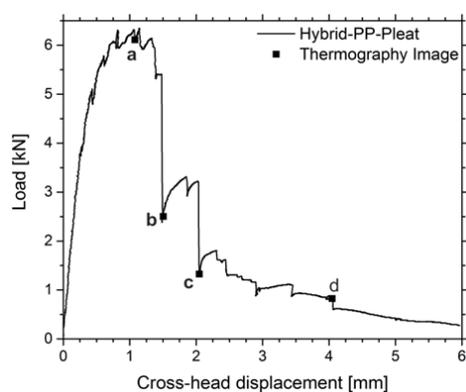
The damage evolution of the aluminum-CFRP hybrid joints was investigated by means of tensile tests with passive thermography. A representative tensile test of a specimen with a pleat is shown in Fig. 5. The corresponding measures with passive thermography are given in Fig. 6.

In the first stage linear behavior was found, which turns to nonlinear behavior above 0.25 mm. Subsequently, several discontinuities are found until the maximum load bearing capability is reached. The maximum value is 6.3 kN located at a displacement of 1.25 mm. After this point, the damage proceeds in a stick-slip manner until the load bearing capability vanishes. The events of damage propagation can easily be identified applying passive thermography (Fig. 6), as spontaneous heating accompanies the characteristic stick-slip behavior. Thus, especially new generated fracture surfaces are well visible. This technique provides information on the damage mechanism and the dimension of the damage. Furthermore, this information can be correlated with mechanical quantities from the force-displacement curve. As

Fig. 5 Force-displacement diagram of a defect-free hybrid-joint, dots: times of the four thermography images shown in the subsequent figure

Fig. 10 shows that the qualitative mechanical response remains the same, regardless of the defect-types. All samples fail in a stick-slip manner accompanied by a decrease of the bearable load. Thereby, several drops of the measured load occur, which can be attributed to delamination growth (see Figs. 5 and 6). Additionally, average-value curves are depicted in Fig. 11, as mechanical quantities are more comparable. Note that each curve is built out of five single tensile tests.

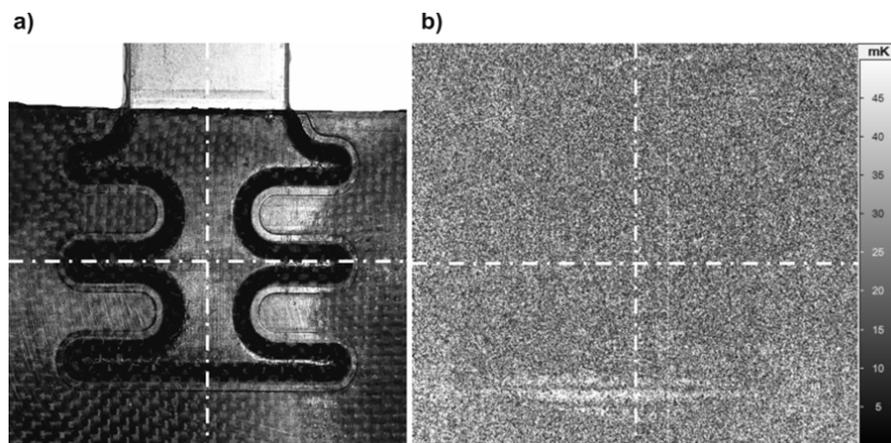
Fig. 7 (a) Position of the investigated specimen, (b) amplitude-image of lock-in thermography, with highlighted maximum and average values of T-amplitude

According to (1), the T-amplitude can be directly correlated to the acting stress. Hence, a stress concentration is located at the bright areas, which is underneath the insert. This measurement is in perfect agreement with the observation that the debonding between the PP and the CFRP starts in this region.

already mentioned, the force-displacement diagram shows several discontinuities before the maximum load is reached. These can be attributed to non-critical damages. One of these is depicted in Fig. 6 (a), emerging beneath the lowest arm of the insert. With this onset of damage, the debonding between PP and CFRP starts at the lowest point of the joining zone. Subsequently radial mode-I delamination propagates (Fig. 6(b) and (c)) until the fir tree formed insert is fully delaminated from the CFRP-laminate. This is accompanied by a vanishing load bearing capability (Fig. 6 (d)). This indicates firstly, that mode-I delamination is induced due to a pull-out effect of the insert, which is in good agreement with the observations of [6]. Secondly the damage somehow starts at the lower end of the insert. Therefore, additional investigations are carried out on the damage initiation using the thermoelastic stress analysis (Fig. 7).

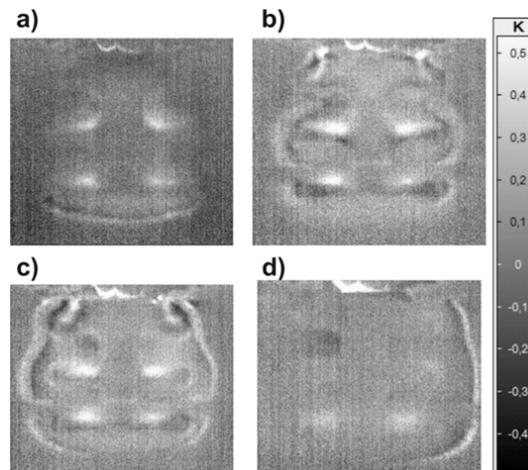
Fig. 6 Thermography images at displacements of (a) 0.98 mm, (b) 1.89 mm, (c) 2.21 mm, (d) 3.06 mm; ΔT -contrast

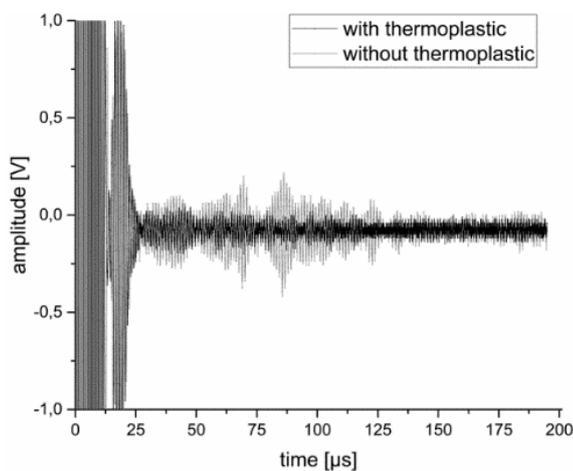
whereas all other signals overlap so that they cannot be clearly identified. Nevertheless, the condition of the aluminum insert can be characterized. In Fig. 9, the signal of an aluminum insert with thermoplastic (black line) is compared to the signal of an aluminum insert without thermoplastic (gray line). The signal of the aluminum insert with thermoplastic is significantly reduced. This can be seen especially at 70 μ s and 85 μ s. This indicates that the bonding to a thermoplastic causes an attenuation of the ultrasonic signal.

Fig. 9 Amplitude of ultrasonic signal in aluminum insert with and without a thermoplastic component

the transmitter and the receiver. The second and third signals are the reflection at the near and the far end of the plate, respectively. By moving the transmitter and the receiver, it is ensured that the signals do not overlap. However, in Fig. 9, only the first signal is separated and can be easily detected,

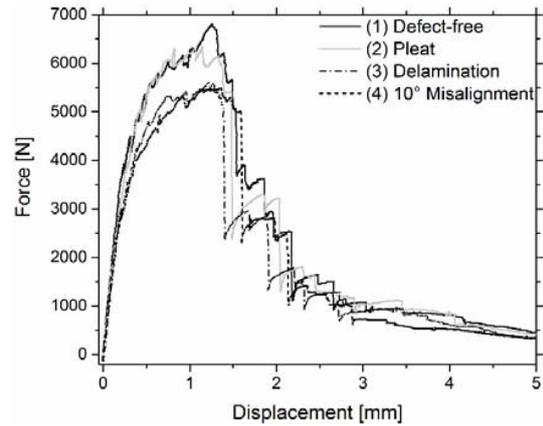
In order to evaluate the influence of the pre-selected defects, the specimens with and without these defects were subjected to tensile tests. Fig. 10 summarizes the results of tensile tests on hybrid-joints with pleat, delamination and 10° misalignment as well as defect-free ones.

Fig. 10 Force-displacement diagram of uniaxial tensile tests (2 mm/min cross-head speed) with hybrid joints containing different defect types

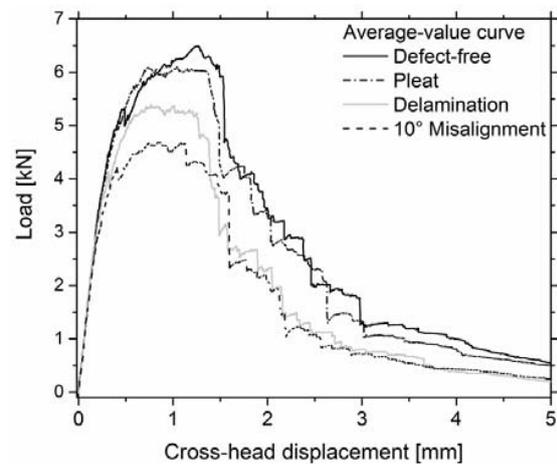
The average-value curves start to diverge at approximately 0.25 mm. From there, various differences are visible. One major effect of the implemented defects is the achieved maximum load, prior to rupture. Focusing on the proceeding damage, the relations between the curves remain similar. This tendency gets clearer as the results on the tensile tests can also be analyzed statistically by means of mechanical quantities, as shown in Fig. 12.

Fig. 11 Average-value curves of uniaxial tensile tests (2 mm/min cross-head speed) with hybrid joints containing different defect types

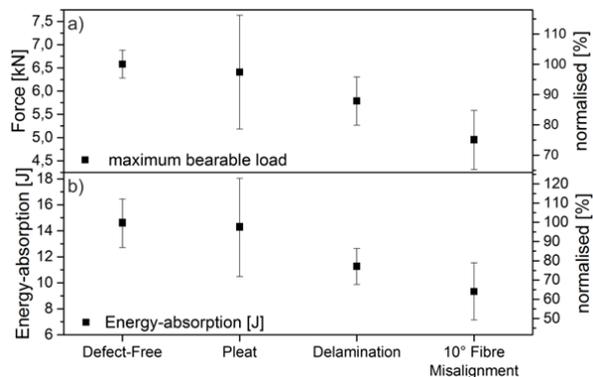
Fig. 12 Statistical analysis of a) load bearing capability (force of rupture), b) energy absorption

It can be found that the maximum load bearing capability hardly decreases due to the pleat. In contrast, the 10° misalignment causes a decrease of 25 % and delamination of 20 %. Likewise, the energy absorption (Fig. 12 (b)) shows the

same tendency as the load bearing capability. The decrease caused by the pleat is neglectable, whereas the energy absorption drops down below 80 % in presence of a delamination. Even higher affection is seen in case of the 10° misalignment reaching 65%.

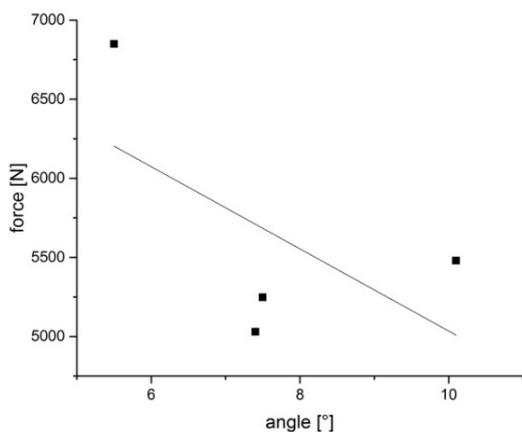
By comparing mechanical characteristics with thermographic results of defects, we are able to assess the state of the hybrid joint. In Fig. 13, a correlation of the loading force and the angle of misalignment has been performed. It can be noted that, by increasing the angle of the misalignment defect, the maximum force decreases.

Fig. 13 Correlation of force and angle of misalignment

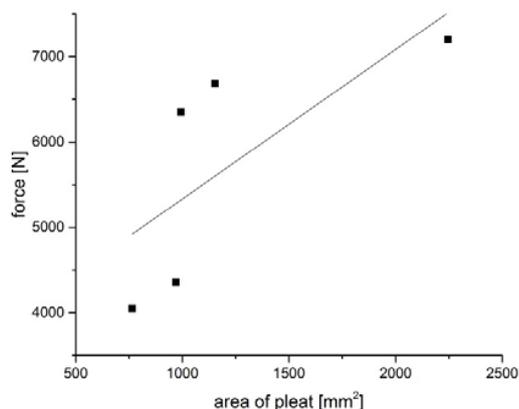
Fig. 14 Correlation of force and area of pleat
