Triplet Shear Tests on Retrofitted Brickwork Masonry Walls

Berna Istegun, Erkan Celebi

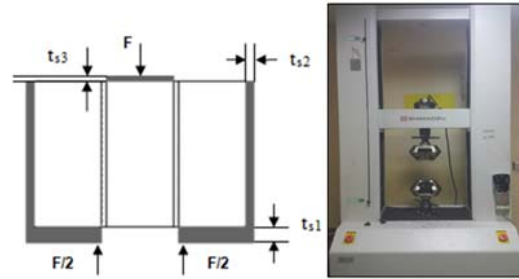
Test device in which all experiments conducted and the scheme of triplet test are illustrated in Fig. 3. The relevant thickness parameters (t_s) used in the triplet shear test are $t_{s1}=30$ mm, $t_{s2}=12$ mm and $t_{s3}=12$ mm, respectively.

Fig. 3 Scheme of triplet shear test and test device

In this study, all experimental tests were executed at the structural mechanics laboratory of Sakarya University. A vertical load-controlled cylinder having force capacity of 50 kN and loading rate of 1.5 mm/min. was applied perpendicularly to the triplet specimens to investigate the failure behavior of the two mortar joints under shear stress. Triplet shear tests were conducted on perforated brick blocks with and without seismic retrofitting.

A steel plate with a thickness of 12 mm was situated on the middle brick of the triplet specimen in order to reduce the influence of the bending moment and transmit the load properly to the mortar. For providing the stability of the test setup, the outer two bricks were also supported by two steel L profiles. The results of the experimental study are recorded by a displacement sensor integrated into the load cylinder.

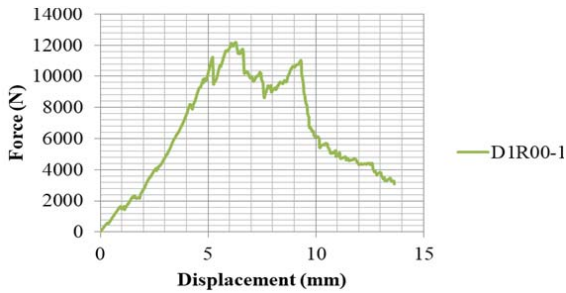
The maximum shear force F_{max} for this sample is obtained as 12200 N. The attained force-displacement relationship is illustrated in Fig. 5.

Fig. 5 Force-displacement diagram of the D1R00-1

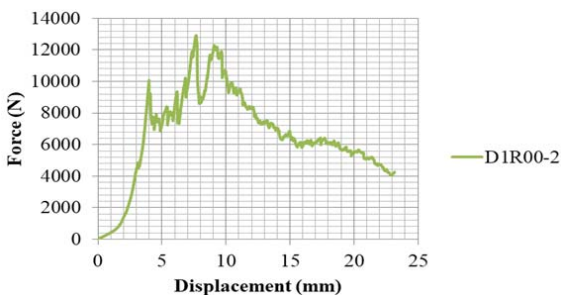
Fig. 7 Force-displacement diagram of the D1R00-2

As can be seen from Figs. 7 and 9, due to lack of ductility, the shear strength of the brick units suddenly decreased and brittle fractures occurred rapidly under stress. These damages are abrupt. The failure surface of specimen exhibits little degradation before the fracture occurs.

In this case, the shear strength, f_v are calculated as 0.117 MPa and 0.138 MPa by considering the experimentally

obtained maximum force of 12920 N and 15316 N, respectively.

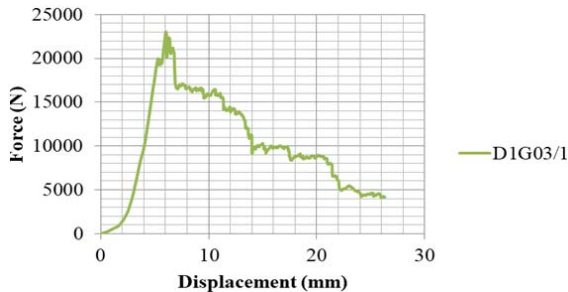
As shown in Fig. 11, the maximum shear force F_{max} is obtained as 23033 N and the corresponding shear stress value f_v is calculated as 0.209 MPa for specimen of D1G03-1.

Fig. 11 Force-displacement diagram of the D1G03-1

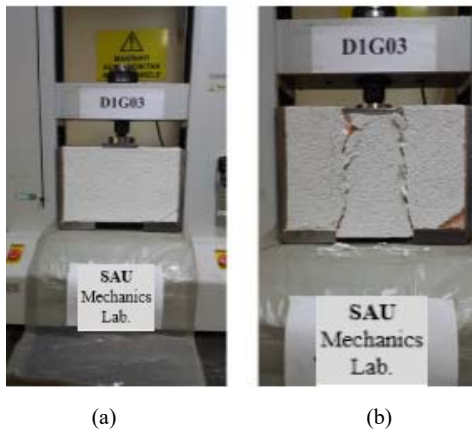
For the D1G03-2 and D1G03-3 specimens; crack patterns, maximum shear loads and strength parameters were similarly determined. The failure mechanism of the test specimens under the vertical load is shown in Figs. 12 and 14. The maximum shear forces of the second and third sample of the D1G03 test set are equal to 24548 N and 29427 N, respectively (Figs. 13 and 15).

Fig. 12 (a) Initial state and (b) final state of D1G03-2

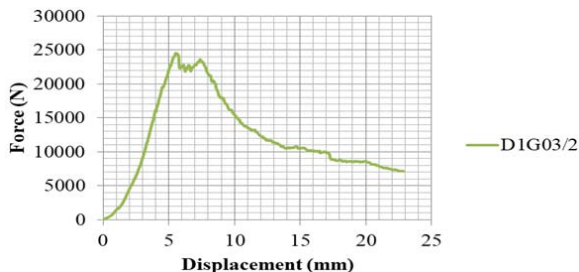
Fig. 13 Force-displacement diagram of the D1G03-2

The values of f_v are 0.220 MPa and 0.267 MPa for D1G03-2

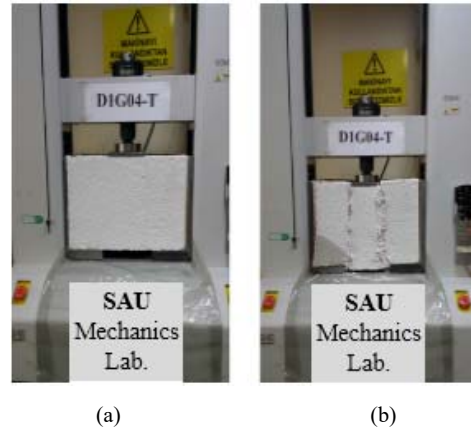
The failure modes of all plastered specimens were similar due to vertical cracks in the direction of loading, which followed the interface between the bricks and joint mortar (Fig. 20).

Fig. 20 (a) Initial state and (b) final state of D1G04-T/3

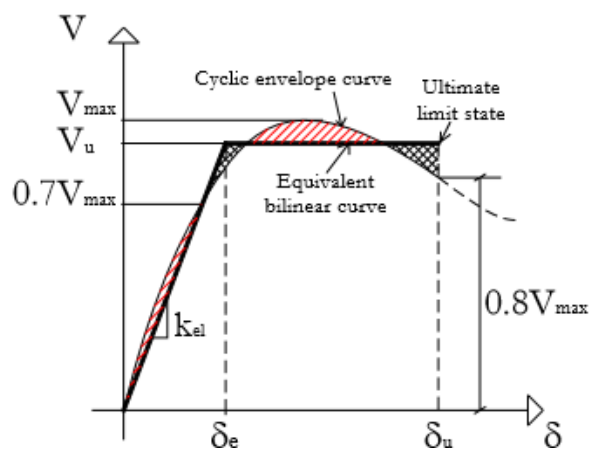
Magenes and Morandi [11] calculated the ductility coefficients by idealizing the envelope curve obtained from the experiment with equivalent bilinear curves (Fig. 22). In a similar way, the energy-dissipation capacities of the samples were determined (3), with the force-displacement curves being idealized in this research.

Fig. 22 Bilinear Idealization

$$\mu = \frac{\delta_u}{\delta_e} \quad (3)$$
