Tensile Test of Corroded Strand and Maintenance of Corroded Prestressed Concrete Girders

Jeon Chi-Ho, Lee Jae-Bin, Shim Chang-Su

Abstract—National bridge inventory in Korea shows that the number of old prestressed concrete (PSC) bridgeover 30 years of service life is rapidly increasing. Recently tendon corrosion is one of the most critical issues in the maintenance of PSC bridges. In this paper, mechanical properties of corroded strands, which were removed from old bridges, were evaluated using tensile test. In the result, the equations to express the mechanical behavior of corroded strand were derived and compared to existing equation. For the decision of tendon replacement, it is necessary to evaluate the effect of corrosion level on strength and ductility of the structure. Considerations on analysis of PSC girders were introduced, and decision making on tendon replacement was also proposed.

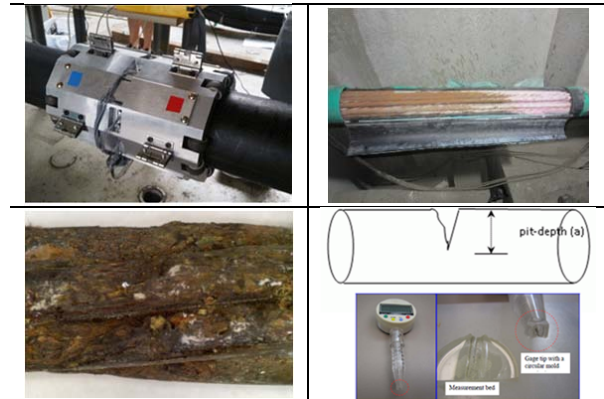
Fig. 1 Inspection procedure for corroded tendon

The first phase of the inspection of post-tensioned bridge is desk-top study to review design and construction details, previous inspection and maintenance record. Grout inspection consists of duct sounding, borescope inspection, grout sampling and non-destructive testing. In the practical maintenance work, there are several non-destructive evaluation (NDE) methods to inspect the corrosion of tendon such as Magnetic Flux Leakage (MFL), Electro-Impedance Spectroscopy (EIS), Impact Echo/Impulse Response (IE/IR), and so on [8]. Fig. 1 shows the corrosion inspection procedure with NDE. Once the suspected part to have corrosion is detected from the NDE, the corrosion state and speed should be evaluated by opening the duct. The corrosion state will account for the performance of corresponding tendon, and speed which is quantity of corrosion divided by time will be used to expect the performance change in the future. In the practical maintenance work, use of pit depth gauge is simple method to quantify the performance reduction of strand according to PTI specification [7], and maintenance method will be decided thereby. However, the use of pit depth has possibility to underestimate the corrosion of a tendon, because inner invisible strands are hard to be measured and considered to be not defective. For severe corrosion part, therefore, detailed corrosion inspection is required.

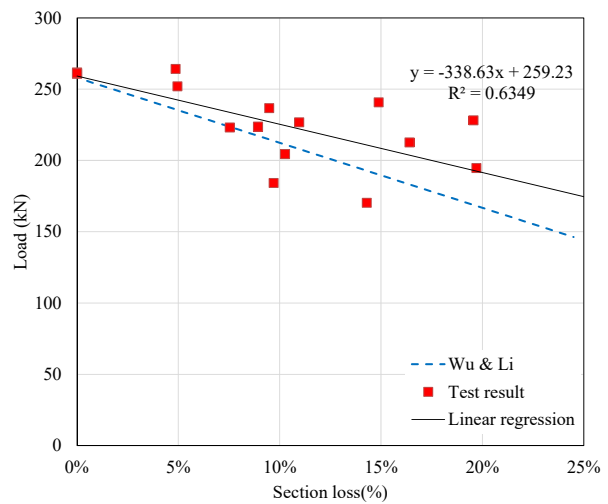
Figs. 4 and 5 show tensile test results of corroded strands according to section loss comparing to expression equation from Wu and Li. There are two differences from Wu and Li expression. One is corrosion degree which will be calculated as (5), because most corroded section will govern the behavior of the strand.

The other is naturally induced corrosion that has occurred over a couple of decades, while corrosion in the study of Wu and Li has occurred over 10 weeks. Therefore, the equation for ultimate strain shows much difference from test specimen. As mentioned above, most corroded section will govern the behavior of the strand; however, corrosion degree calculated based on weight loss can overestimates it because quantity of corrosion is accumulated along the length of a strand. That is the reason that equation from Wu and Li shows lower force comparing to the linear regression equation of test result.

Fig. 4 Test result of corroded strand

In this paper, different expression equations for corroded strand are suggested based on regression analysis of test result.

The ultimate force and strain of corroded strand can be modified from Wu and Li as (6) and (7).

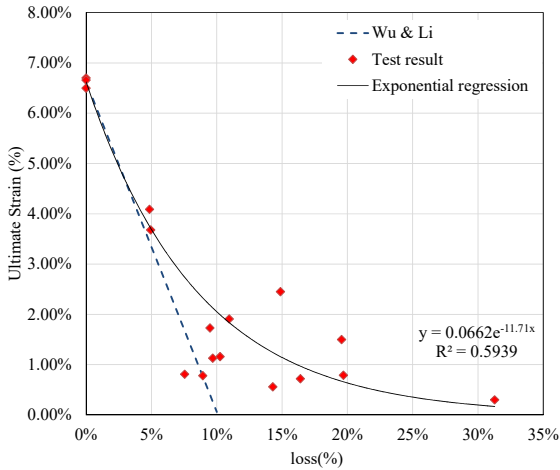
Fig. 5 Evaluation of corroded section
