# Analysis of Possible Causes of Fukushima Disaster

Abid Hossain Khan, Syam Hasan, M. A. R. Sarkar

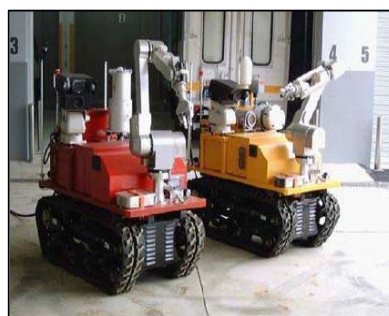
Fig. 4 MoniRobo-A and B [8]

NUSTEC developed MoniRobo-A and MoniRobo-B; robots that could monitor the exterior of a building in which an accident had occurred JAERI, now the Japan Atomic Energy Agency (JAEA), developed two REmote Surveillance Squad (RESQ)-A robots that were anticipated to be able to acquire initial information, such as beta and gamma dose level

Before Fukushima disaster, NUSTEC had kept MoniRobo-A and MoniRobo-B maintained. JAEA had stored RESQ-A, RESQ-B and RESQ-C but had not maintained them after 2006. These robots were not able to work as a result of some failures. The vendor that had co-operated when the robots were developed, was requested to repair RESQ-A, RESQ-B and RESQ-C, but the vender refused the request because the engineer who had involved had since left, with the result that necessary information had been lost. During Fukushima disaster, NUSTEC sent MoniRobo-A to J-Village, which became the base for the emergency response to Fukushima Daiichi accident. However, it was not deployed because it was considered to be too heavy and could damage cables and hoses that were temporarily setup for electric power supply and water supply [8].

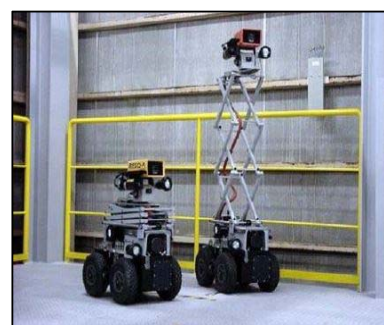
Fig. 5 RESQ-A [8]

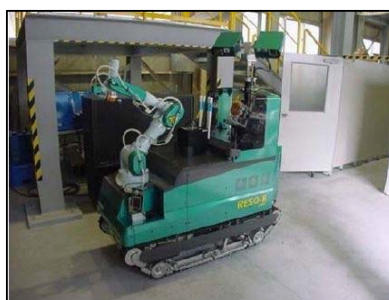
Fig. 6 RESQ-B [8]

data and neutron data, a REAQ-B robot that was to acquire detailed information, a RESQ-C that was to acquire samples, and a Radiation proof roBOT (RaBOT) that could be resistant to radiation. These robots were planned to monitor the insides of buildings, when accidents have occurred in the buildings, so RESQ-B, RESQ-C and RaBOT were equipped with arms that could deal with opening door handles. MSTC developed an operation assistance robot SMERT-K for quick reconnaissance, an operation assistance robot SMERT-M which could carry SMERT-K and run over rubble, a light operation robot SWAN, an operation robot MARS-A, a heavy transporter robot MARS-T, and an anti-high radiation robot MENHIR [8].

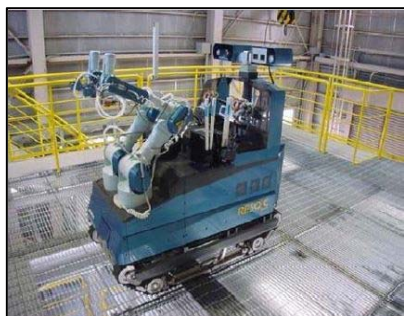
Fig. 7 RESQ-C [8]

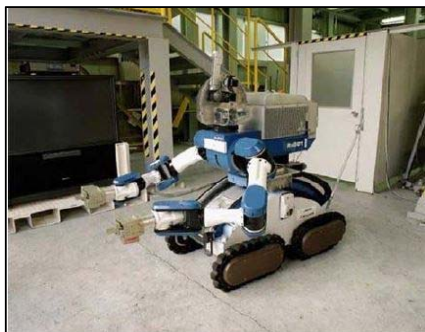
Fig. 8 RaBOT [8]

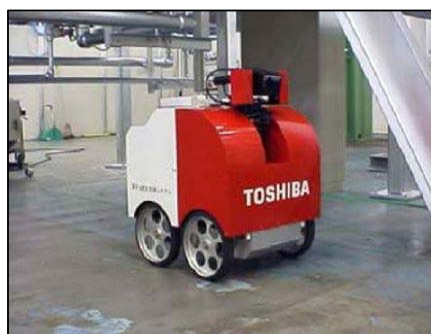
Fig. 9 SMERT-K [8]
