Performance Analysis of Ferrocement Retrofitted Masonry Wall Units under Cyclic Loading

Raquib Ahsan, Md. Mahir Asif, Md. Zahidul Alam

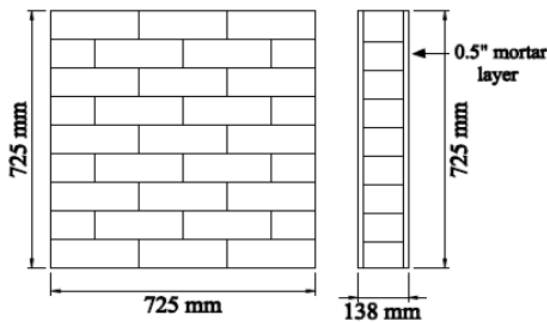
Four masonry wall specimens were investigated. Two of them were control specimens (bare masonry wall) denoted as URM (for partially reversed cyclic loading) and URM-C (for cyclic compression) whose final section size stood 725 mm × 725 mm × 138 mm as shown in Fig. 1. The other two were ferrocement retrofitted specimens denoted as FRS-20 (for partially reversed cyclic loading) and FRSC-20 (for cyclic compression) whose final section size stood 725 mm × 725 mm × 163 mm as shown in Fig. 2. All the bricks were connected by stretcher bond. 12.5 mm mortar was used between two adjacent layers of bricks. Between ferrocement layer and brick wall 37.5 mm standard nails were placed at a spacing of 150 mm c/c at alternate brick layers and embedded to 25 mm into the wall.

Fig. 1 Control Specimens

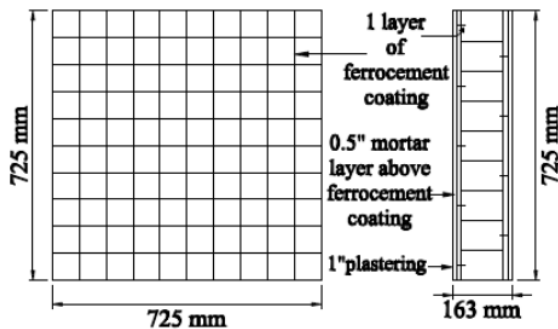
Fig. 2 Ferrocement Retrofitted Specimens

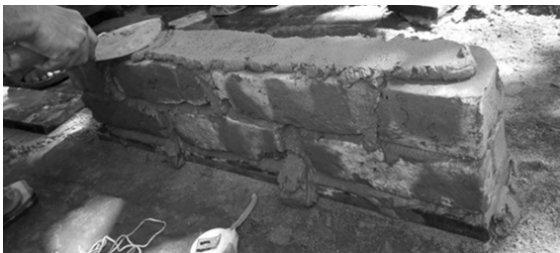
Proper preparation of specimens is one of the important conditions for obtaining accurate results from structural tests. Four walls were prepared with bricks and mortar. Mortar preparation is the first stage which is necessary for brick bonding. For brick jointing the ratio 1:4 (cement: sand) was used in mortar. After preparation of mortar, the brick walls

were built as shown in Fig. 3.

Fig. 3 Construction Process of Brick Wall

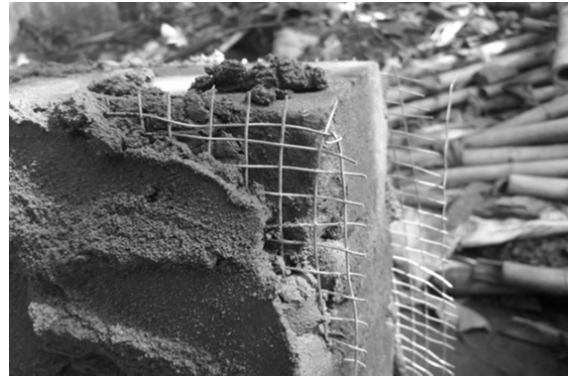
plastered with 12.5 mm mortar on both faces. Now 20 gauge woven wire meshes were wrapped on two walls (FRS-20 and FRSC- 20) on both faces. 12.5 mm mortar was again applied on these wrapped wire meshes to complete the ferrocement work. Fig. 4 represents the state of a wall after the completion of applying ferrocement coating.

Fig. 4 Brick Wall After Applying of Ferrocement Coating

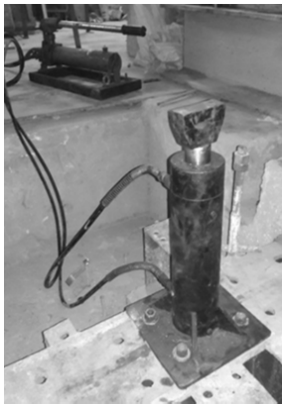
After completion of preparation, the walls were ready to be tested by testing machine. A hydraulic jack was used to apply cyclic load to the specimens as showed in Fig. 5. The hydraulic jack was pressure operated and its maximum capacity was 150 Mpa. Two M-shaped steel frames were also used in this experiment. One steel frame was attached with the hydraulic jack.

Fig. 5 Hydraulic Jack

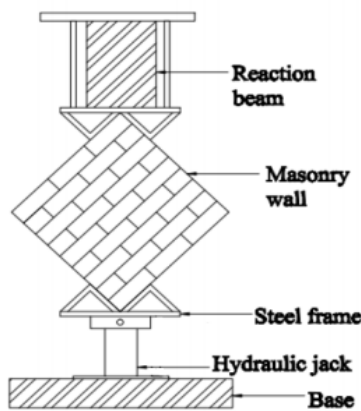
Another M-shaped steel frame was attached with reaction beam. Pure epoxy binder was applied at the interface of brick wall and steel frame allowing the application of tensile force. A dial gauge was used in this experiment to measure the deflection of the specimen along both directions with the precision of 0.01 mm. Schematic diagram of full experimental

setup of our experiment is pictured in Fig. 6.

Fig. 6 Schematic Diagram of Experimental Setup

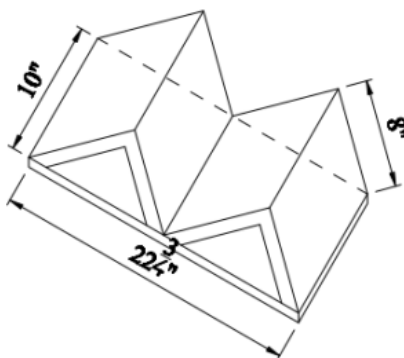
It should be noted that, two M-shaped steel frames were used to hold the specimen diagonally. So the dimension of each of this steel frame should be such that it can properly hold the specimen. Fig. 7 represents its dimension.

Fig. 7 M-Shaped Steel Frame

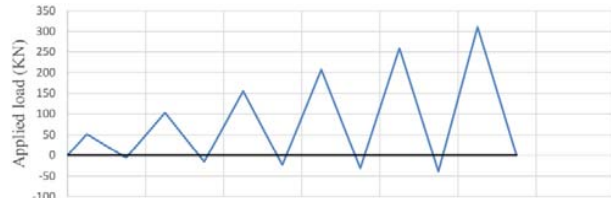
Partially reversed cyclic loading i.e. a complete loading cycle consists of both compression half cycle and tension half cycle was applied on specimen URM and FRS-20 as shown in Fig. 8. Applied tensile force was 15% of the compressive force for each cycle.

Fig. 8 Load History of Specimen URM and FRS-20

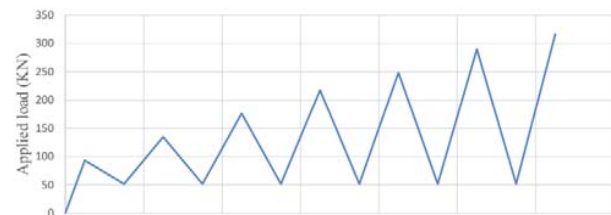
Cyclic compression i.e. loading cycle only consists of compressive force was applied on URM and FRS-20 maintaining 51.5 KN of residual compression as showed in Fig. 9. Maximum value of compressive force per cycle was increased with the increment of cycle number.

Fig. 9 Load History of Specimen URM and FRSC-20

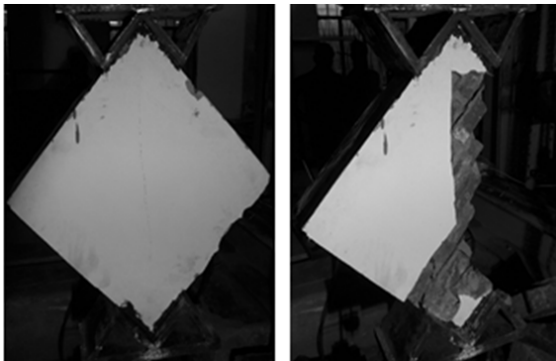
After applying partially reversed cyclic load on URM, first crack appeared on the surface along the diagonal of the specimen as shown in Fig. 10 (a) at the load of 155.15 KN during 3rd cycle under compression and corresponding deformation was 2.05 mm. Crack started to extend along the diagonal with the increment of load. Finally failure occurred by diagonal splitting of the specimen as shown in Fig. 10 (b) at the load of 206.97 KN and corresponding deformation was 4.1 mm. Failure occurred along the mortar joint.

Fig. 10 (a) First Crack Pattern and (b) After Failure State of URM

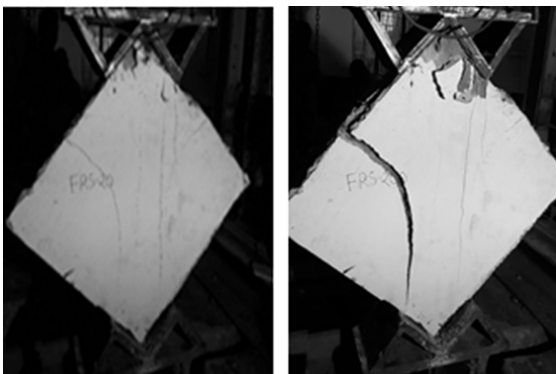
After applying partially reversed cyclic load on FRS-20, First crack on the surface occurred on the surface along the diagonal as shown in Fig. 11 (a) at the load of 258.79 KN during 5th cycle under compression and corresponding deformation was 5.7 mm. Gradually this crack extended further along the diagonal and was accompanied by a series of small cracks. Finally complete failure of the specimen occurred along the diagonal as shown in Fig. 11 (b) at the load of 280.59 KN and corresponding deformation was 5.9 mm. Failure occurred due to both mortar joint failure and brick

failure under compression.

Fig. 11 (a) First Crack Pattern and (b) After Failure State of FRS-20

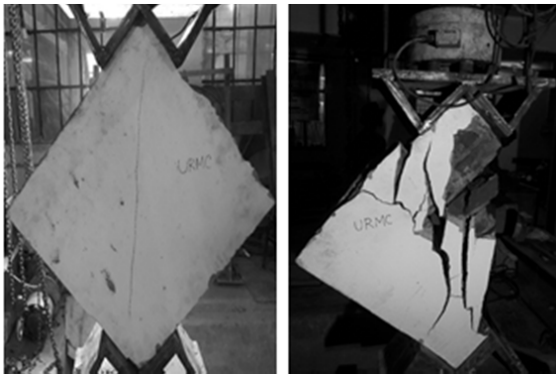
Fig. 12 (a) First Crack Pattern and (b) After Failure State of URM

After applying cyclic compression on URM, first crack appeared on the surface along the diagonal of the specimen as shown in Fig. 12 (a) at the load of 217.49 KN during 4th cycle under compression and corresponding deformation was 4.69 mm. Crack started to extend along the diagonal with the increment of load. Finally failure occurred by diagonal splitting of the specimen as shown in Fig. 12 (b) at the load of

248.61 KN and corresponding deformation was 4.93 mm. Failure occurred along the mortar joint.

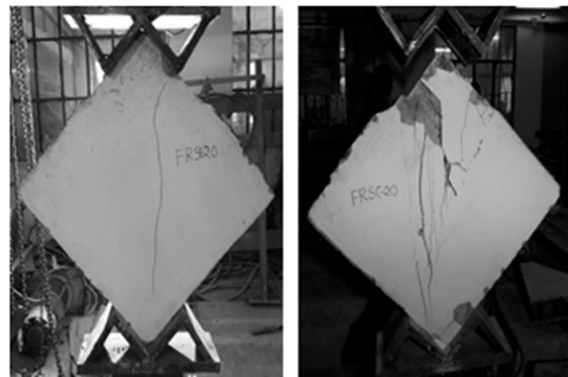
After applying cyclic compression on URM, first crack on the surface occurred on the surface along the diagonal as shown in Fig. 13(a) at the load of 290.11 KN during 5th cycle under compression and corresponding deformation was 5.97 mm. Gradually this crack extend further along the diagonal and was accompanied by a series of cracks. Finally complete failure of the specimen occurred along the diagonal as illustrated in Fig. 13 (b) at the load of 316.62 KN and corresponding deformation was 6.56 mm. Failure occurred due to both mortar joint failure and brick failure under compression.

Fig. 13 (a) First Crack Pattern and (b) After Failure State of FRSC-20

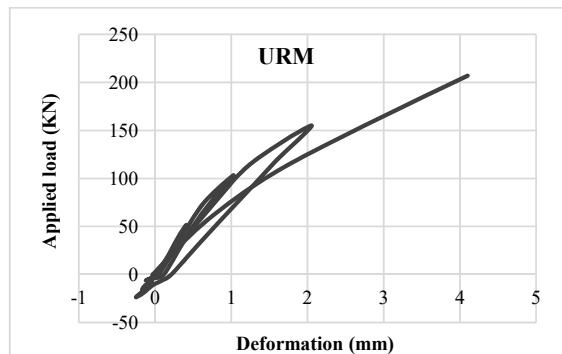
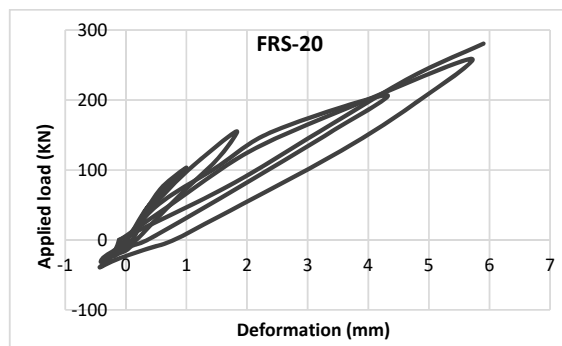
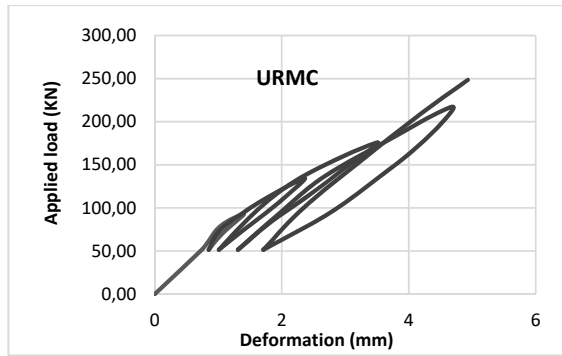
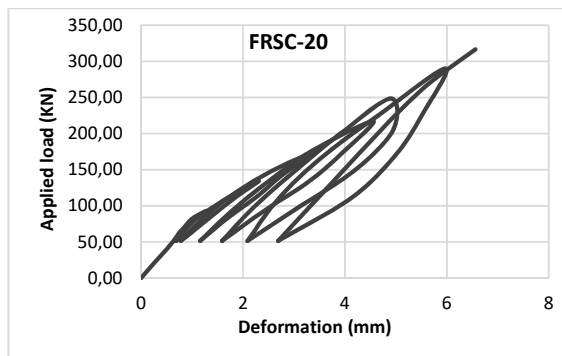
Fig. 14 Load-Deformation graph of (a) URM (b) FRS-20 (c) URM (d) FRSC-20

The load-deformation curves of all specimens are expressed in Fig. 14.

It is obtained from the graph that stiffness of the ferrocement retrofitted specimens is greater than the control specimens. The ferrocement retrofitted specimens also showed greater ductility. Stiffness of both retrofitted specimens and control specimens decreases with the increment of each cycle.

Before failure, the ferrocement retrofitted specimens experienced 43% and 33% greater deformation than the unreinforced specimens under partially reversed cyclic loading and cyclic compression respectively. Also, 72% deformation increment of ferrocement retrofitted specimen in tensile force was found over control specimen. This indicates that ductility of the masonry wall was enhanced due to the ferrocement overlay. Moreover, the improvement of stiffness of the specimens for using ferrocement coating was also clear from load-deformation graphs.
