The Application of Distributed Optical Strain Sensing to Measure Rock Bolt Deformation Subject to Bedding Shear

Thomas P. Roper, Brad Forbes, Jurij Karlovšek

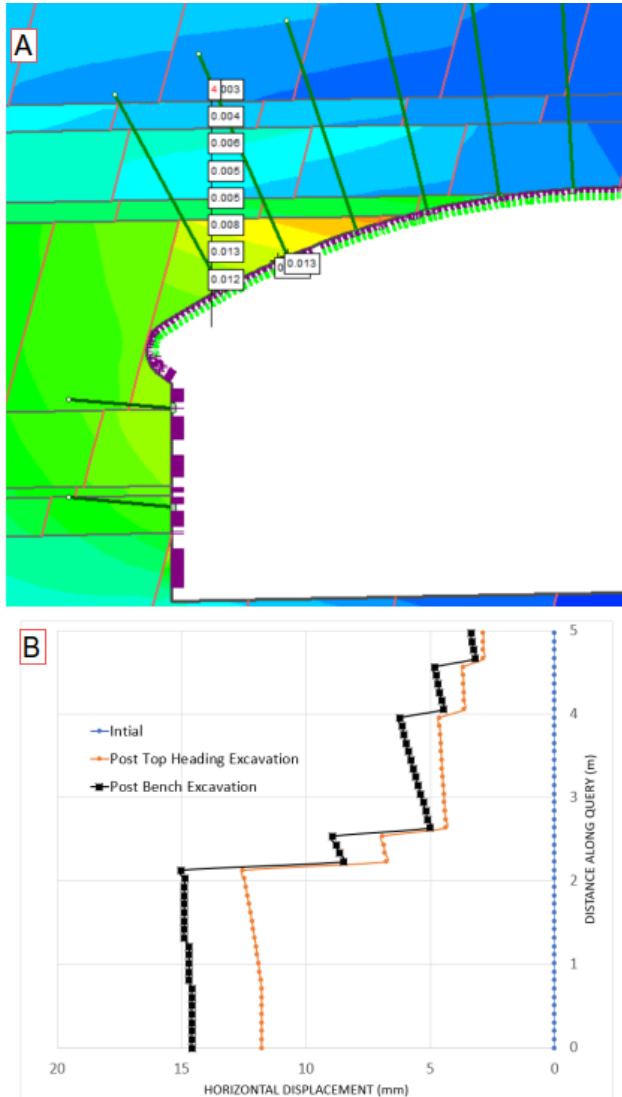
Fig. 1 (A) RS2 model of typical Hawkesbury Sandstone tunnel at 60 m depth after heading excavation and bench excavation (B) Horizontal displacement query above the tunnel shoulder showing displacement along the bedding planes (bedding shear) after heading and bench excavation

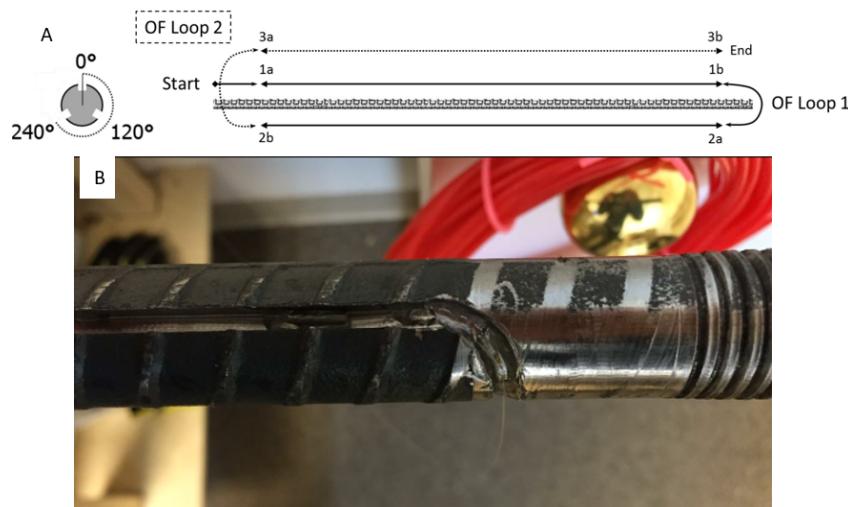
Fig. 3 A) Schematic representation of the optical sensor embedded in to the bolt in to the bolt at 120° spacing. Xa to Xb represents one sensing length of the bolt. These lengths are used allocate strain to the appropriate section of cable for accurate calculation B) photograph of the 2 mm x 2 mm milled groove in the bolt

DCP rock bolts with milled grooves at 120° spacing (Fig. 3) were made for the project. An optical fiber is looped around the bolt in these grooves and encapsulated with a resin. Knowing the length of each groove, elastic bending theory can be used to separate the coaxial strain and lateral strain using the method in [4]. A 3D strain profile is the result. Using DOS, strain can be measured every 0.65 mm along the bolt, which is equivalent to thousands of strain gauges. The maximum strain can be determined regardless of the installation orientation. This monitoring solution provides the accuracy and resolution required for monitoring of discrete deformation along the rock bolts.

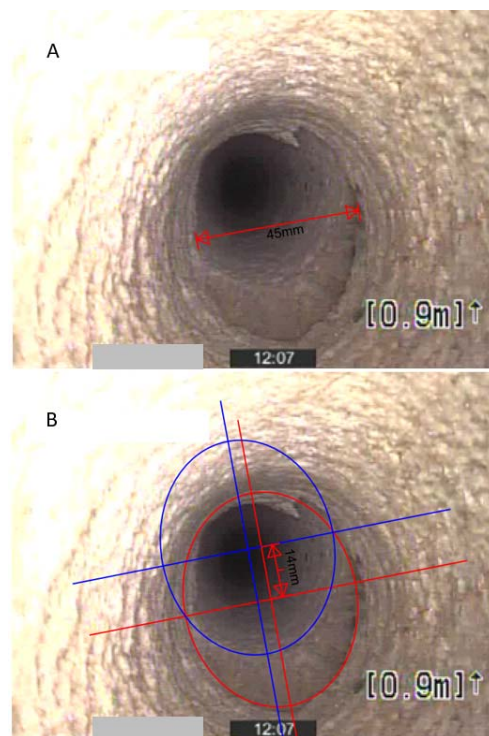
Fig. 8 Image captured in a borescope hole adjacent to the FOS bolt in Fig. 7; the 45-mm hole is off-set by ~14 mm following bedding shear

During the excavation of an adjacent cross-passage a ground displacement ‘event’ occurred. Using the local industry-standard method of monitoring (and inferring) shear damage on bolts, through the borescope holes, bedding shear displacement of ~14mm was recorded (Fig. 8) along a very ‘clean’ and simple bedding shear plane. Several geologists and engineers independently scaled the same borescope hole and all estimated this value with ± 2 mm. The adjacent DOS monitoring bolt measured similar lateral displacement as shown in Fig. 7 of 14 mm. The bolt’s ‘S’ shaped reaction occurred over a 290 mm section of the bolt, giving insight to the elongation geometry occurring around a bedding shear. Coaxial strain of $8720 \mu\epsilon$ was measured corresponding to a load of 200-225 kN through the rebar at this bedding shear location. This triggered the reinstallation of rock bolts. The two bolts on the left-hand side of Fig. 6 were damaged by equipment after the displacement event following shotcrete repairs and re-installation of bolts so unfortunately the post deformation event measurement could not be taken on these bolts. A visualisation of the behaviour measured in Figs. 6 and 7 can be seen in Fig. 9. In similar ground conditions, a temporary DCP rock bolt can be seen in cross section above the tunnel, after secondary excavation above a tunnel in creating a cavern and exposing the previously installed ground support. A DCP bolt is seen to intersect a bedding plane (between a sandstone bed and a siltstone bed) and dilated concentric fracturing. The bolt is resisting both the dilation of the concentric fracturing and (likely) shear along the bedding plane keeping the blocks secure. A ‘real world example’ of the behaviour models, such as that in Fig. 1, is represented. Having the opportunity to visually capture this behaviour is rare; however, the use of FOS monitoring bolts allows the capture and measurement of it.
