The Performance and the Induced Rebar Corrosion of Acrylic Resins for Injection Systems in Concrete Structures

C. S. Paglia, E. Pesenti, A. Krattiger

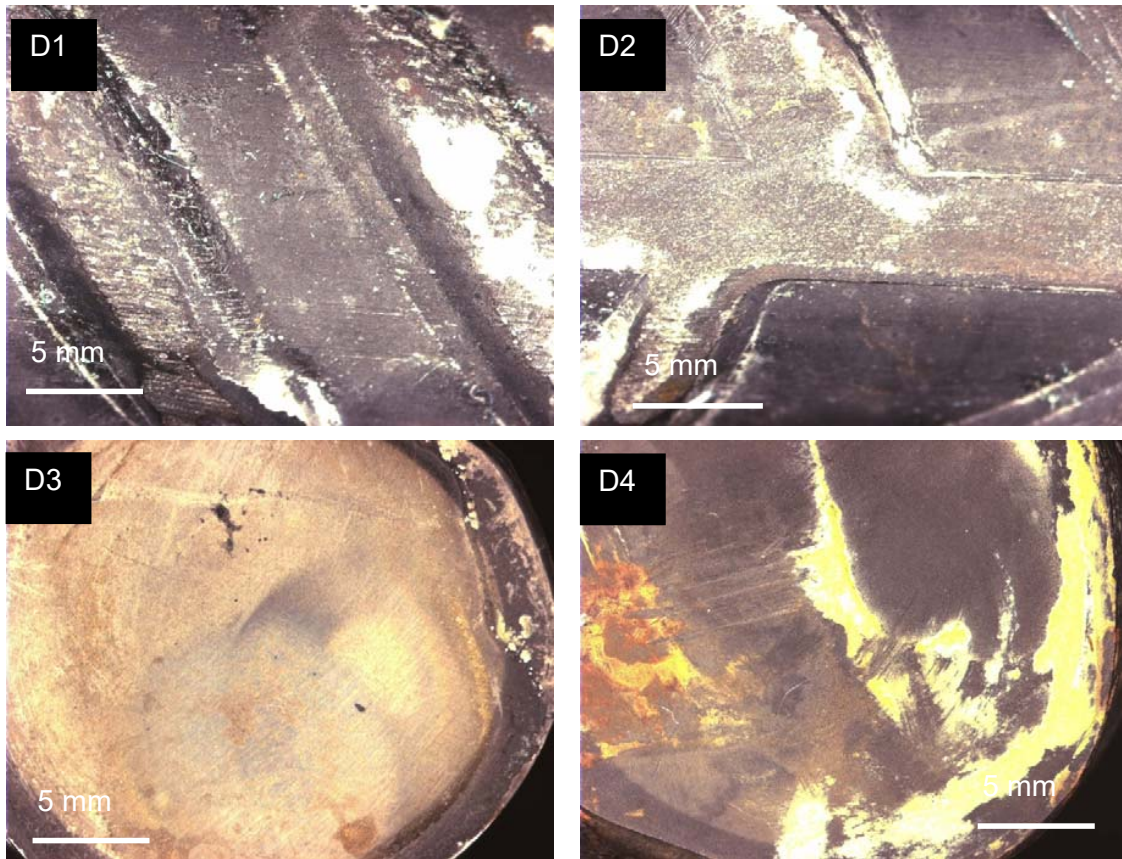
Fig. 8 Detailed view of the rebar in contact with resin D. The corrosion of the rebar immersed in the resin (D1, D3) or in the aqueous solution D (D2, D4) is basically absent

For resin D (methacrylate-based), the corrosion is generally absent for the rebar region immersed in the resin as well as for the rebar region immersed in the aqueous solution D (Fig. 8).
