# Amine Solution Recovery Package and Controlling Corrosion in Regeneration Tower

**Abstract**—Sarkhoon gas plant, located in south of Iran, has been installed to removal H<sub>2</sub>S contained in a high pressure natural gas stream. The solvent used for the H<sub>2</sub>S removal from gaseous stream is 34% by weight (wt%) Di-ethanol amine (DEA) solutions. Due to increasing concentration of heat stable salt (HSS) in solvent, corrosivity of amine solution had been increased. Reports indicated that there was corrosion on the shell of regeneration column. Because source formation of HSS was unknown, we decided to control the amount of HSS at the limit less than 3% wt amine solvent. Therefore, two small columns were filled by strong anionic base and carbon active, and then polluted amine was passed through beds. Finally a temporary amine recovery package on industrial scale was made based on laboratory's results. From economical point of view we could save \$700000 beside corrosion occurrence of the stripping column has been vigorously decreased.

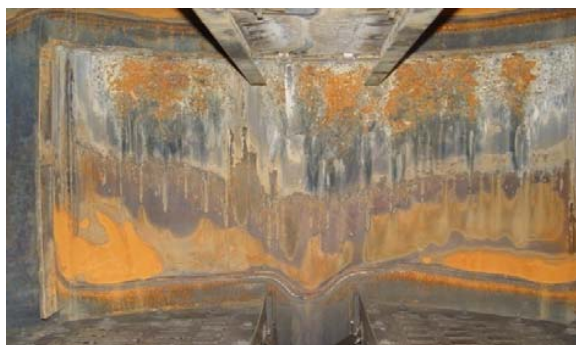
Because of increasing HSS in DEA solutions, amine regenerator column had faced with huge corrosion on shell side especially at places between trays is which continent of vapor most likely had had (fig 1).

Fig. 1 Corrosion on shell on vapor area

Due to visual check of regenerator during its overhaul – based on inspection on inspection department report we had about 3.4mm corrosion at different site on shell of regenerator

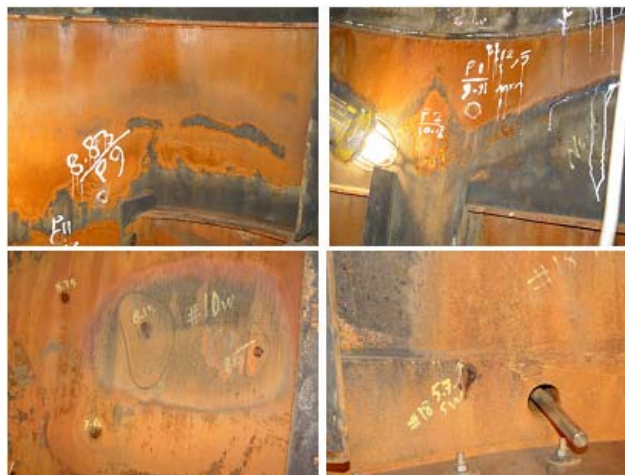
Fig. 3 CORROSION on Different Side of Shell(Top left to right ,Tray 9, tray 8, Bottom left to right ,Tray 10, Tray 18)

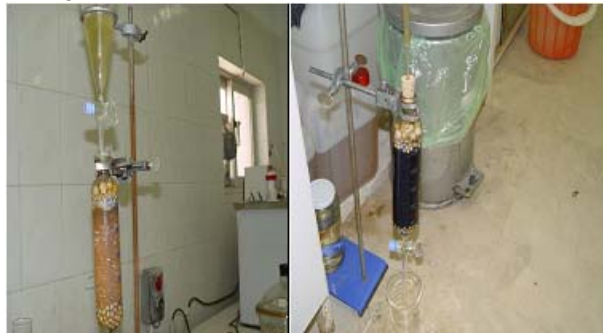
Lean amine solution feed through a bubbler in to an activated column filter and the resin column. The ion exchange resin removes the heat stable salts and the purified amine solution is collected for further analysis. Diluted caustic soda is used to regenerate the resin column.

Fig. 4 Laboratory set up of (Left Resin Bed, Right Carbon Active bed)

Laboratory scale .The HSS in solution were at approximately 3.5 wt% ( as DEA ) when laboratory test started to removal HSS form the solution .In order to reduce level of HSS to 0.5/wt% which strong ion resin studied an onions strong resin type was selected and all experimental test on it . As shown (figure4) our set up was consist of two 250 glass (decanter) which used as anionic resin column and activated carbon .That scope was removing HSS and fine Particles and color of amine(figure 5) by means of those manipulated column respectively .

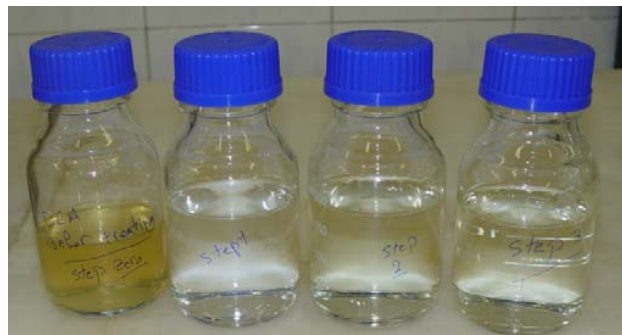
Fig. 5 Quality of sample in inlet and outlet of resin and carbon active beds(left. 1st, polluted amine right, 2st to 4rd batch of outlet bed)
