# An Investigation of Shipping Comb Failures due to usage in Manufacturing Processes using RCFA and FMEA

**Abstract**—Shipping comb is mounted on Head Stack Assembly (HSA) to prevent collision of the heads, maintain the gap between suspensions and protect HSA tips from unintentional contact damaged in the manufacturing process. Failure analysis of shipping comb in hard disk drive production processes is proposed. Field observations were performed to determine the fatal areas on shipping comb and their failure fraction. Root cause failure analysis (RCFA) is applied to specify the failure causes subjected to various loading conditions. For reliability improvement, failure mode and effects analysis (FMEA) procedure to evaluate the risk priority is performed. Consequently, the more suitable information design criterions were obtained.

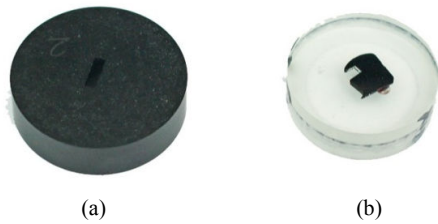
lower surface hardness than rejected comb which mean the softer surface as indicated in table 1. Thus, it can conclude that the thermal load in manufacturing process affect the mechanical properties by harden the comb surface. Statistical analysis of tested data illustrated was calculated base on 95% confidence interval. Results of one-way ANOVA indicates significant difference in hardness between new and rejected shipping comb ( $P\text{-value} = 0.02 < 0.05$ ). To ensure that the thermal effect influence the surface hardness variation, shipping comb from same batch were attached to the bases using hot and cold mounting technique as shown in figure 9. Indentation results show statistically significance of level difference.

Fig. 9 Thermal effect evaluations using (a) hot mounting technique (b) cold mounting technique
